Profile/Photo Observation Report

Street:	RANDOLPH PL & E 33RD AVE	Flow Control:	Not Controlled
City:	Hobart, IN	Year Renewed:	
Location:	Main Highway - Suburban/Rural	Tape/Media #:	
Purpose:	Resurvey	Dia/Height:	10"
Use:	Sanitary	Material:	VCP
Drain Area:	NA	Lining:	
Category:	NA		
Comment:

Location Details:		Direction of Survey:	Downstream
US MH:	M-902-025	DS MH:	M-902-024
		Total Length Surveyed (ft):	199.9

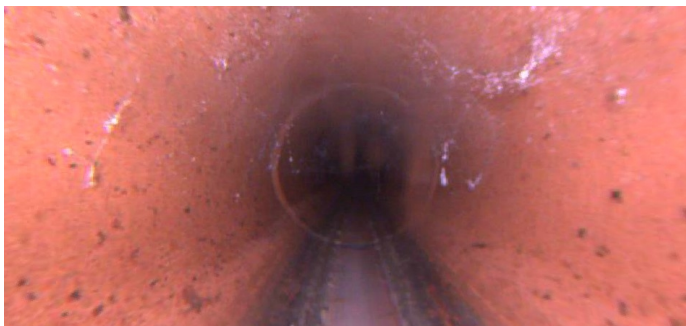
Code: **AMH**
Description: **Manhole**

Distance (ft): **.0**
Structural Grade: **0**
O&M Grade: **0**
Clock Start/From:
Clock To:
1st Value:
2nd Value:
Value Percent:
Continuous Index:
Within 8" of Joint: **NO**
Remarks: **M-902-025**

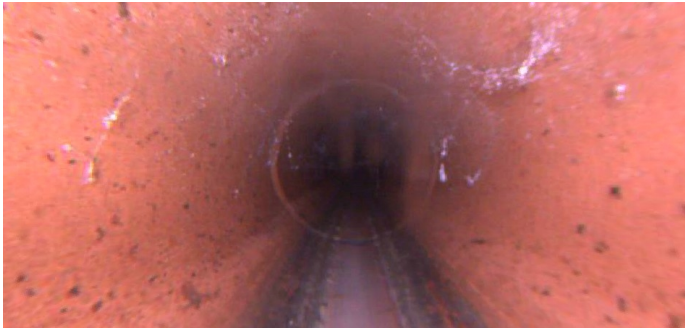
Code:	MWL
Description:	Water Level

Distance (ft):	.0
Structural Grade:	0
O&M Grade:	0
Clock Start/From:	
Clock To:	
1st Value:	
2nd Value:	
Value Percent:	5.000
Continuous Index:	
Within 8" of Joint:	NO
Remarks:

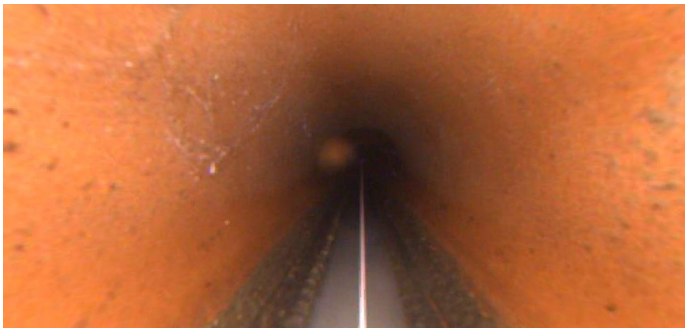
Code:	MGO
Description:	General Observation

Distance (ft):	11.7
Structural Grade:	0
O&M Grade:	0
Clock Start/From:	
Clock To:	
1st Value:	
2nd Value:	
Value Percent:	
Continuous Index:	
Within 8" of Joint:	NO
Remarks:	Switching to rear camera

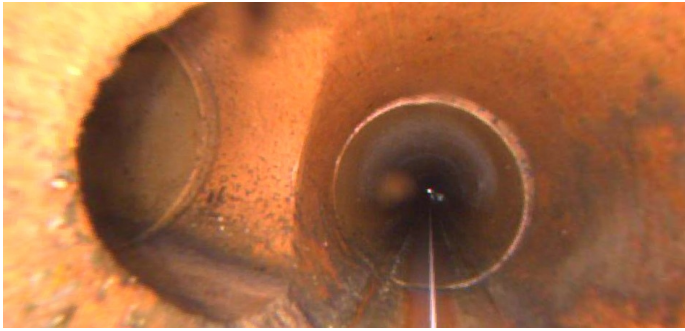
Code: **TF**
Description: **Tap Factory**

Distance (ft): **57.8**
Structural Grade: **0**
O&M Grade: **0**
Clock Start/From: **3**
Clock To:
1st Value: **4.000**
2nd Value:
Value Percent:
Continuous Index:
Within 8" of Joint:
Remarks:

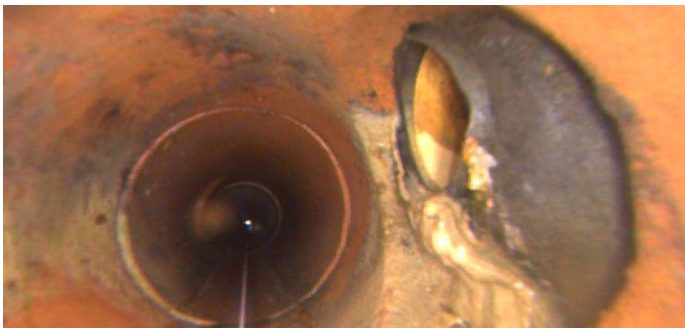
Code: **TB**
Description: **Tap Break-in**

Distance (ft): **59.7**
Structural Grade: **0**
O&M Grade: **0**
Clock Start/From: **10**
Clock To:
1st Value: **4.000**
2nd Value:
Value Percent:
Continuous Index:
Within 8" of Joint:
Remarks:

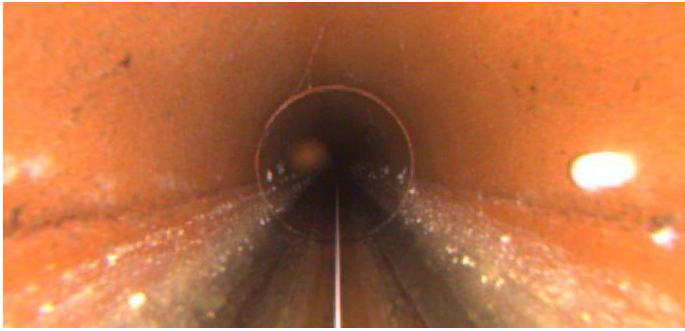
Code: **DAGS**
Description: **Deposits Attached Grease**

Distance (ft): **136.5**
Structural Grade: **0**
O&M Grade: **2**
Clock Start/From: **4**
Clock To: **8**
1st Value:
2nd Value:
Value Percent: **5.000**
Continuous Index: **S01**
Within 8" of Joint: **NO**
Remarks:

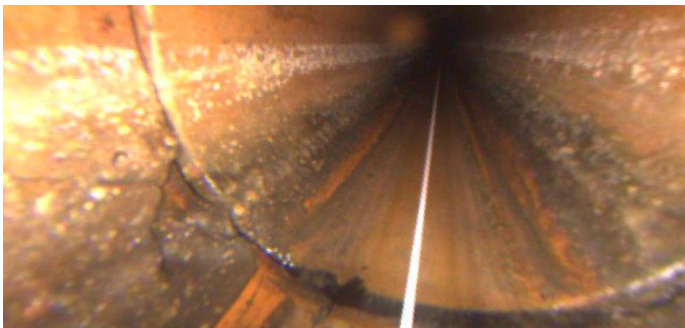
Code: **FM**
Description: **Fracture Multiple**

Distance (ft): **145.5**
Structural Grade: **4**
O&M Grade: **0**
Clock Start/From: **4**
Clock To: **5**
1st Value:
2nd Value:
Value Percent:
Continuous Index:
Within 8" of Joint: **YES**
Remarks:

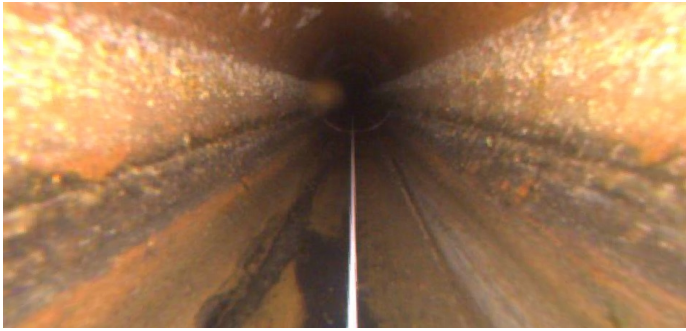
Code: **DSF**
Description: **Deposits Settled Fine**

Distance (ft): **149.5**
Structural Grade: **0**
O&M Grade: **2**
Clock Start/From: **5**
Clock To: **7**
1st Value:
2nd Value:
Value Percent: **5.000**
Continuous Index: **S02**
Within 8" of Joint: **NO**
Remarks:

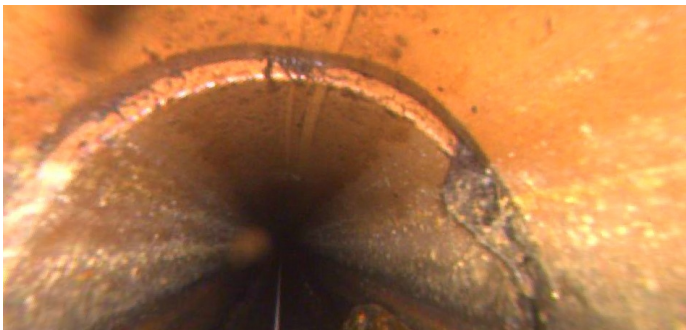
Code: **RFJ**
Description: **Roots Fine Joint**

Distance (ft): **170.3**
Structural Grade: **0**
O&M Grade: **1**
Clock Start/From: **8**
Clock To: **12**
1st Value:
2nd Value:
Value Percent:
Continuous Index:
Within 8" of Joint: **YES**
Remarks:

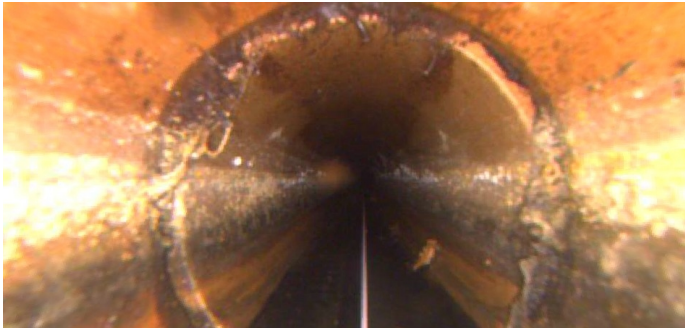
Code: **RFJ**
Description: **Roots Fine Joint**

Distance (ft): **180.4**
Structural Grade: **0**
O&M Grade: **1**
Clock Start/From: **7**
Clock To: **3**
1st Value:
2nd Value:
Value Percent:
Continuous Index:
Within 8" of Joint: **YES**
Remarks:

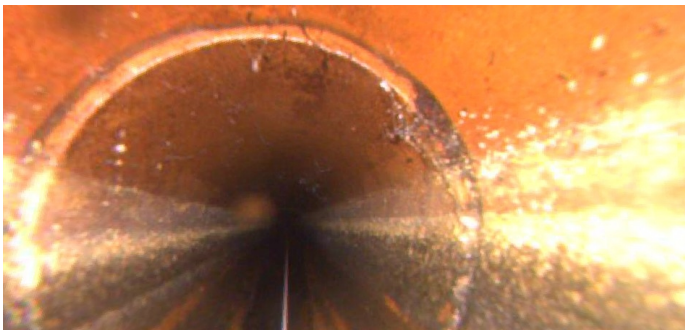
Code: **RFJ**
Description: **Roots Fine Joint**

Distance (ft): **190.2**
Structural Grade: **0**
O&M Grade: **1**
Clock Start/From: **9**
Clock To: **10**
1st Value:
2nd Value:
Value Percent:
Continuous Index:
Within 8" of Joint: **YES**
Remarks:

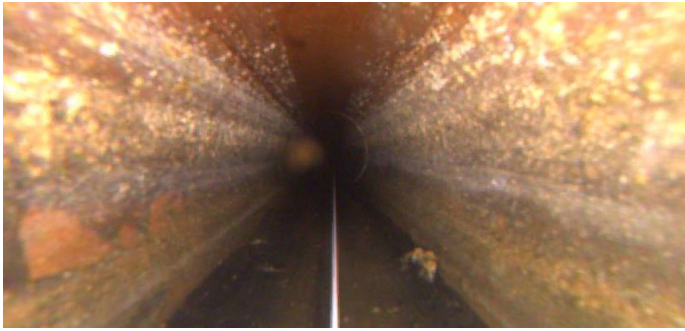
Code: **DSF**
Description: **Deposits Settled Fine**

Distance (ft): **197.1**
Structural Grade: **0**
O&M Grade: **2**
Clock Start/From: **5**
Clock To: **7**
1st Value:
2nd Value:
Value Percent: **5.000**
Continuous Index: **F02**
Within 8" of Joint: **NO**
Remarks: **Clock positions vary**

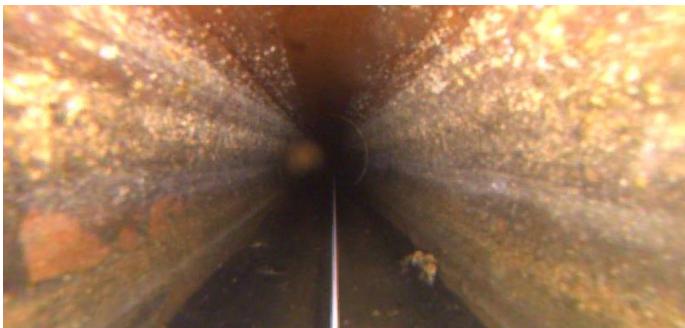
Code: **DAGS**
Description: **Deposits Attached Grease**

Distance (ft): **197.1**
Structural Grade: **0**
O&M Grade: **2**
Clock Start/From: **4**
Clock To: **8**
1st Value:
2nd Value:
Value Percent: **5.000**
Continuous Index: **F01**
Within 8" of Joint: **NO**
Remarks: **Clock positions vary**

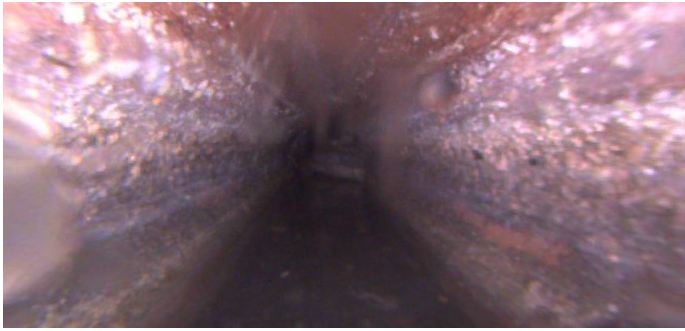
Code: **MGO**
Description: **General Observation**

Distance (ft): **197.1**
Structural Grade: **0**
O&M Grade: **0**
Clock Start/From:
Clock To:
1st Value:
2nd Value:
Value Percent:
Continuous Index:
Within 8" of Joint: **NO**
Remarks: **Switching to front camera**

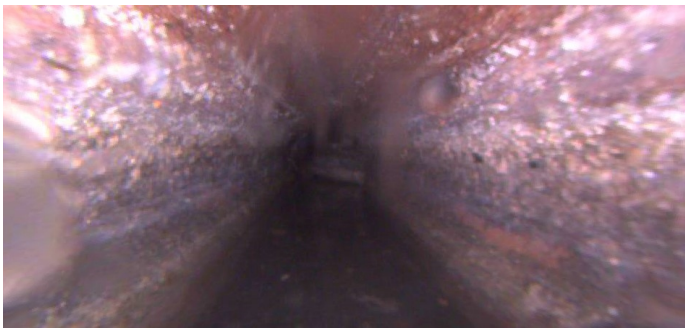
Code: **DAGS**
Description: **Deposits Attached Grease**

Distance (ft): **197.1**
Structural Grade: **0**
O&M Grade: **2**
Clock Start/From: **8**
Clock To: **5**
1st Value:
2nd Value:
Value Percent: **10.000**
Continuous Index:
Within 8" of Joint: **NO**
Remarks:

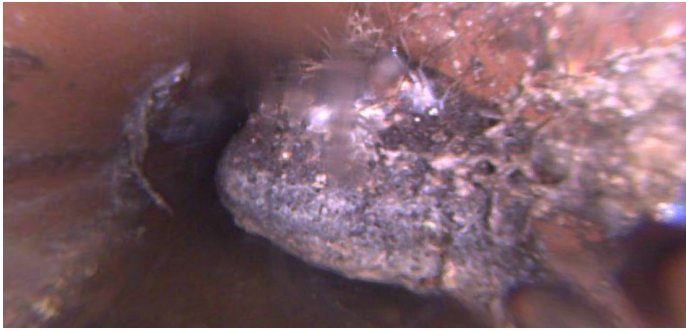
Code: **RBC**
Description: **Roots Ball Connection**

Distance (ft): **199.0**
Structural Grade: **0**
O&M Grade: **4**
Clock Start/From: **12**
Clock To: **5**
1st Value:
2nd Value:
Value Percent: **60.000**
Continuous Index:
Within 8" of Joint: **NO**
Remarks:

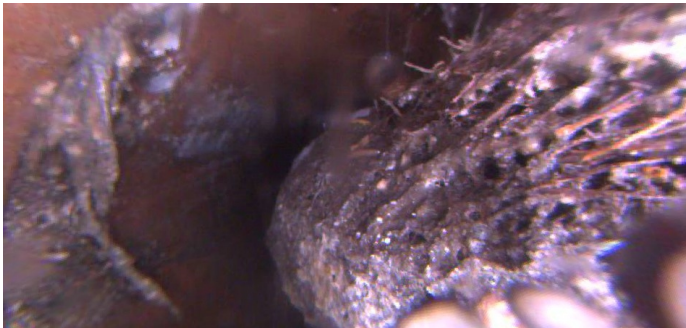
Code: **MSA**
Description: **Abandoned Survey**

Distance (ft): **199.9**
Structural Grade: **0**
O&M Grade: **0**
Clock Start/From:
Clock To:
1st Value:
2nd Value:
Value Percent:
Continuous Index:
Within 8" of Joint: **NO**
Remarks: **RBC**
