Profile/Photo Observation Report

Date:	03/23/2018	Weather:		Coding:	PACP 6.0
Pipe Length (ft):	114.0	Owner:	NA	Pre Clean:	No Pre-Cleaning
P.O.#:		Surveyor:	Jen Costello	PSR:	P-208-013-014
Customer:		Clean Date:	01/01/1900	Shape:	C

Street:	16TH ST	Flow Control:	Not Controlled
City:	Hobart, IN	Year Renewed:	
Location:	Light Highway	Tape/Media #:	
Purpose:	Routine Assessment	Dia/Height:	12"
Use:	Sanitary	Material:	VCP
Drain Area:	NA	Lining:	
Category:	NA		
Comment:	P_C at 13 ft nothing visible. Flow direction wrong		
Location Details:		Direction of Survey:	Upstream
US MH:	M-208-014	DS MH:	M-208-013
		Total Length Surveyed (ft):	13.4

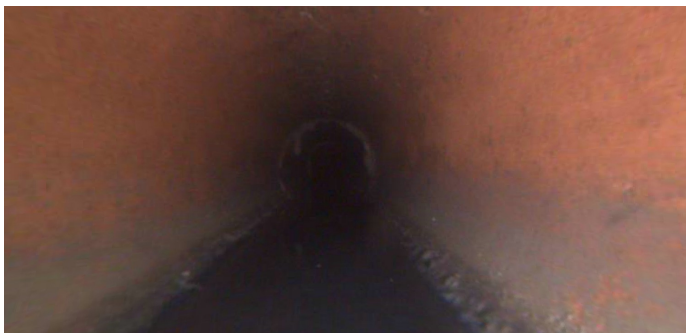
Code: **AMH**
Description: **Manhole**

Distance (ft): **.0**
Structural Grade: **0**
O&M Grade: **0**
Clock Start/From:
Clock To:
1st Value:
2nd Value:
Value Percent:
Continuous Index:
Within 8" of Joint: **NO**
Remarks: **M-208-013**

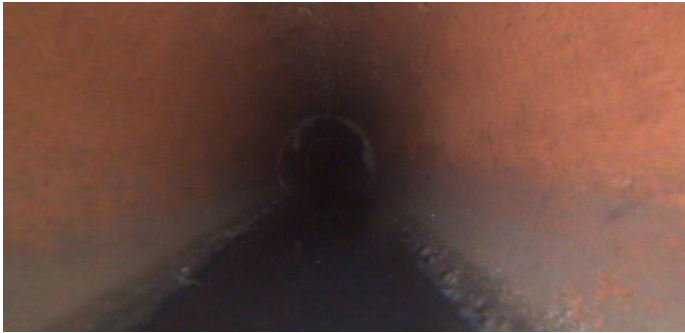
Code:	MWL
Description:	Water Level

Distance (ft):	.0
Structural Grade:	0
O&M Grade:	0
Clock Start/From:	
Clock To:	
1st Value:	
2nd Value:	
Value Percent:	10.000
Continuous Index:	
Within 8" of Joint:	NO
Remarks:

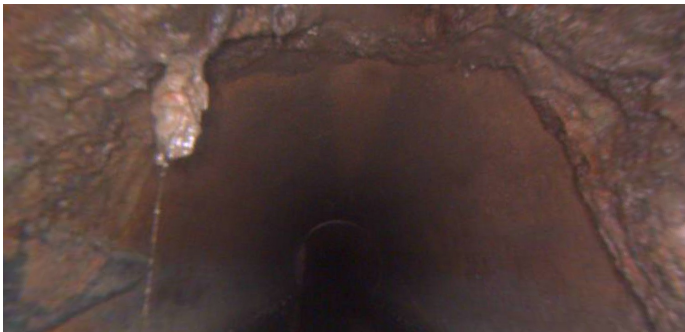
Code:	DAE
Description:	Deposits Attached Encrustation

Distance (ft):	3.7
Structural Grade:	0
O&M Grade:	2
Clock Start/From:	8
Clock To:	4
1st Value:	
2nd Value:	
Value Percent:	10.000
Continuous Index:	S01
Within 8" of Joint:	YES
Remarks:

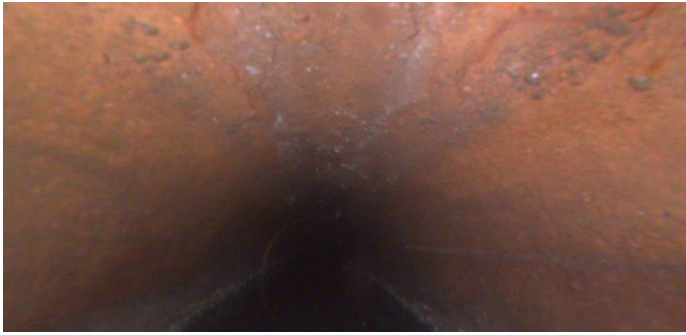
Code: **DAE**
Description: **Deposits Attached Encrustation**

Distance (ft): **13.4**
Structural Grade: **0**
O&M Grade: **2**
Clock Start/From: **8**
Clock To: **4**
1st Value:
2nd Value:
Value Percent: **5.000**
Continuous Index:
Within 8" of Joint: **YES**
Remarks:

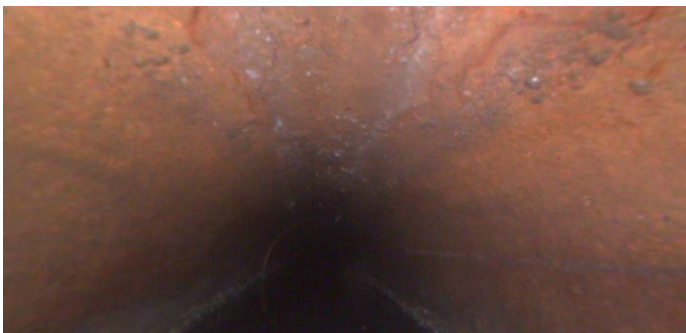
Code: **DAE**
Description: **Deposits Attached Encrustation**

Distance (ft): **13.4**
Structural Grade: **0**
O&M Grade: **2**
Clock Start/From: **8**
Clock To: **4**
1st Value:
2nd Value:
Value Percent: **10.000**
Continuous Index: **F01**
Within 8" of Joint: **YES**
Remarks:

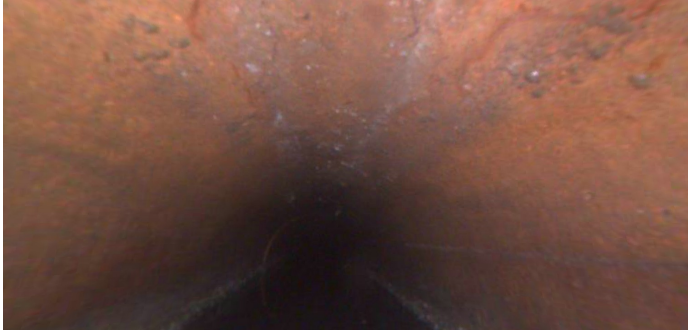
Code:	MSA
Description:	Abandoned Survey
Distance (ft):	13.4
Structural Grade:	0
O&M Grade:	0
Clock Start/From:	
Clock To:	
1st Value:	
2nd Value:	
Value Percent:	
Continuous Index:	
Within 8" of Joint:	NO
Remarks:	DAE
