Profile/Photo Observation Report

Date:	03/23/2018	Weather:		Coding:	PACP 6.0
Pipe Length (ft):	114.0	Owner:	NA	Pre Clean:	No Pre-Cleaning
P.O.#:		Surveyor:	Jen Costello	PSR:	P-208-013-014
Customer:		Clean Date:	01/01/1900	Shape:	C

Street:	16TH ST	Flow Control:	Not Controlled
City:	Hobart, IN	Year Renewed:	
Location:	Light Highway	Tape/Media #:	
Purpose:	Routine Assessment	Dia/Height:	12"
Use:	Sanitary	Material:	VCP
Drain Area:	NA	Lining:	
Category:	NA		
Comment:	P_C at 33 ft build up at the joint .Flow direction wrong		
Location Details:		Direction of Survey:	Downstream
US MH:	M-208-014	DS MH:	M-208-013
		Total Length Surveyed (ft):	34.8

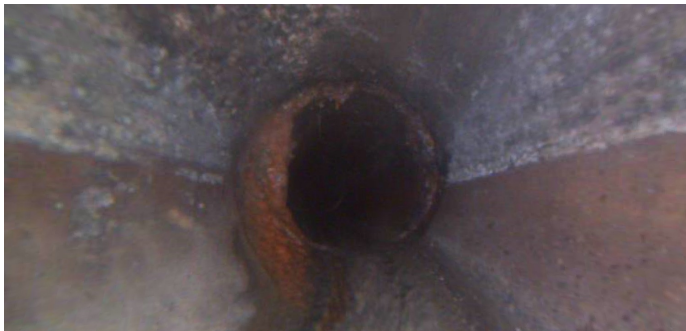
Code: **AMH**
Description: **Manhole**

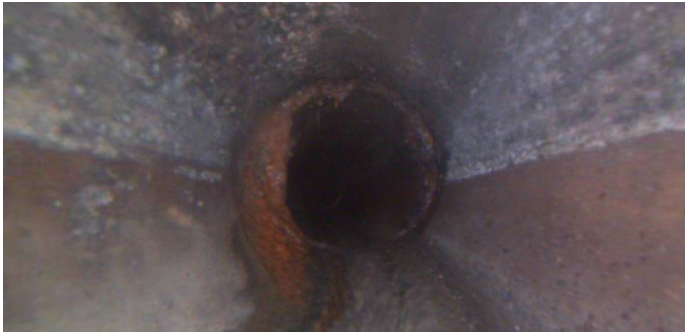
Code:	MWL
Description:	Water Level

Distance (ft):	.0
Structural Grade:	0
O&M Grade:	0
Clock Start/From:	
Clock To:	
1st Value:	
2nd Value:	
Value Percent:	5.000
Continuous Index:	
Within 8" of Joint:	NO
Remarks:

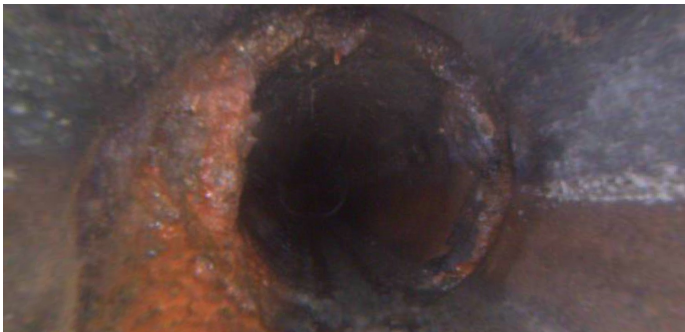
Code:	DAE
Description:	Deposits Attached Encrustation

Distance (ft):	.7
Structural Grade:	0
O&M Grade:	2
Clock Start/From:	8
Clock To:	4
1st Value:	
2nd Value:	
Value Percent:	10.000
Continuous Index:	
Within 8" of Joint:	YES
Remarks:

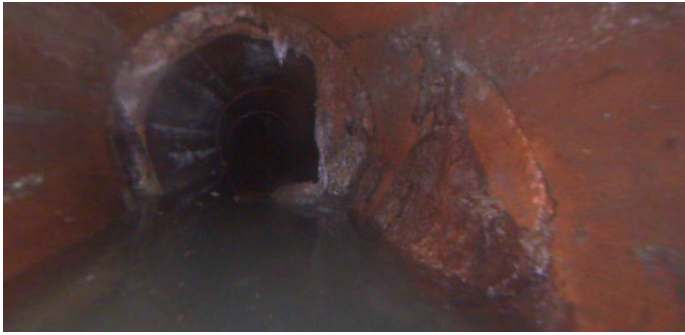
Code: **FS**
Description: **Fracture Spiral**

Distance (ft): **10.5**
Structural Grade: **3**
O&M Grade: **0**
Clock Start/From: **1**
Clock To: **4**
1st Value:
2nd Value:
Value Percent:
Continuous Index:
Within 8" of Joint: **YES**
Remarks:

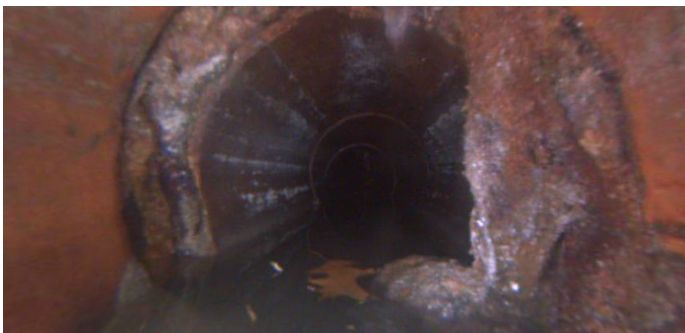
Code: **DAE**
Description: **Deposits Attached Encrustation**

Distance (ft): **11.2**
Structural Grade: **0**
O&M Grade: **3**
Clock Start/From: **8**
Clock To: **4**
1st Value:
2nd Value:
Value Percent: **20.000**
Continuous Index:
Within 8" of Joint: **YES**
Remarks:

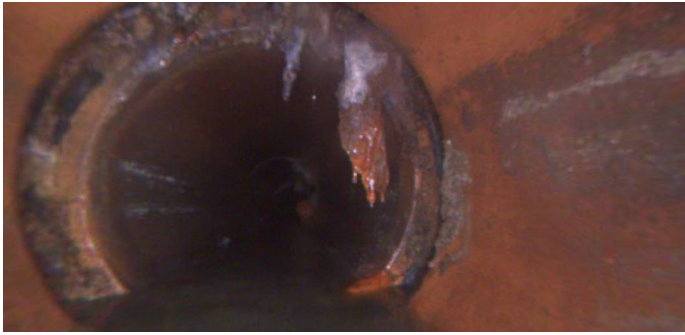
Code: **DAR**
Description: **Deposits Attached Ragging**

Distance (ft): **17.6**
Structural Grade: **0**
O&M Grade: **2**
Clock Start/From: **12**
Clock To: **2**
1st Value:
2nd Value:
Value Percent: **5.000**
Continuous Index:
Within 8" of Joint: **YES**
Remarks:

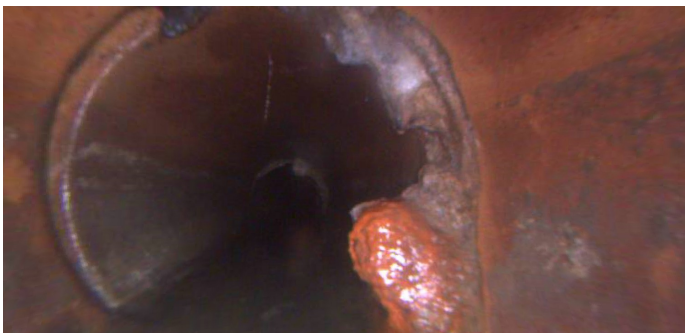
Code: **DAE**
Description: **Deposits Attached Encrustation**

Distance (ft): **20.8**
Structural Grade: **0**
O&M Grade: **2**
Clock Start/From: **12**
Clock To: **4**
1st Value:
2nd Value:
Value Percent: **10.000**
Continuous Index:
Within 8" of Joint: **YES**
Remarks:

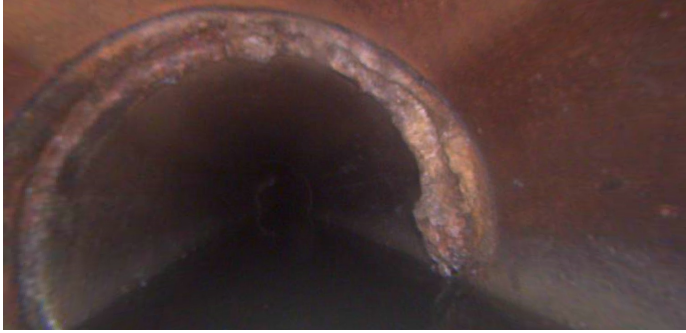
Code: **DAE**
Description: **Deposits Attached Encrustation**

Distance (ft): **27.1**
Structural Grade: **0**
O&M Grade: **2**
Clock Start/From: **8**
Clock To: **4**
1st Value:
2nd Value:
Value Percent: **5.000**
Continuous Index:
Within 8" of Joint: **YES**
Remarks:

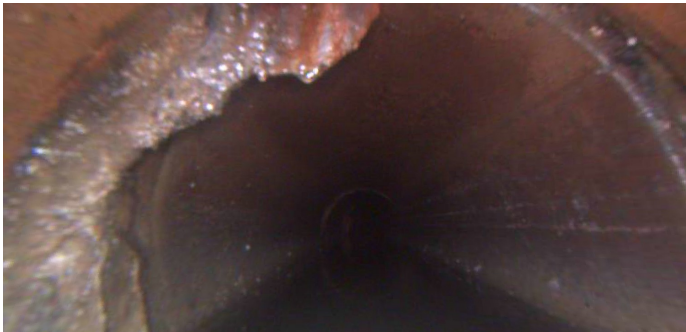
Code: **DAE**
Description: **Deposits Attached Encrustation**

Distance (ft): **33.6**
Structural Grade: **0**
O&M Grade: **2**
Clock Start/From: **8**
Clock To: **12**
1st Value:
2nd Value:
Value Percent: **10.000**
Continuous Index:
Within 8" of Joint: **YES**
Remarks:

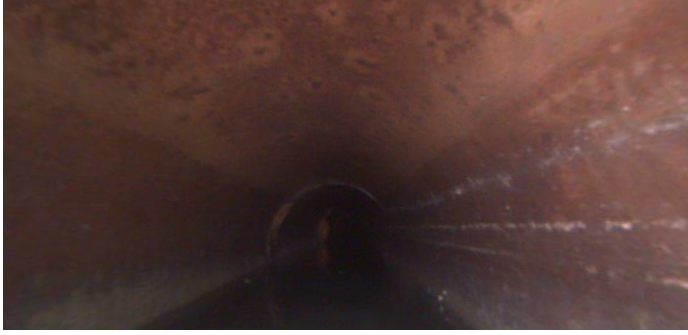
Code:	MSA
Description:	Abandoned Survey
Distance (ft):	34.8
Structural Grade:	0
O&M Grade:	0
Clock Start/From:	
Clock To:	
1st Value:	
2nd Value:	
Value Percent:	
Continuous Index:	
Within 8" of Joint:	NO
Remarks:	DAE
