Profile/Photo Observation Report

Date:	03/23/2018	Weather:		Coding:	PACP 6.0
Pipe Length (ft):	114.0	Owner:	NA	Pre Clean:	No Pre-Cleaning
P.O.#:		Surveyor:	Jen Costello	PSR:	P-208-013-014
Customer:		Clean Date:	01/01/1900	Shape:	C

Street:	FOXCROFT STREET	Flow Control:	Not Controlled
City:	Hobart, IN	Year Renewed:	
Location:	Light Highway	Tape/Media #:	
Purpose:	Routine Assessment	Dia/Height:	12"
Use:	Sanitary	Material:	VCP
Drain Area:	NA	Lining:	
Category:	NA		
Comment:	P_C at 33 ft build up at the joint .Flow direction wrong		
Location Details:		Direction of Survey:	Downstream
US MH:	M-208-014	DS MH:	M-208-013
		Total Length Surveyed (ft):	34.8

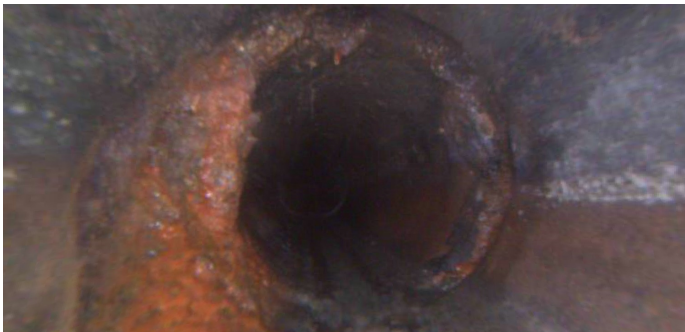
Code:	DAE
Description:	Deposits Attached Encrustation

Distance (ft):	.7
Structural Grade:	0
O&M Grade:	2
Clock Start/From:	8
Clock To:	4
1st Value:	
2nd Value:	
Value Percent:	10.000
Continuous Index:	
Within 8" of Joint:	YES
Remarks:

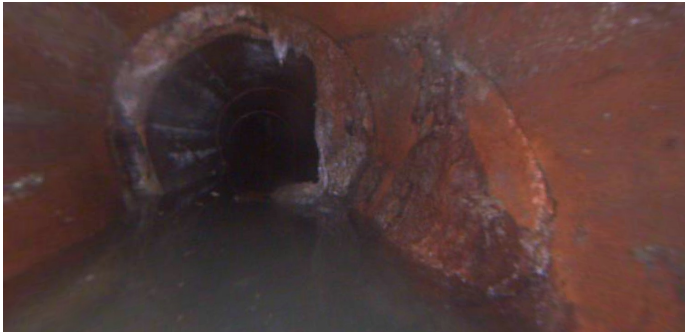
Code: **FS**
Description: **Fracture Spiral**

Distance (ft): **10.5**
Structural Grade: **3**
O&M Grade: **0**
Clock Start/From: **1**
Clock To: **4**
1st Value:
2nd Value:
Value Percent:
Continuous Index:
Within 8" of Joint: **YES**
Remarks:

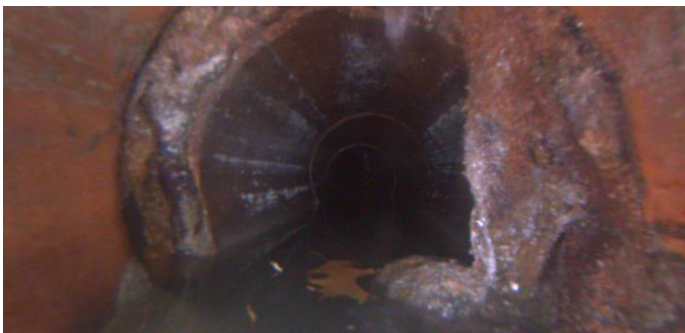
Code: **DAE**
Description: **Deposits Attached Encrustation**

Distance (ft): **11.2**
Structural Grade: **0**
O&M Grade: **3**
Clock Start/From: **8**
Clock To: **4**
1st Value:
2nd Value:
Value Percent: **20.000**
Continuous Index:
Within 8" of Joint: **YES**
Remarks:

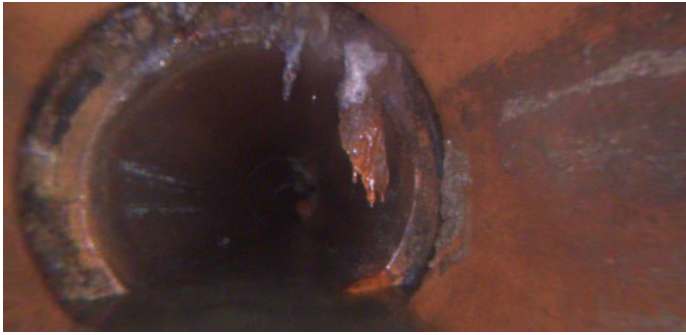
Code: **DAR**
Description: **Deposits Attached Ragging**

Distance (ft): **17.6**
Structural Grade: **0**
O&M Grade: **2**
Clock Start/From: **12**
Clock To: **2**
1st Value:
2nd Value:
Value Percent: **5.000**
Continuous Index:
Within 8" of Joint: **YES**
Remarks:

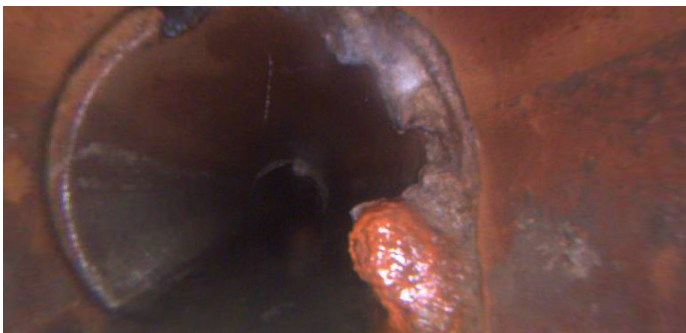
Code: **DAE**
Description: **Deposits Attached Encrustation**

Distance (ft): **20.8**
Structural Grade: **0**
O&M Grade: **2**
Clock Start/From: **12**
Clock To: **4**
1st Value:
2nd Value:
Value Percent: **10.000**
Continuous Index:
Within 8" of Joint: **YES**
Remarks:

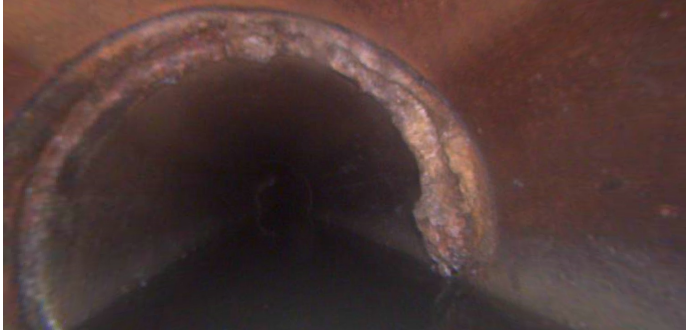
Code: **DAE**
Description: **Deposits Attached Encrustation**

Distance (ft): **27.1**
Structural Grade: **0**
O&M Grade: **2**
Clock Start/From: **8**
Clock To: **4**
1st Value:
2nd Value:
Value Percent: **5.000**
Continuous Index:
Within 8" of Joint: **YES**
Remarks:

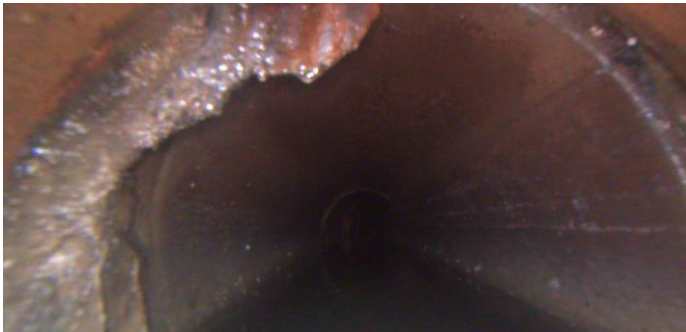
Code: **DAE**
Description: **Deposits Attached Encrustation**

Distance (ft): **33.6**
Structural Grade: **0**
O&M Grade: **2**
Clock Start/From: **8**
Clock To: **12**
1st Value:
2nd Value:
Value Percent: **10.000**
Continuous Index:
Within 8" of Joint: **YES**
Remarks:

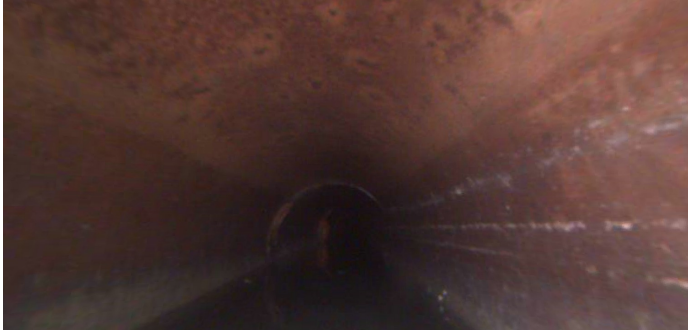
Code:	MSA
Description:	Abandoned Survey
Distance (ft):	34.8
Structural Grade:	0
O&M Grade:	0
Clock Start/From:	
Clock To:	
1st Value:	
2nd Value:	
Value Percent:	
Continuous Index:	
Within 8" of Joint:	NO
Remarks:	DAE
