Profile/Photo Observation Report

Date:	04/11/2018	Weather:		Coding:	PACP 6.0
Pipe Length (ft):		Owner:	City of Hobart	Pre Clean:	Not Known
P.O.#:	230	Surveyor:	B. Helbling	PSR:	P-208-014-029
Customer:	City of Hobart	Clean Date:		Shape:	C

Street:	16th Street	Flow Control:	Not Controlled
City:	Hobart, IN	Year Renewed:	
Location:	Light Highway	Tape/Media #:	DEP230
Purpose:	Routine Assessment	Dia/Height:	21"
Use:	Sanitary	Material:	VCP
Drain Area:		Lining:	
Category:	NA		
Comment:	YES501824 Submittal 2		
Location Details:		Direction of Survey:	Downstream
US MH:	M-208-014	DS MH:	M-208-029
		Total Length Surveyed (ft):	51.7

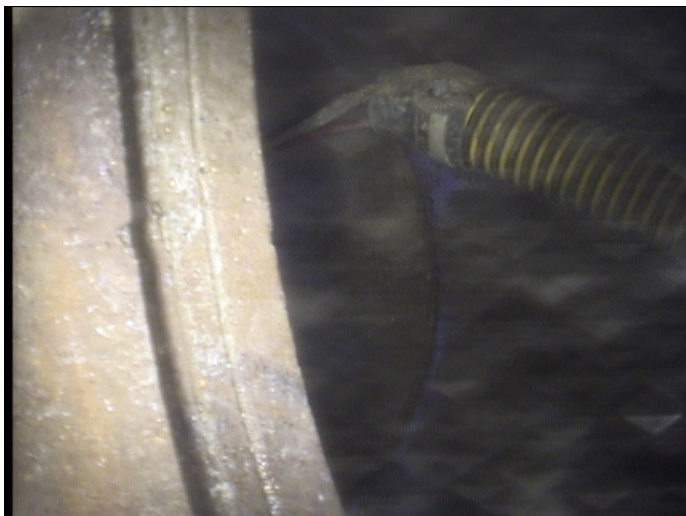
Code: **AMH**
 Description: **Manhole**

Distance (ft): **.0**
 Structural Grade: **0**
 O&M Grade: **0**
 Clock Start/From:
 Clock To:
 1st Value:
 2nd Value:
 Value Percent:
 Continuous Index:
 Within 8" of Joint: **NO**
 Remarks: **M-208-014**

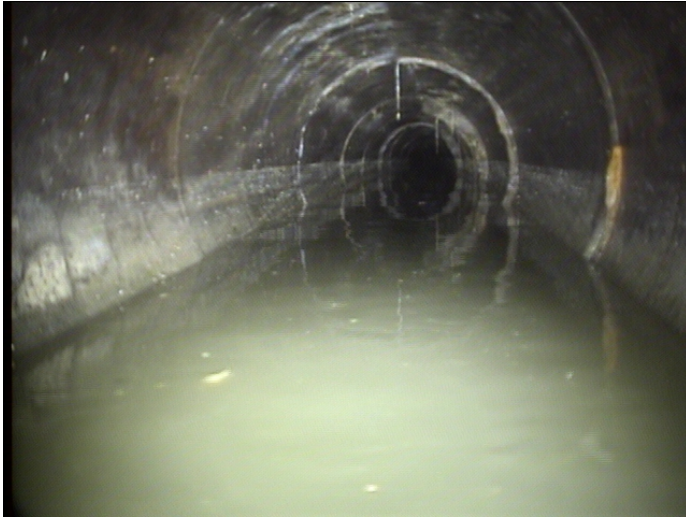
Code: **MWL**
Description: **Water Level**

Distance (ft): **.0**
Structural Grade: **0**
O&M Grade: **0**
Clock Start/From:
Clock To:
1st Value:
2nd Value:
Value Percent: **20.000**
Continuous Index:
Within 8" of Joint: **NO**
Remarks:

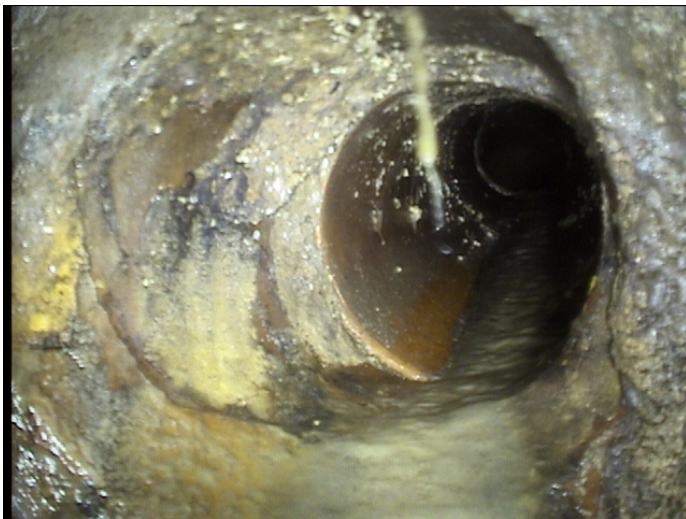
Code: **TF**
Description: **Tap Factory**

Distance (ft): **9.1**
Structural Grade: **0**
O&M Grade: **0**
Clock Start/From: **2**
Clock To:
1st Value: **6.000**
2nd Value:
Value Percent:
Continuous Index:
Within 8" of Joint: **NO**
Remarks:

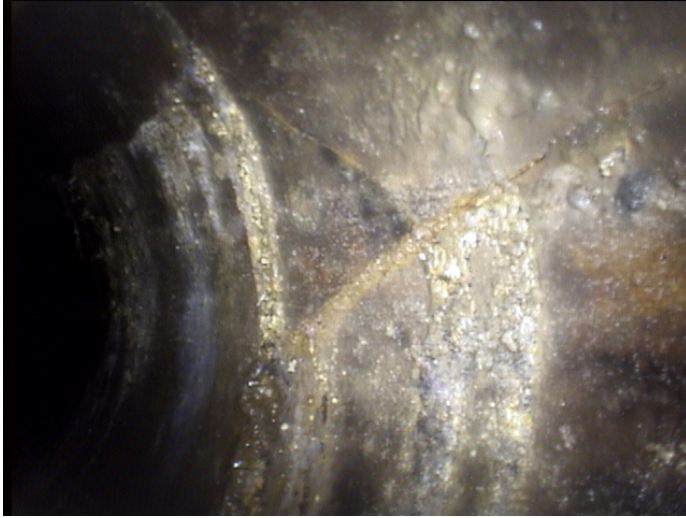
Code:	CM
Description:	Crack Multiple
Distance (ft):	10.0
Structural Grade:	3
O&M Grade:	0
Clock Start/From:	2
Clock To:	3
1st Value:	
2nd Value:	
Value Percent:	
Continuous Index:	
Within 8" of Joint:	NO
Remarks:

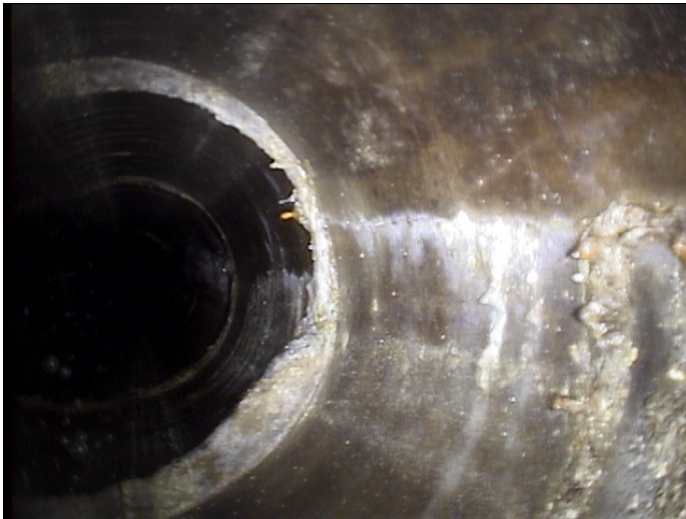
Code:	CL
Description:	Crack Longitudinal
Distance (ft):	11.2
Structural Grade:	2
O&M Grade:	0
Clock Start/From:	12
Clock To:	
1st Value:	
2nd Value:	
Value Percent:	
Continuous Index:	
Within 8" of Joint:	NO
Remarks:

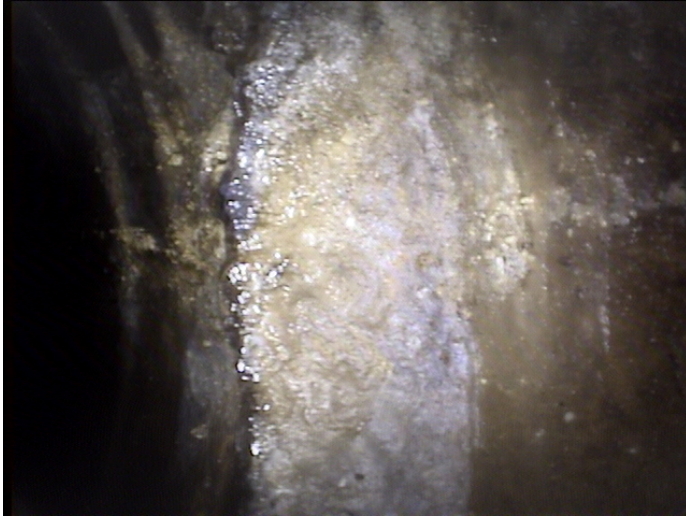
Code: **DAE**
Description: **Deposits Attached Encrustation**

Distance (ft): **13.4**
Structural Grade: **0**
O&M Grade: **2**
Clock Start/From: **8**
Clock To: **4**
1st Value:
2nd Value:
Value Percent: **5.000**
Continuous Index:
Within 8" of Joint: **YES**
Remarks:

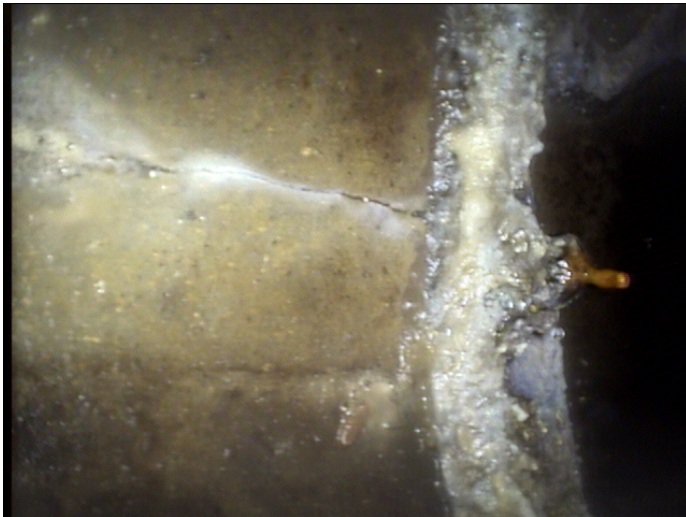
Code: **CL**
Description: **Crack Longitudinal**

Distance (ft): **13.4**
Structural Grade: **2**
O&M Grade: **0**
Clock Start/From: **11**
Clock To:
1st Value:
2nd Value:
Value Percent:
Continuous Index:
Within 8" of Joint: **NO**
Remarks:

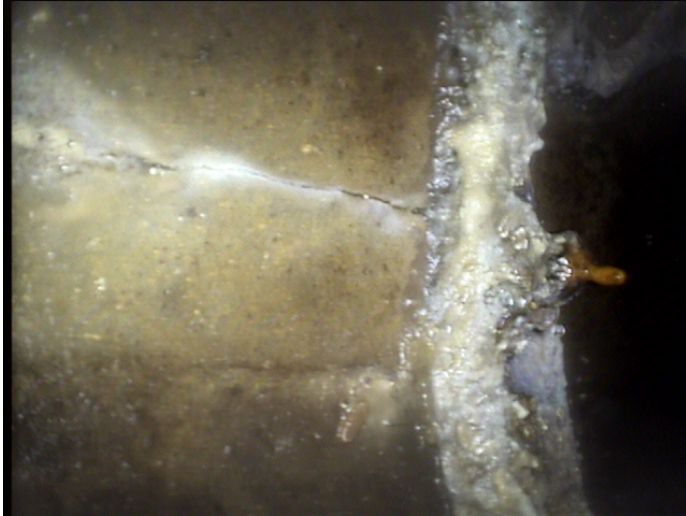
Code: **ID**
Description: **Infil Dripper**

Distance (ft): **13.4**
Structural Grade: **0**
O&M Grade: **3**
Clock Start/From: **11**
Clock To:
1st Value:
2nd Value:
Value Percent:
Continuous Index:
Within 8" of Joint: **YES**
Remarks:

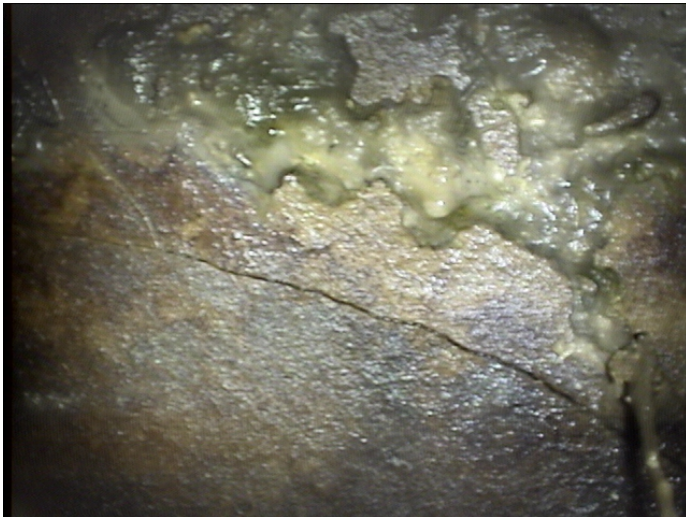
Code: **CM**
Description: **Crack Multiple**

Distance (ft): **23.9**
Structural Grade: **3**
O&M Grade: **0**
Clock Start/From: **12**
Clock To: **3**
1st Value:
2nd Value:
Value Percent:
Continuous Index:
Within 8" of Joint: **NO**
Remarks:

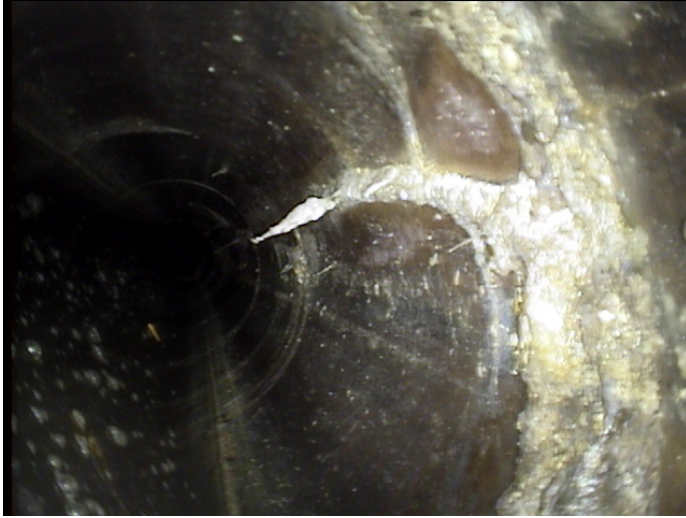
Code: **CM**
Description: **Crack Multiple**

Distance (ft): **28.2**
Structural Grade: **3**
O&M Grade: **0**
Clock Start/From: **11**
Clock To: **3**
1st Value:
2nd Value:
Value Percent:
Continuous Index: **S01**
Within 8" of Joint: **NO**
Remarks:

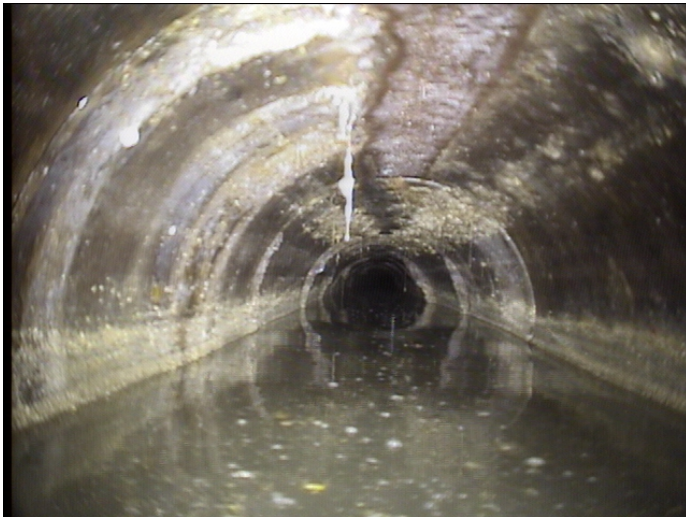
Code: **DSF**
Description: **Deposits Settled Fine**

Distance (ft): **36.9**
Structural Grade: **0**
O&M Grade: **2**
Clock Start/From: **4**
Clock To: **8**
1st Value:
2nd Value:
Value Percent: **10.000**
Continuous Index: **S02**
Within 8" of Joint: **NO**
Remarks:

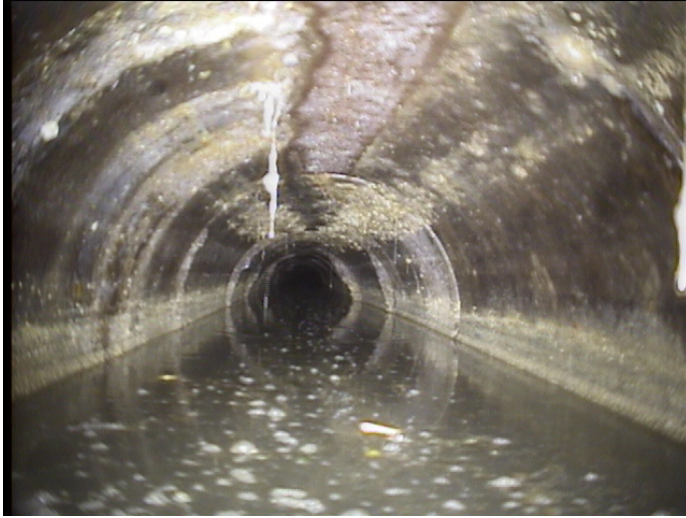
Code: **CM**
Description: **Crack Multiple**

Distance (ft): **37.0**
Structural Grade: **3**
O&M Grade: **0**
Clock Start/From: **11**
Clock To: **3**
1st Value:
2nd Value:
Value Percent:
Continuous Index: **F01**
Within 8" of Joint: **NO**
Remarks:

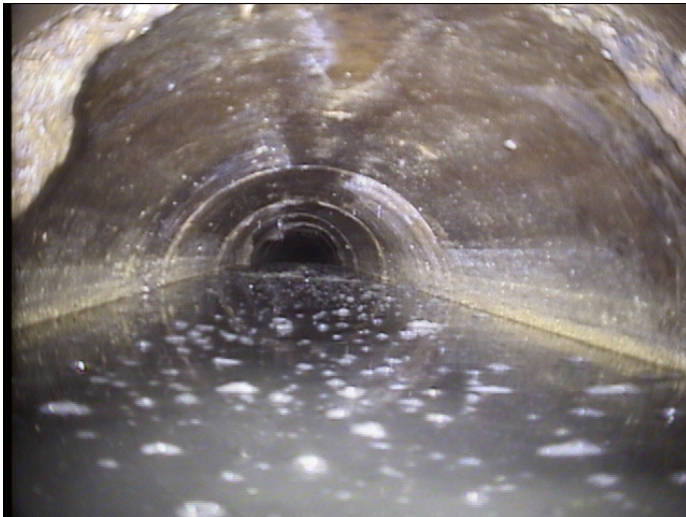
Code: **DSF**
Description: **Deposits Settled Fine**

Distance (ft): **51.7**
Structural Grade: **0**
O&M Grade: **2**
Clock Start/From: **4**
Clock To: **8**
1st Value:
2nd Value:
Value Percent: **10.000**
Continuous Index: **F02**
Within 8" of Joint: **NO**
Remarks:

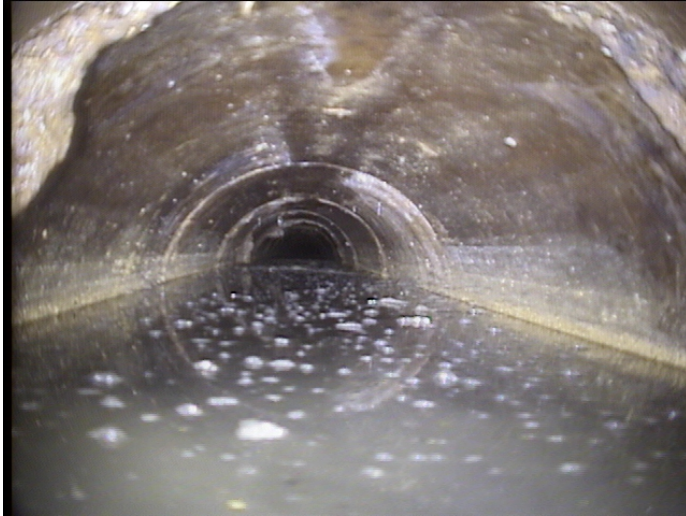
Code:	MSA
Description:	Abandoned Survey
Distance (ft):	51.7
Structural Grade:	0
O&M Grade:	0
Clock Start/From:	
Clock To:	
1st Value:	
2nd Value:	
Value Percent:	
Continuous Index:	
Within 8" of Joint:	NO
Remarks:	Heavy sediment
