Profile/Photo Observation Report

Date:	04/11/2018	Weather:		Coding:	PACP 6.0
Pipe Length (ft):		Owner:	City of Hobart	Pre Clean:	Not Known
P.O.#:	231	Surveyor:	B. Helbling	PSR:	P-208-014-029
Customer:	City of Hobart	Clean Date:		Shape:	C

Street:	16th Street	Flow Control:	Not Controlled
City:	Hobart, IN	Year Renewed:	
Location:	Yard	Tape/Media #:	DEP231
Purpose:	Routine Assessment	Dia/Height:	21"
Use:	Sanitary	Material:	VCP
Drain Area:		Lining:	
Category:	NA		
Comment:	YES501824 Submittal 2		
Location Details:		Direction of Survey:	Upstream
US MH:	M-208-014	DS MH:	M-208-029
		Total Length Surveyed (ft):	25.2

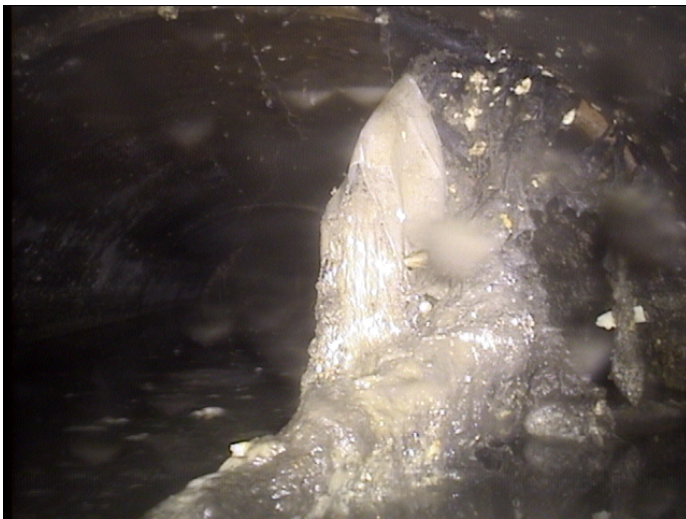
Code: **RMJ**
Description: **Roots Medium Joint**

Distance (ft): **4.0**
Structural Grade: **0**
O&M Grade: **3**
Clock Start/From: **1**
Clock To: **3**
1st Value:
2nd Value:
Value Percent: **15.000**
Continuous Index:
Within 8" of Joint: **YES**
Remarks:

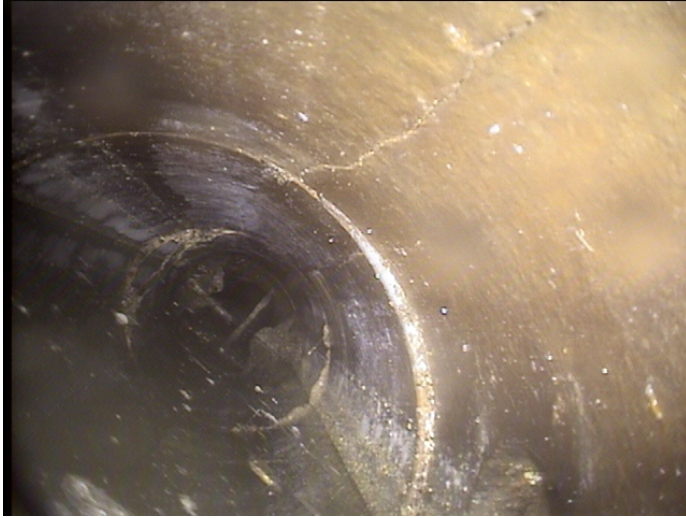
Code:	FL
Description:	Fracture Longitudinal
Distance (ft):	6.0
Structural Grade:	3
O&M Grade:	0
Clock Start/From:	12
Clock To:	
1st Value:	
2nd Value:	
Value Percent:	
Continuous Index:	
Within 8" of Joint:	NO
Remarks:

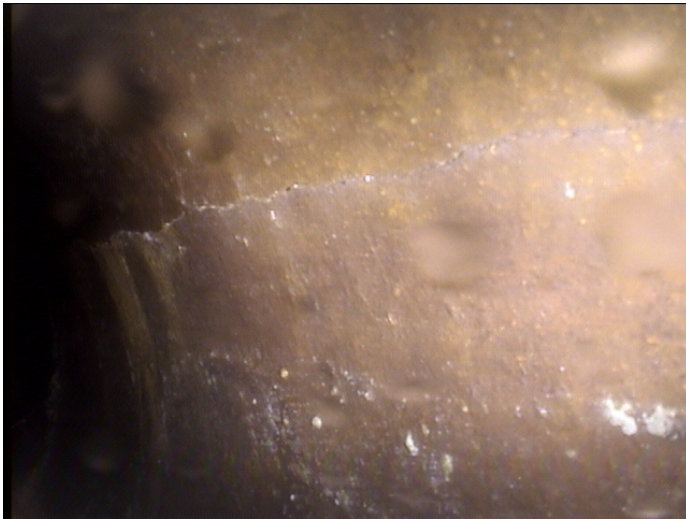
Code:	CL
Description:	Crack Longitudinal
Distance (ft):	8.7
Structural Grade:	2
O&M Grade:	0
Clock Start/From:	12
Clock To:	
1st Value:	
2nd Value:	
Value Percent:	
Continuous Index:	
Within 8" of Joint:	NO
Remarks:

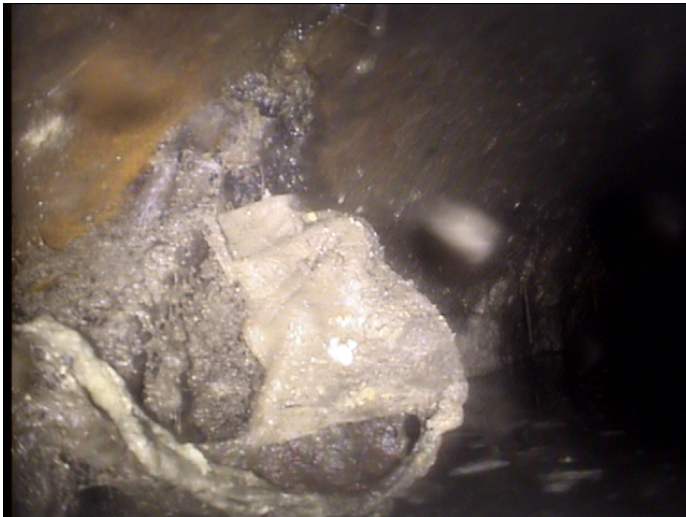
Code: **RMJ**
Description: **Roots Medium Joint**

Distance (ft): **13.5**
Structural Grade: **0**
O&M Grade: **3**
Clock Start/From: **9**
Clock To: **3**
1st Value:
2nd Value:
Value Percent: **15.000**
Continuous Index:
Within 8" of Joint: **YES**
Remarks:

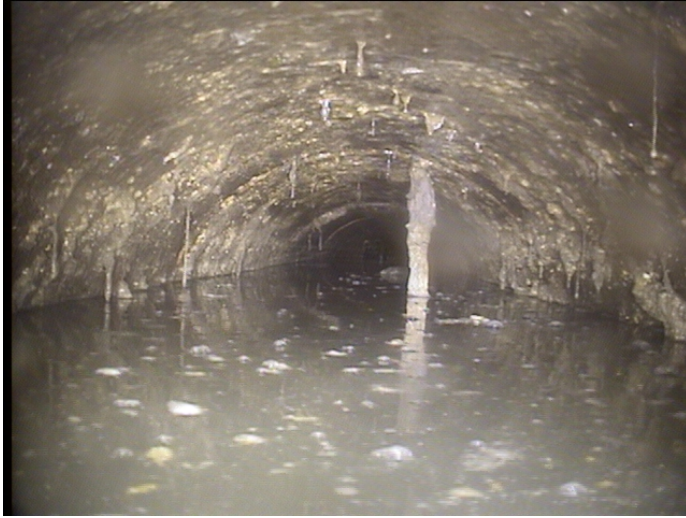
Code: **DSF**
Description: **Deposits Settled Fine**

Distance (ft): **14.1**
Structural Grade: **0**
O&M Grade: **2**
Clock Start/From: **4**
Clock To: **8**
1st Value:
2nd Value:
Value Percent: **10.000**
Continuous Index:
Within 8" of Joint: **NO**
Remarks:

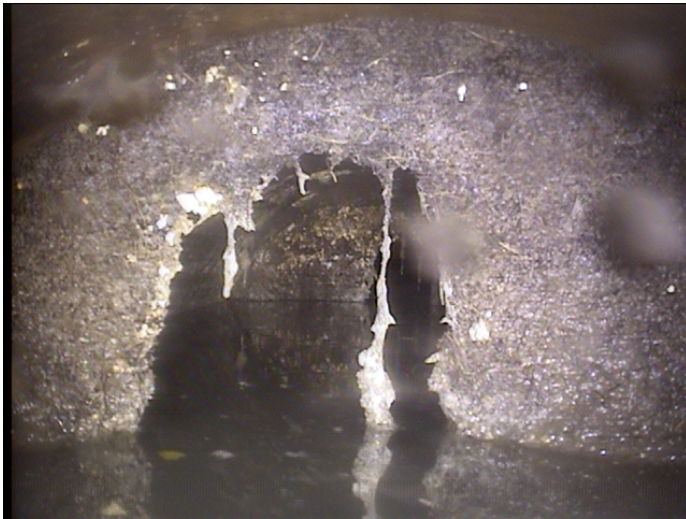
Code: **RMJ**
Description: **Roots Medium Joint**

Distance (ft): **25.2**
Structural Grade: **0**
O&M Grade: **3**
Clock Start/From: **9**
Clock To: **3**
1st Value:
2nd Value:
Value Percent: **40.000**
Continuous Index:
Within 8" of Joint: **YES**
Remarks:

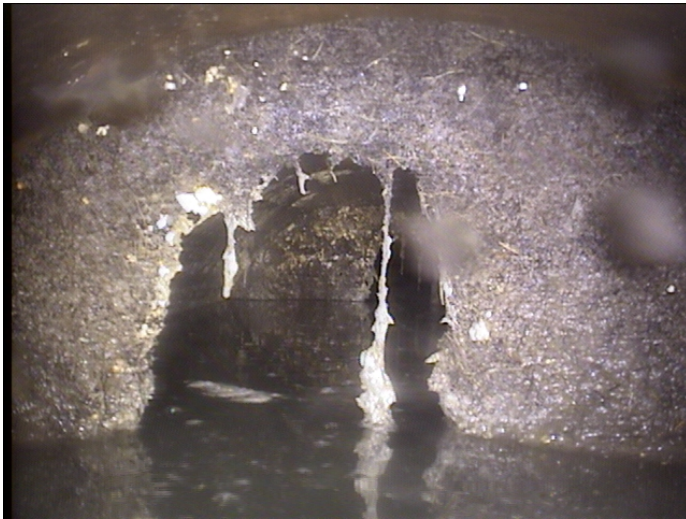
Code:	MSA
Description:	Abandoned Survey
Distance (ft):	25.2
Structural Grade:	0
O&M Grade:	0
Clock Start/From:	
Clock To:	
1st Value:	
2nd Value:	
Value Percent:	
Continuous Index:	
Within 8" of Joint:	NO
Remarks:	Roots
