Profile/Photo Observation Report

Date:	03/23/2018	Weather:		Coding:	PACP 6.0
Pipe Length (ft):	245.4	Owner:	NA	Pre Clean:	No Pre-Cleaning
P.O.#:		Surveyor:	Jen Costello	PSR:	P-208-015-016
Customer:		Clean Date:	01/01/1900	Shape:	C

Street:	OFF W 17TH ST	Flow Control:	Not Controlled
City:	Hobart, IN	Year Renewed:	
Location:	Light Highway	Tape/Media #:	
Purpose:	Routine Assessment	Dia/Height:	8"
Use:	Sanitary	Material:	VCP
Drain Area:	NA	Lining:	
Category:	NA		
Comment:	P_C at 25 ft nothing visible . Flow direction wrong		
Location Details:		Direction of Survey:	Upstream
US MH:	M-208-016	DS MH:	M-208-015
		Total Length Surveyed (ft):	26.7

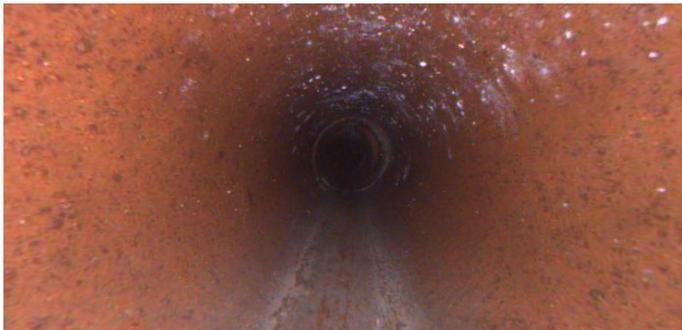
Code: **AMH**
Description: **Manhole**

Distance (ft): **.0**
Structural Grade: **0**
O&M Grade: **0**
Clock Start/From:
Clock To:
1st Value:
2nd Value:
Value Percent:
Continuous Index:
Within 8" of Joint: **NO**
Remarks: **M-208-015**

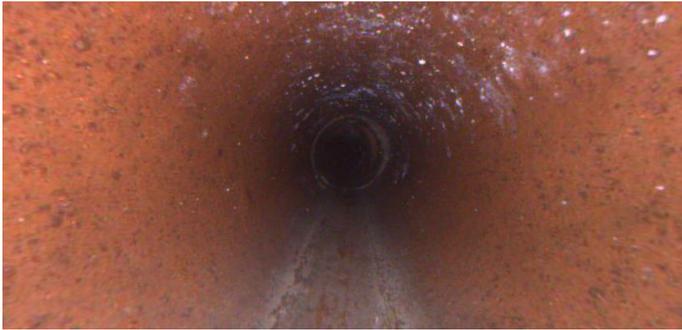
Code: **MWL**
Description: **Water Level**

Distance (ft): **.0**
Structural Grade: **0**
O&M Grade: **0**
Clock Start/From:
Clock To:
1st Value:
2nd Value:
Value Percent: **5.000**
Continuous Index:
Within 8" of Joint: **NO**
Remarks:

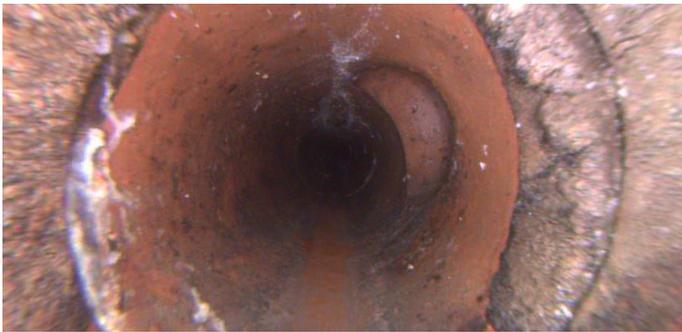
Code: **DAE**
Description: **Deposits Attached Encrustation**

Distance (ft): **3.2**
Structural Grade: **0**
O&M Grade: **2**
Clock Start/From: **8**
Clock To: **4**
1st Value:
2nd Value:
Value Percent: **5.000**
Continuous Index:
Within 8" of Joint: **YES**
Remarks:

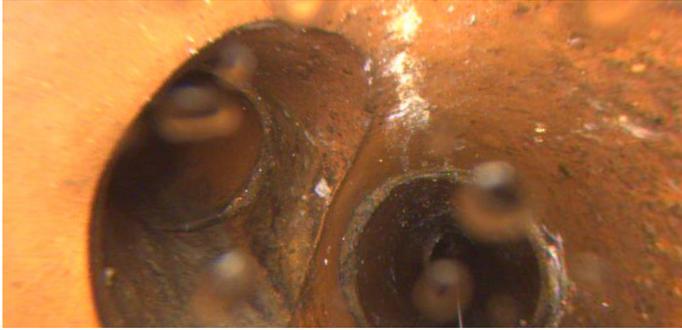
Code: **TF**
Description: **Tap Factory**

Distance (ft): **4.3**
Structural Grade: **0**
O&M Grade: **0**
Clock Start/From: **3**
Clock To:
1st Value: **4.000**
2nd Value:
Value Percent:
Continuous Index:
Within 8" of Joint:
Remarks:

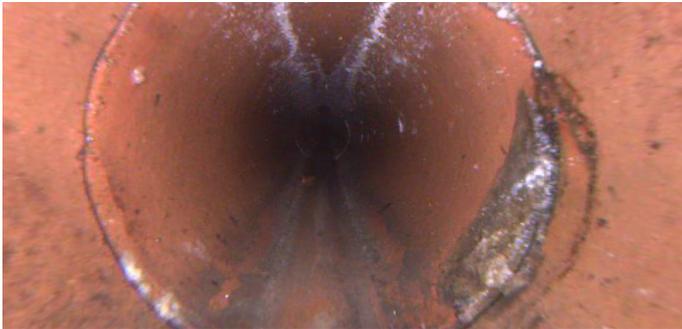
Code: **DAE**
Description: **Deposits Attached Encrustation**

Distance (ft): **4.8**
Structural Grade: **0**
O&M Grade: **2**
Clock Start/From: **2**
Clock To: **4**
1st Value:
2nd Value:
Value Percent: **5.000**
Continuous Index:
Within 8" of Joint: **YES**
Remarks:

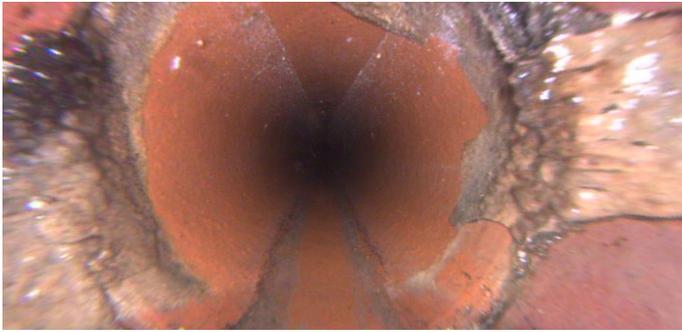
Code: **DAE**
Description: **Deposits Attached Encrustation**

Distance (ft): **16.8**
Structural Grade: **0**
O&M Grade: **2**
Clock Start/From: **8**
Clock To: **4**
1st Value:
2nd Value:
Value Percent: **5.000**
Continuous Index:
Within 8" of Joint: **YES**
Remarks:

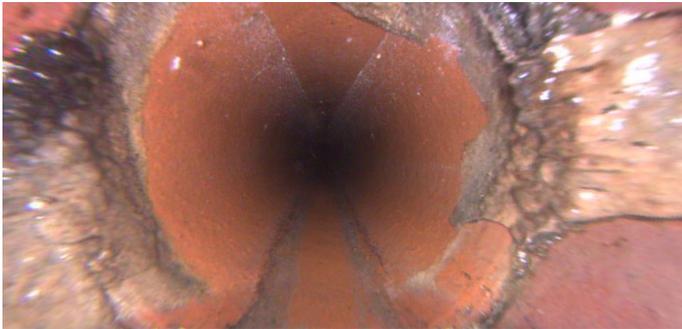
Code: **IW**
Description: **Infil Weeper**

Distance (ft): **16.8**
Structural Grade: **0**
O&M Grade: **2**
Clock Start/From: **8**
Clock To: **4**
1st Value:
2nd Value:
Value Percent:
Continuous Index:
Within 8" of Joint: **YES**
Remarks:

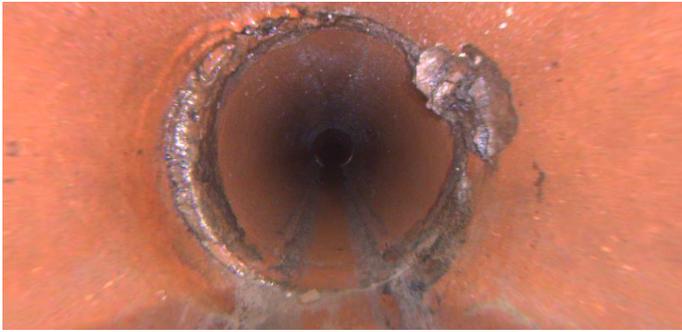
Code: **DAE**
Description: **Deposits Attached Encrustation**

Distance (ft): **22.6**
Structural Grade: **0**
O&M Grade: **2**
Clock Start/From: **8**
Clock To: **4**
1st Value:
2nd Value:
Value Percent: **10.000**
Continuous Index:
Within 8" of Joint: **YES**
Remarks:

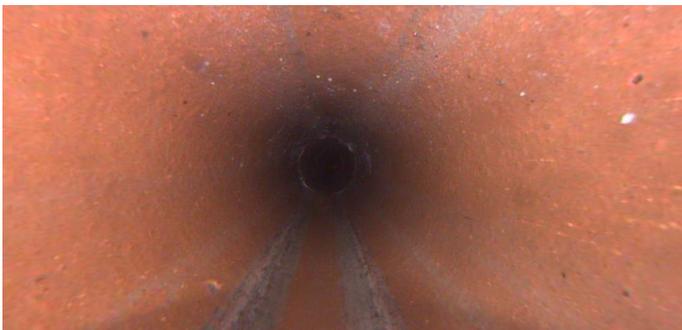
Code: **MSA**
Description: **Abandoned Survey**

Distance (ft): **26.7**
Structural Grade: **0**
O&M Grade: **0**
Clock Start/From:
Clock To:
1st Value:
2nd Value:
Value Percent:
Continuous Index:
Within 8" of Joint: **NO**
Remarks: **UNKNOWN**
