## Profile/Photo Observation Report

Street:	<b>RUSH PL</b>	Flow Control:	<b>Not Controlled</b>
City:	<b>Hobart, IN</b>	Year Renewed:	
Location:	<b>Other</b>	Tape/Media #:	
Purpose:	<b>Not Known</b>	Dia/Height:	<b>8"</b>
Use:	<b>Sanitary</b>	Material:	<b>PVC</b>
Drain Area:	<b>NA</b>	Lining:	
Category:	<b>NA</b>		
Comment:

Location Details:		Direction of Survey:	<b>Downstream</b>
US MH:	<b>M-902-048</b>	DS MH:	<b>M-902-075</b>
		Total Length Surveyed (ft):	<b>204.4</b>

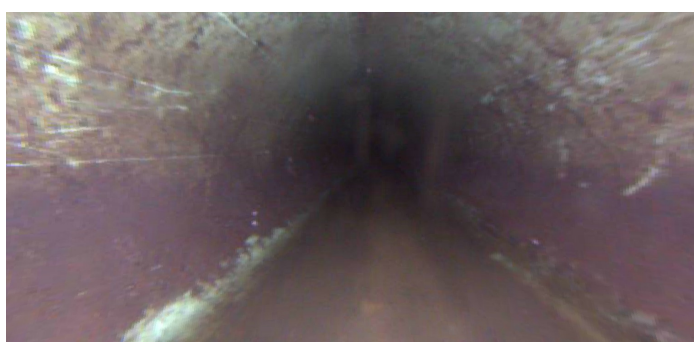
Code: **AMH**  
Description: **Manhole**

Distance (ft): **.0**  
Structural Grade: **0**  
O&M Grade: **0**  
Clock Start/From:  
Clock To:  
1st Value:  
2nd Value:  
Value Percent:  
Continuous Index:  
Within 8" of Joint: **NO**  
Remarks: **M-902-048**

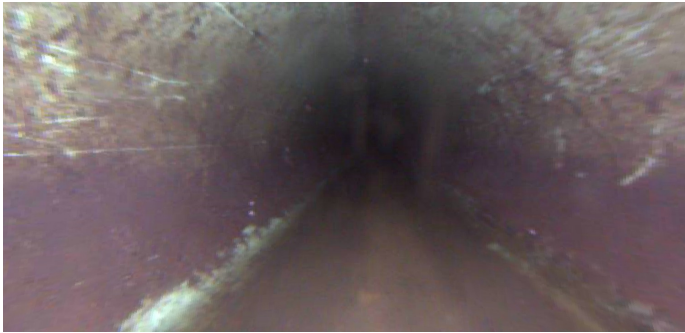
Code:	<b>MWL</b>
Description:	<b>Water Level</b>

Distance (ft):	<b>.0</b>
Structural Grade:	<b>0</b>
O&M Grade:	<b>0</b>
Clock Start/From:	
Clock To:	
1st Value:	
2nd Value:	
Value Percent:	<b>5.000</b>
Continuous Index:	
Within 8" of Joint:	<b>NO</b>
Remarks:

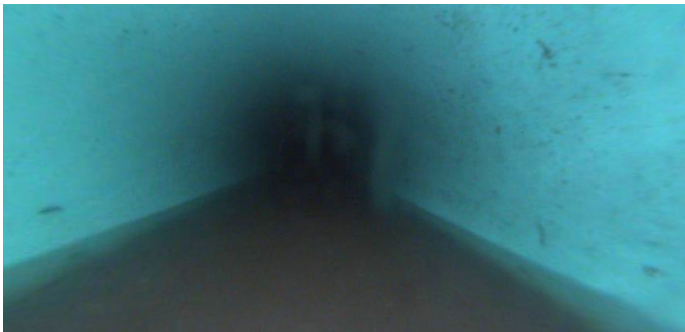
Code:	<b>MWL</b>
Description:	<b>Water Level</b>

Distance (ft):	<b>152.3</b>
Structural Grade:	<b>0</b>
O&M Grade:	<b>0</b>
Clock Start/From:	
Clock To:	
1st Value:	
2nd Value:	
Value Percent:	<b>40.000</b>
Continuous Index:	
Within 8" of Joint:	<b>NO</b>
Remarks:

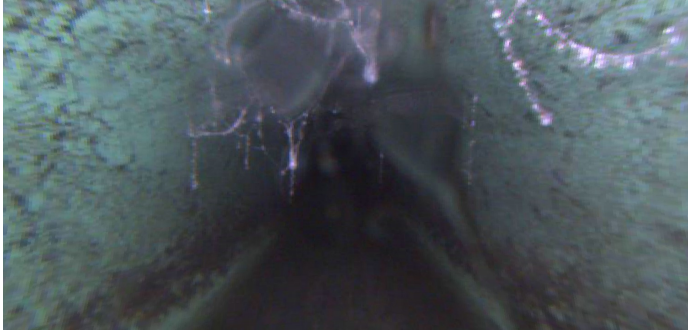
Code:	MSA
Description:	Abandoned Survey
Distance (ft):	204.4
Structural Grade:	0
O&M Grade:	0
Clock Start/From:	
Clock To:	
1st Value:	
2nd Value:	
Value Percent:	
Continuous Index:	
Within 8" of Joint:	NO
Remarks:	pipe appears to get smaller
