## Profile/Photo Observation Report

Date:	<b>01/24/2025</b>	Weather:		Coding:	<b>PACP 7.0</b>
Pipe Length (ft):	<b>289.0</b>	Owner:	<b>City of Hobart</b>	Pre Clean:	<b>Heavy Cleaning</b>
P.O.#:	<b>YES502259</b>	Surveyor:	<b>S. Bucklin</b>	PSR:	<b>P-208-017-018</b>
Customer:	<b>City of Hobart</b>	Clean Date:	<b>08/01/2024</b>	Shape:	<b>C</b>

Street:	<b>Brookview Court</b>	Flow Control:	<b>Not Controlled</b>
City:	<b>Hobart, IN</b>	Year Renewed:	
Location:	<b>Easement/Right of Way</b>	Tape/Media #:	
Purpose:	<b>Sewer System Evaluation Survey (SS</b>	Dia/Height:	<b>15"</b>
Use:	<b>Sanitary Sewage Pipe</b>	Material:	<b>VCP</b>
Drain Area:		Lining:	<b>None</b>
Category:	<b>NA</b>		
Comment:			
Location Details:		Direction of Survey:	<b>Upstream</b>
US MH:	<b>M-208-017</b>	DS MH:	<b>M-208-018</b>
		Total Length Surveyed (ft):	<b>274.2</b>

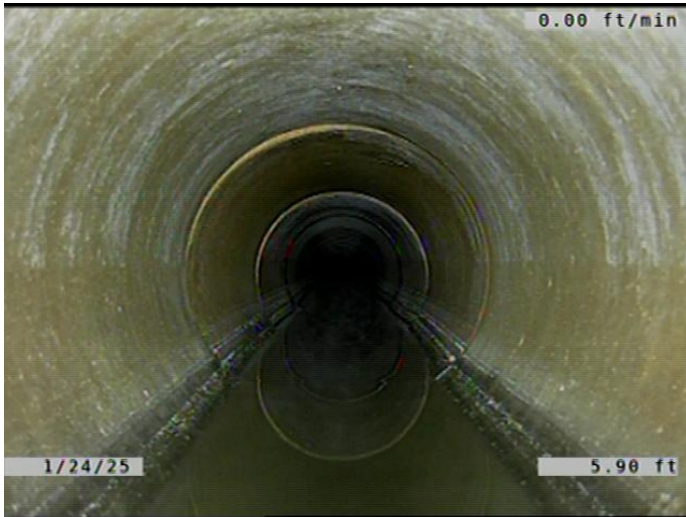
Code: **MWLS**  
Description: **Miscellaneous Water Level Sag**

Distance (ft): **5.9**  
Structural Grade: **2**  
O&M Grade: **0**  
Clock Start/From:  
Clock To:  
1st Value:  
2nd Value:  
Value Percent: **20.000**  
Continuous Index: **S01**  
Within 8" of Joint: **NO**  
Remarks:

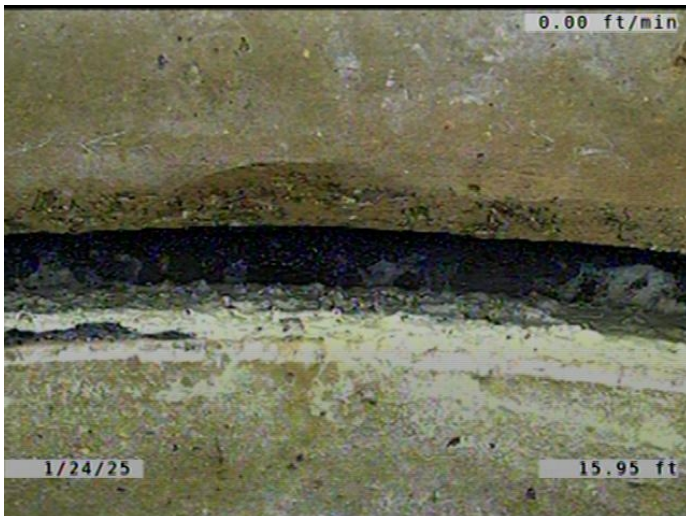
Code: **DAE**  
Description: **Deposits Attached Encrustation**

Distance (ft): **16.0**  
Structural Grade: **0**  
O&M Grade: **2**  
Clock Start/From: **7**  
Clock To: **5**  
1st Value:  
2nd Value:  
Value Percent: **5.000**  
Continuous Index:  
Within 8" of Joint: **YES**  
Remarks:

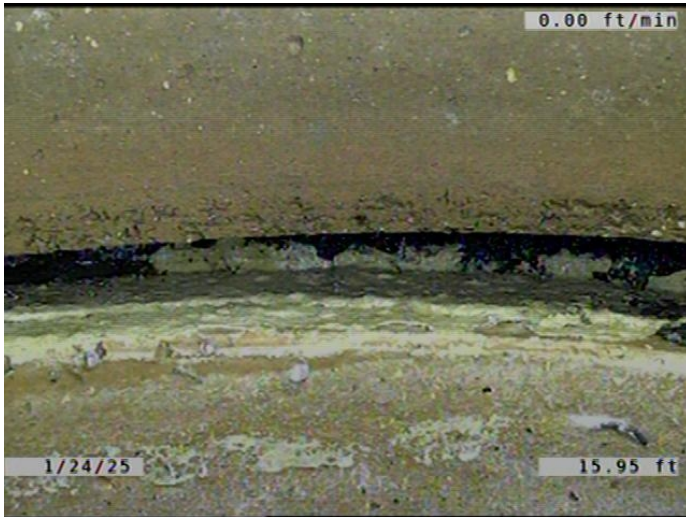
Code: **IDJ**  
 Description: **Infiltration Dripper Joint**

Distance (ft): **16.0**  
 Structural Grade: **0**  
 O&M Grade: **3**  
 Clock Start/From: **10**  
 Clock To:  
 1st Value:  
 2nd Value:  
 Value Percent:  
 Continuous Index:  
 Within 8" of Joint: **YES**  
 Remarks:

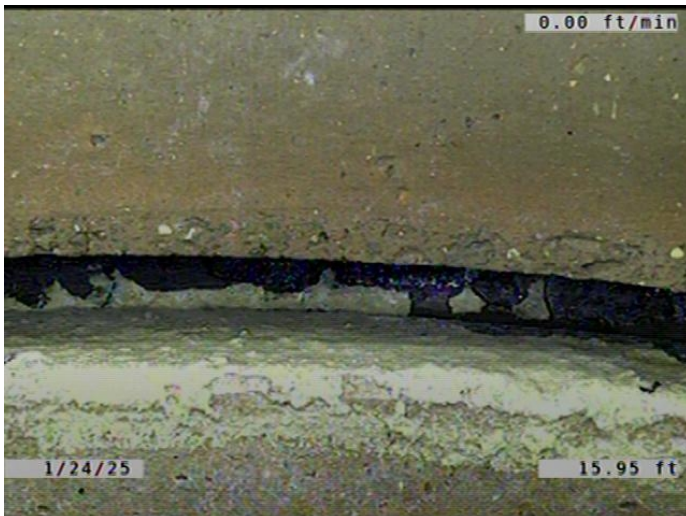
Code: **IWJ**  
 Description: **Infiltration Weeper Joint**

Distance (ft): **16.0**  
 Structural Grade: **0**  
 O&M Grade: **2**  
 Clock Start/From: **2**  
 Clock To:  
 1st Value:  
 2nd Value:  
 Value Percent:  
 Continuous Index:  
 Within 8" of Joint: **YES**  
 Remarks:

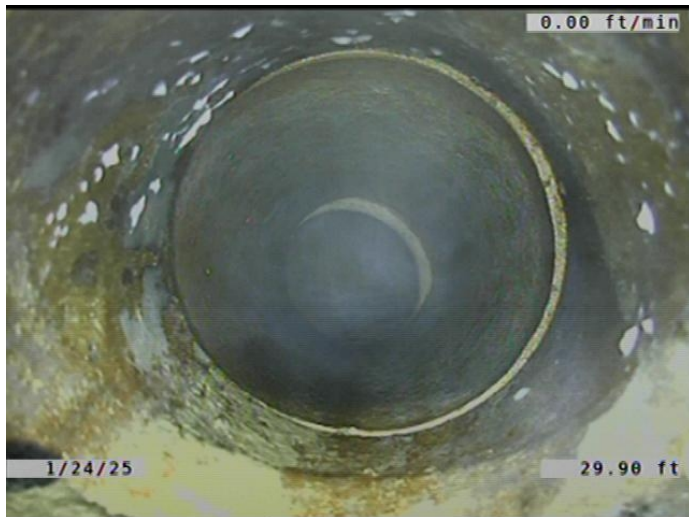
Code: **TF**  
 Description: **Tap Factory**

Distance (ft): **29.9**  
 Structural Grade: **0**  
 O&M Grade: **0**  
 Clock Start/From: **11**  
 Clock To:  
 1st Value: **6.000**  
 2nd Value:  
 Value Percent:  
 Continuous Index:  
 Within 8" of Joint: **YES**  
 Remarks: **SERVICE JOINTS OFFSET.**

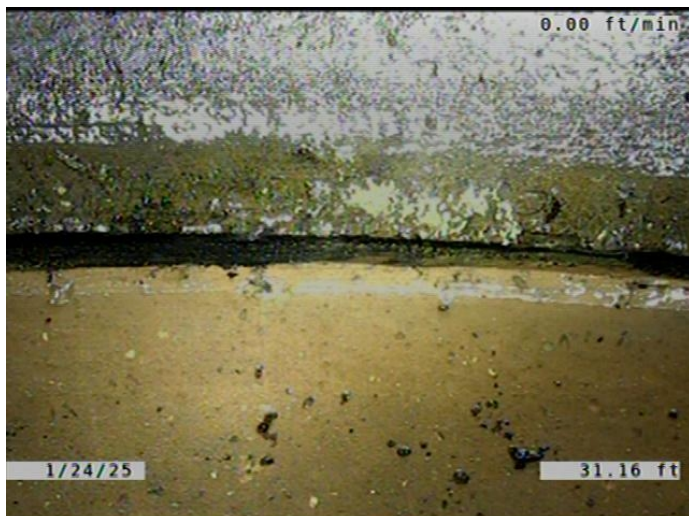
Code: **DAE**  
 Description: **Deposits Attached Encrustation**

Distance (ft): **31.2**  
 Structural Grade: **0**  
 O&M Grade: **2**  
 Clock Start/From: **8**  
 Clock To: **4**  
 1st Value:  
 2nd Value:  
 Value Percent: **5.000**  
 Continuous Index: **S02**  
 Within 8" of Joint: **YES**  
 Remarks:

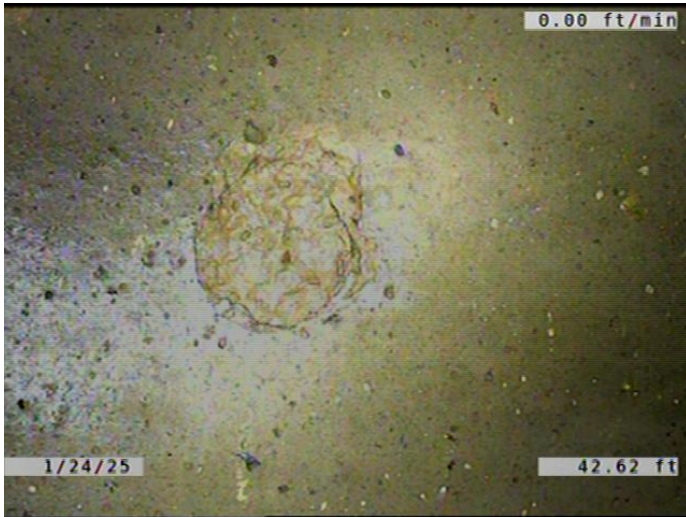
Code:	SSC
Description:	Surface Spalling of Damage Coating
Distance (ft):	42.6
Structural Grade:	1
O&M Grade:	0
Clock Start/From:	2
Clock To:	
1st Value:	
2nd Value:	
Value Percent:	
Continuous Index:	
Within 8" of Joint:	YES
Remarks:

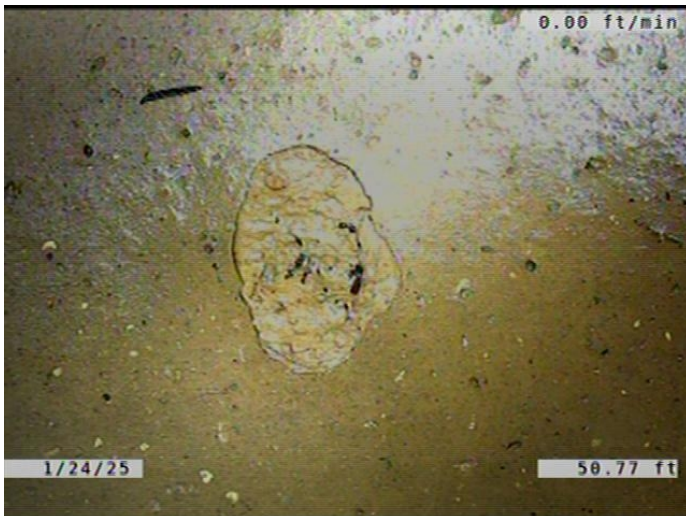
Code:	SSC
Description:	Surface Spalling of Damage Coating
Distance (ft):	50.8
Structural Grade:	1
O&M Grade:	0
Clock Start/From:	10
Clock To:	
1st Value:	
2nd Value:	
Value Percent:	
Continuous Index:	
Within 8" of Joint:	NO
Remarks:

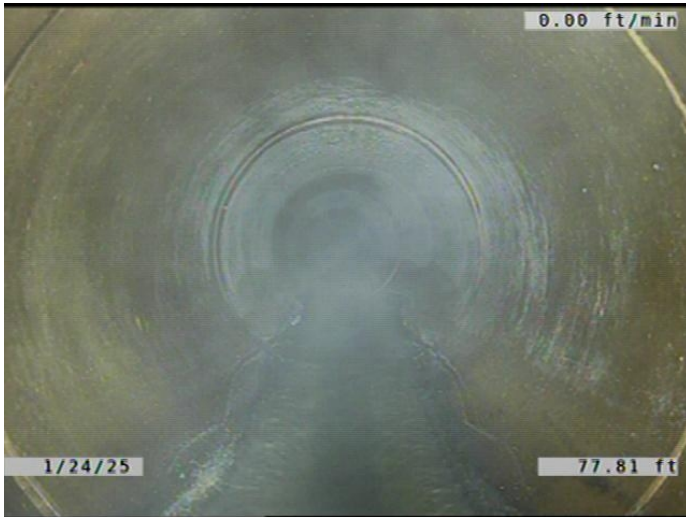
Code: **MWLS**  
Description: **Miscellaneous Water Level Sag**

Distance (ft): **77.8**  
Structural Grade: **2**  
O&M Grade: **0**  
Clock Start/From:  
Clock To:  
1st Value:  
2nd Value:  
Value Percent: **20.000**  
Continuous Index: **F01**  
Within 8" of Joint: **NO**  
Remarks:

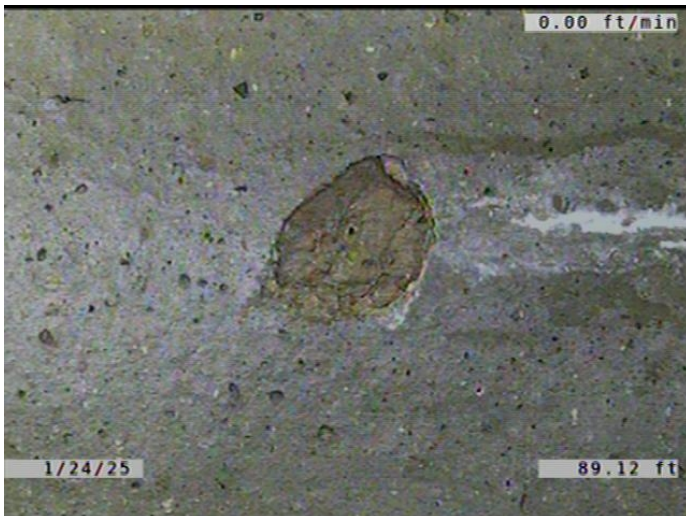
Code: **SSS**  
Description: **Surface Damage Surface Spalling**

Distance (ft): **89.1**  
Structural Grade: **2**  
O&M Grade: **0**  
Clock Start/From: **2**  
Clock To:  
1st Value:  
2nd Value:  
Value Percent:  
Continuous Index:  
Within 8" of Joint: **YES**  
Remarks:

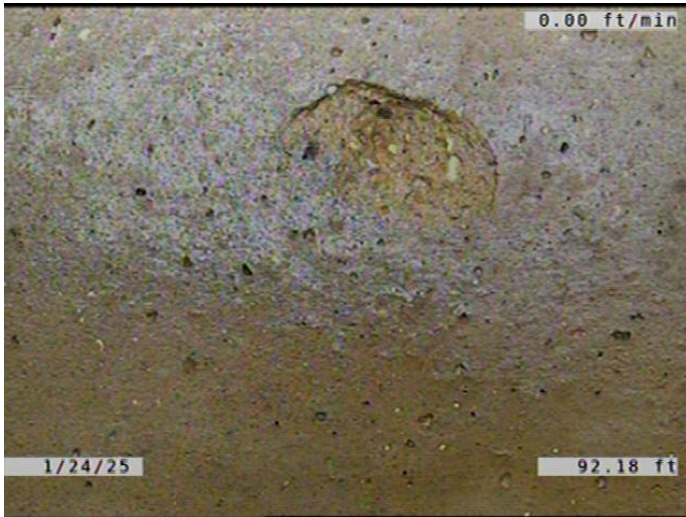
Code:	<b>SSC</b>
Description:	<b>Surface Spalling of Damage Coating</b>
Distance (ft):	<b>92.2</b>
Structural Grade:	<b>1</b>
O&M Grade:	<b>0</b>
Clock Start/From:	<b>12</b>
Clock To:	
1st Value:	
2nd Value:	
Value Percent:	
Continuous Index:	
Within 8" of Joint:	<b>YES</b>
Remarks:

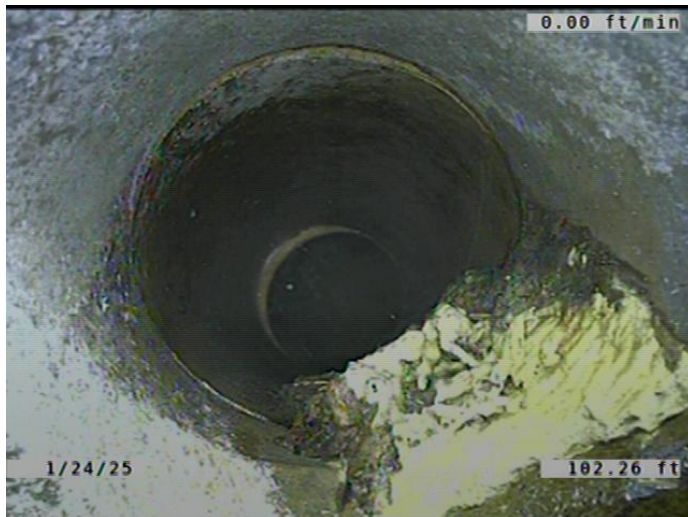
Code: **TFD**  
 Description: **Tap Factory Defective**

Distance (ft): **102.3**  
 Structural Grade: **0**  
 O&M Grade: **3**  
 Clock Start/From: **1**  
 Clock To:  
 1st Value: **6.000**  
 2nd Value:  
 Value Percent:  
 Continuous Index:  
 Within 8" of Joint: **YES**  
 Remarks: **ENCRUSTATION COMING FROM THE SERVICE INTO THE MAIN.**

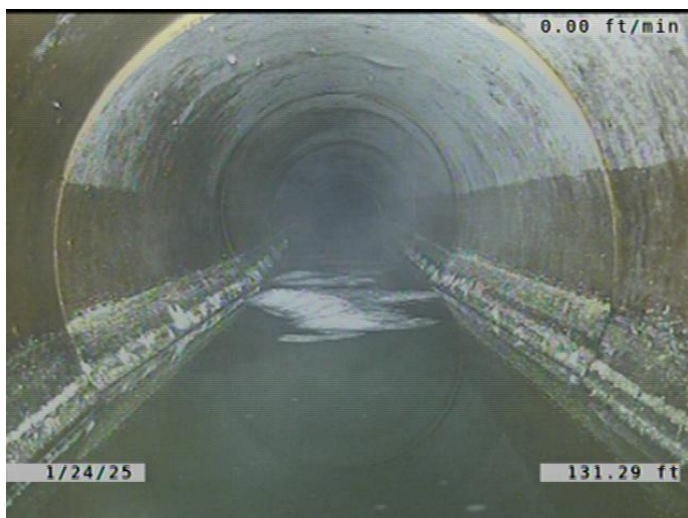
Code: **MWLS**  
 Description: **Miscellaneous Water Level Sag**

Distance (ft): **131.3**  
 Structural Grade: **4**  
 O&M Grade: **0**  
 Clock Start/From:  
 Clock To:  
 1st Value:  
 2nd Value:  
 Value Percent: **70.000**  
 Continuous Index: **S03**  
 Within 8" of Joint: **NO**  
 Remarks:

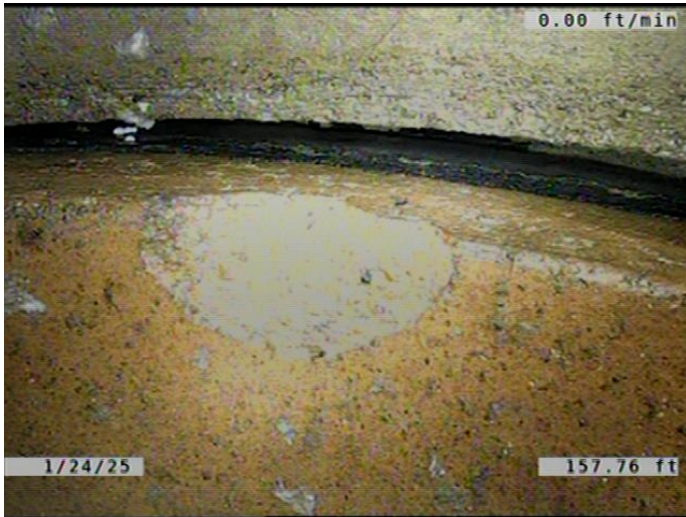
Code: **SSS**  
Description: **Surface Damage Surface Spalling**

Distance (ft): **157.8**  
Structural Grade: **2**  
O&M Grade: **0**  
Clock Start/From: **10**  
Clock To:  
1st Value:  
2nd Value:  
Value Percent:  
Continuous Index:  
Within 8" of Joint: **YES**  
Remarks:

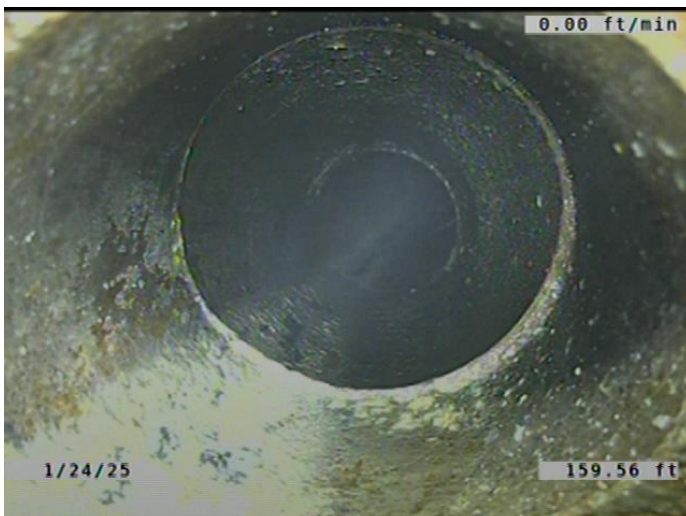
Code: **TF**  
Description: **Tap Factory**

Distance (ft): **159.6**  
Structural Grade: **0**  
O&M Grade: **0**  
Clock Start/From: **11**  
Clock To:  
1st Value: **6.000**  
2nd Value:  
Value Percent:  
Continuous Index:  
Within 8" of Joint: **YES**  
Remarks: **CONSTANTLY RUNNING WATER.**

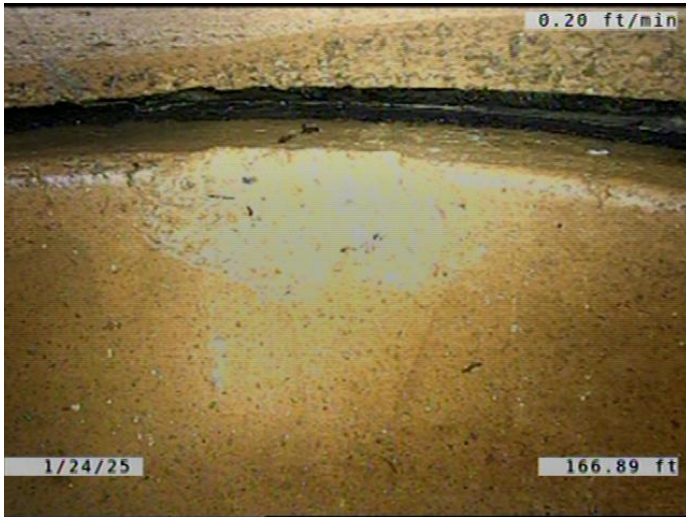
Code:	<b>SSS</b>
Description:	<b>Surface Damage Surface Spalling</b>
Distance (ft):	<b>166.9</b>
Structural Grade:	<b>2</b>
O&M Grade:	<b>0</b>
Clock Start/From:	<b>10</b>
Clock To:	
1st Value:	
2nd Value:	
Value Percent:	
Continuous Index:	
Within 8" of Joint:	<b>YES</b>
Remarks:

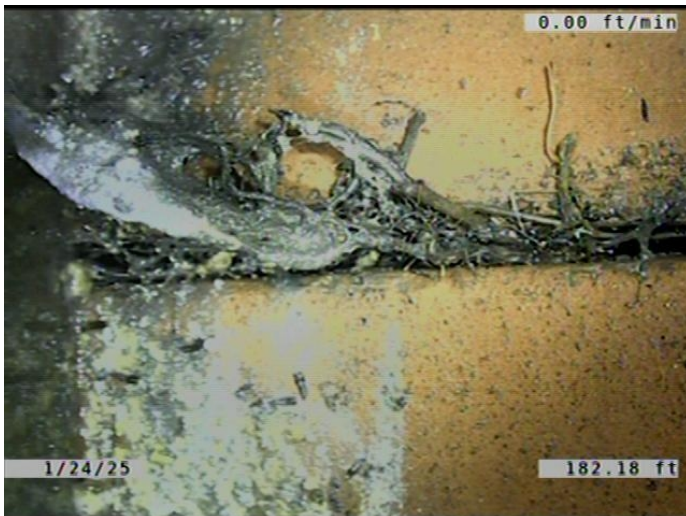
Code:	<b>RFJ</b>
Description:	<b>Roots Fine Joint</b>
Distance (ft):	<b>182.2</b>
Structural Grade:	<b>0</b>
O&M Grade:	<b>1</b>
Clock Start/From:	<b>9</b>
Clock To:	<b>3</b>
1st Value:	
2nd Value:	
Value Percent:	
Continuous Index:	<b>S04</b>
Within 8" of Joint:	<b>YES</b>
Remarks:

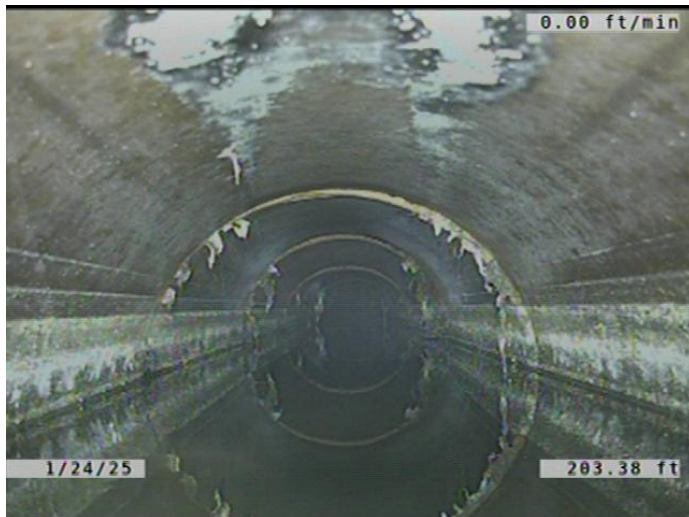
Code: **RFJ**  
 Description: **Roots Fine Joint**

Distance (ft): **203.4**  
 Structural Grade: **0**  
 O&M Grade: **1**  
 Clock Start/From: **9**  
 Clock To: **3**  
 1st Value:  
 2nd Value:  
 Value Percent:  
 Continuous Index: **F04**  
 Within 8" of Joint: **YES**  
 Remarks:

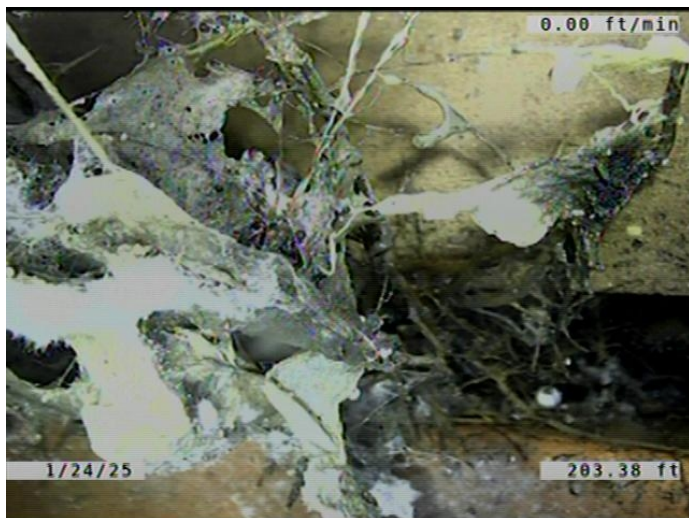
Code: **RMJ**  
 Description: **Roots Medium Joint**

Distance (ft): **203.4**  
 Structural Grade: **0**  
 O&M Grade: **3**  
 Clock Start/From: **8**  
 Clock To: **4**  
 1st Value:  
 2nd Value:  
 Value Percent: **5.000**  
 Continuous Index: **S05**  
 Within 8" of Joint: **YES**  
 Remarks:

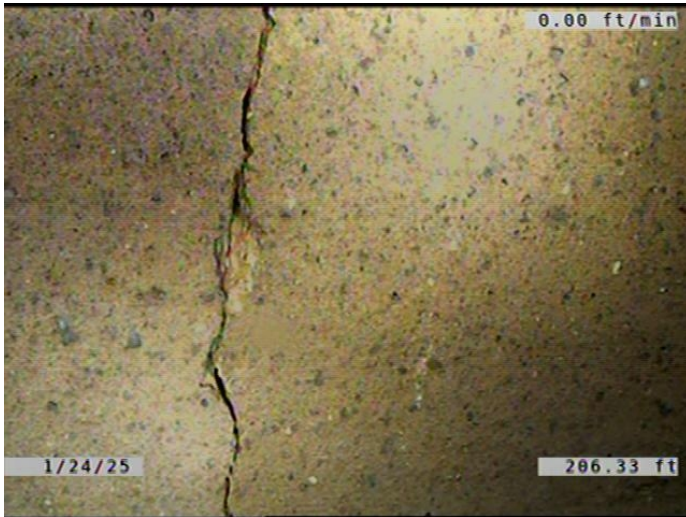
Code: **FS**  
Description: **Fracture Spiral**

Distance (ft): **206.3**  
Structural Grade: **3**  
O&M Grade: **0**  
Clock Start/From: **10**  
Clock To: **2**  
1st Value:  
2nd Value:  
Value Percent:  
Continuous Index: **S06**  
Within 8" of Joint: **YES**  
Remarks:

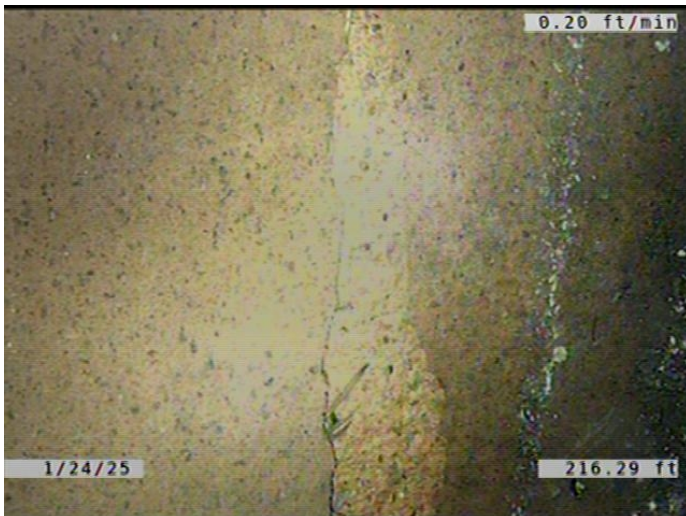
Code: **FS**  
Description: **Fracture Spiral**

Distance (ft): **216.3**  
Structural Grade: **3**  
O&M Grade: **0**  
Clock Start/From: **2**  
Clock To: **3**  
1st Value:  
2nd Value:  
Value Percent:  
Continuous Index:  
Within 8" of Joint: **YES**  
Remarks:

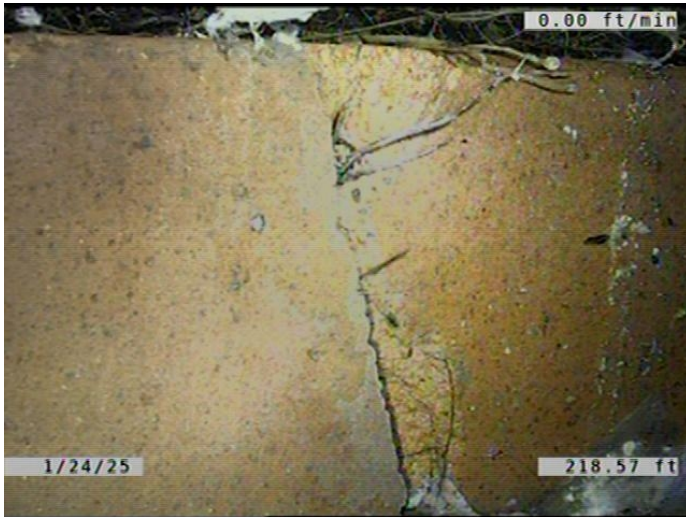
Code: **FS**  
 Description: **Fracture Spiral**

Distance (ft): **218.6**  
 Structural Grade: **3**  
 O&M Grade: **0**  
 Clock Start/From: **2**  
 Clock To: **4**  
 1st Value:  
 2nd Value:  
 Value Percent:  
 Continuous Index:  
 Within 8" of Joint: **YES**  
 Remarks:

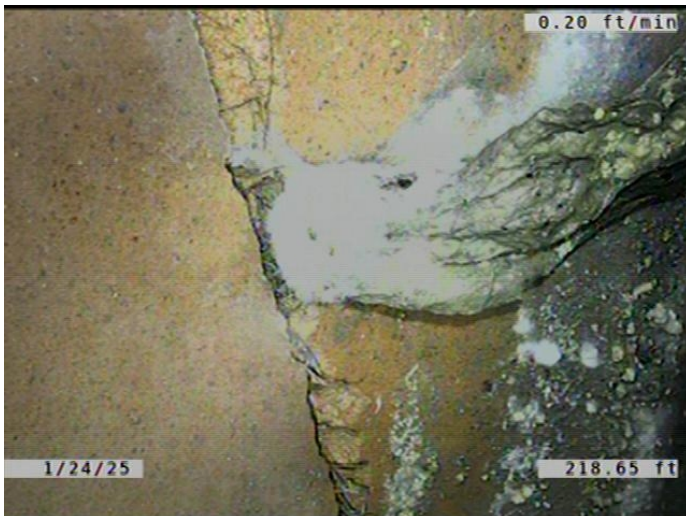
Code: **RFB**  
 Description: **Roots Fine Barrel**

Distance (ft): **218.6**  
 Structural Grade: **0**  
 O&M Grade: **2**  
 Clock Start/From: **2**  
 Clock To: **4**  
 1st Value:  
 2nd Value:  
 Value Percent:  
 Continuous Index:  
 Within 8" of Joint: **NO**  
 Remarks:

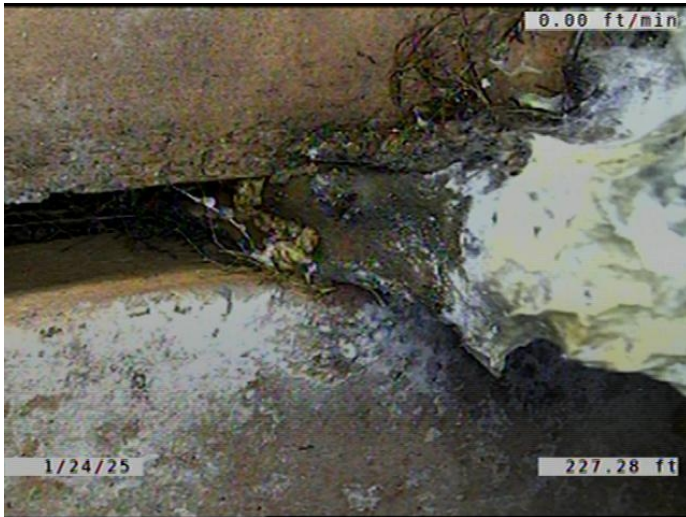
Code: **RTJ**  
 Description: **Roots Tap Joint**

Distance (ft): **227.3**  
 Structural Grade: **0**  
 O&M Grade: **2**  
 Clock Start/From: **1**  
 Clock To: **3**  
 1st Value:  
 2nd Value:  
 Value Percent: **10.000**  
 Continuous Index:  
 Within 8" of Joint: **YES**  
 Remarks:

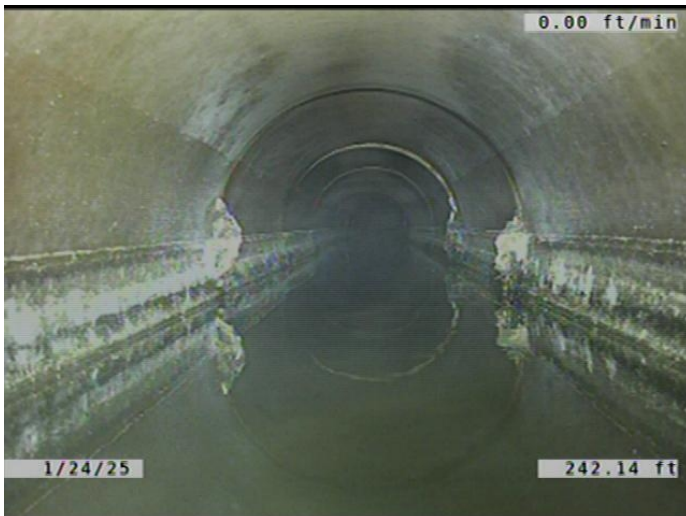
Code: **FS**  
 Description: **Fracture Spiral**

Distance (ft): **242.1**  
 Structural Grade: **3**  
 O&M Grade: **0**  
 Clock Start/From: **10**  
 Clock To: **2**  
 1st Value:  
 2nd Value:  
 Value Percent:  
 Continuous Index: **F06**  
 Within 8" of Joint: **YES**  
 Remarks:

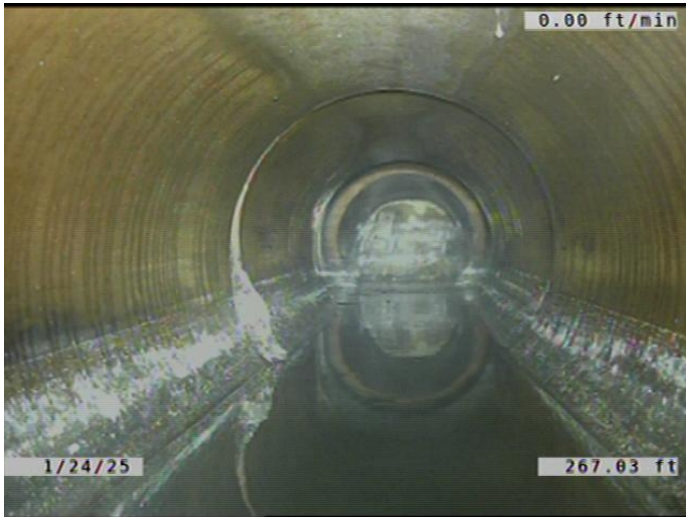
Code: **MWLS**  
 Description: **Miscellaneous Water Level Sag**

Distance (ft): **267.0**  
 Structural Grade: **4**  
 O&M Grade: **0**  
 Clock Start/From:  
 Clock To:  
 1st Value:  
 2nd Value:  
 Value Percent: **70.000**  
 Continuous Index: **F03**  
 Within 8" of Joint: **NO**  
 Remarks:

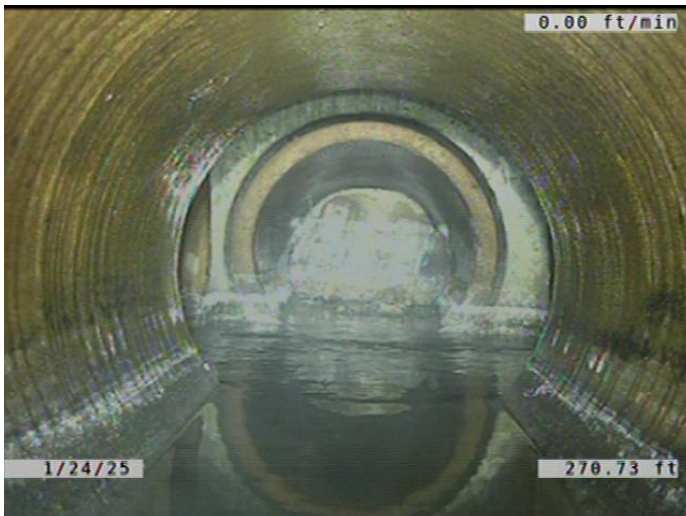
Code: **RMJ**  
 Description: **Roots Medium Joint**

Distance (ft): **270.7**  
 Structural Grade: **0**  
 O&M Grade: **3**  
 Clock Start/From: **8**  
 Clock To: **4**  
 1st Value:  
 2nd Value:  
 Value Percent: **5.000**  
 Continuous Index: **F05**  
 Within 8" of Joint: **YES**  
 Remarks:

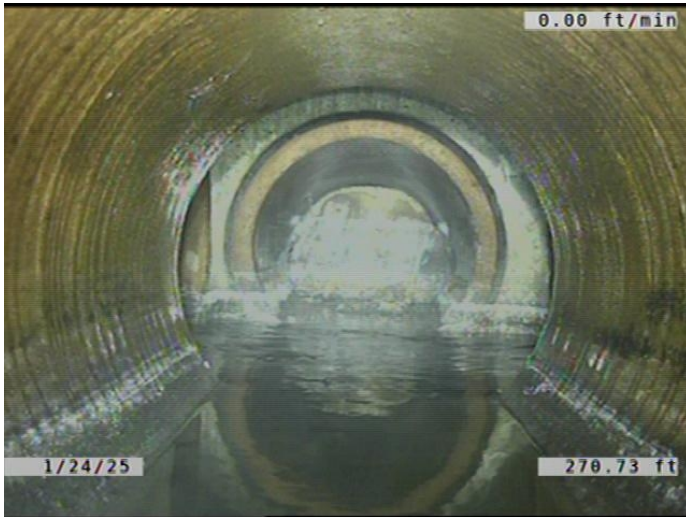
Code:	<b>DAE</b>
Description:	<b>Deposits Attached Encrustation</b>
Distance (ft):	<b>270.7</b>
Structural Grade:	<b>0</b>
O&M Grade:	<b>2</b>
Clock Start/From:	<b>8</b>
Clock To:	<b>4</b>
1st Value:	
2nd Value:	
Value Percent:	<b>5.000</b>
Continuous Index:	<b>F02</b>
Within 8" of Joint:	<b>YES</b>
Remarks:
