Profile/Photo Observation Report

Date:	04/11/2018	Weather:		Coding:	PACP 6.0
Pipe Length (ft):		Owner:	City of Hobart	Pre Clean:	Not Known
P.O.#:	229	Surveyor:	B. Helbling	PSR:	P-208-018-019
Customer:	City of Hobart	Clean Date:		Shape:	C

Street:	Brookview Court	Flow Control:	Not Controlled
City:	Hobart, IN	Year Renewed:	
Location:	Easement/Right of Way	Tape/Media #:	DEP229
Purpose:	Routine Assessment	Dia/Height:	15"
Use:	Sanitary	Material:	VCP
Drain Area:		Lining:	
Category:	NA		
Comment:	YES501824 Submittal 2		
Location Details:		Direction of Survey:	Upstream
US MH:	M-208-018	DS MH:	M-208-019
		Total Length Surveyed (ft):	77.4

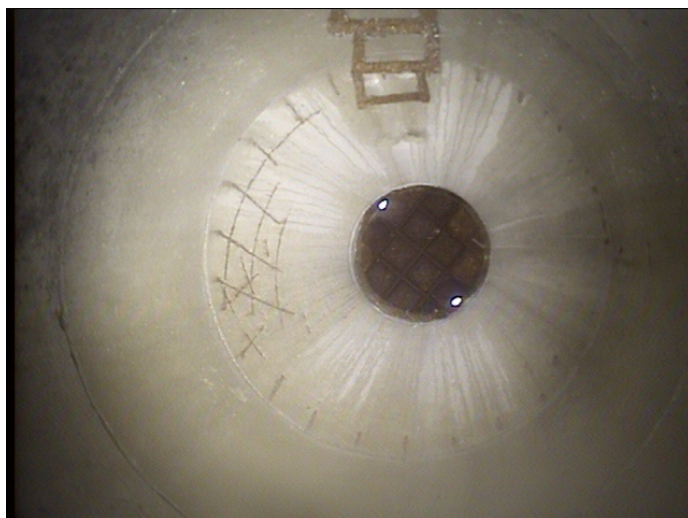
Code: **AMH**
Description: **Manhole**

Distance (ft): **.0**
Structural Grade: **0**
O&M Grade: **0**
Clock Start/From:
Clock To:
1st Value:
2nd Value:
Value Percent:
Continuous Index:
Within 8" of Joint: **NO**
Remarks: **M-208-019**

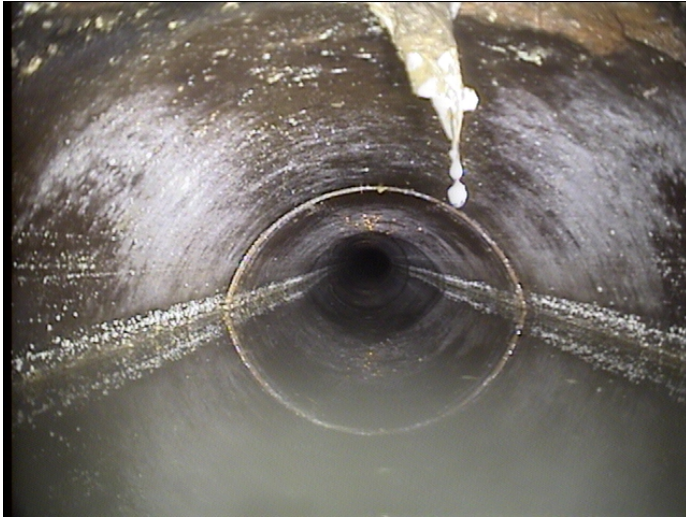
Code:	MWL
Description:	Water Level
Distance (ft):	.0
Structural Grade:	0
O&M Grade:	0
Clock Start/From:	
Clock To:	
1st Value:	
2nd Value:	
Value Percent:	30.000
Continuous Index:	
Within 8" of Joint:	NO
Remarks:

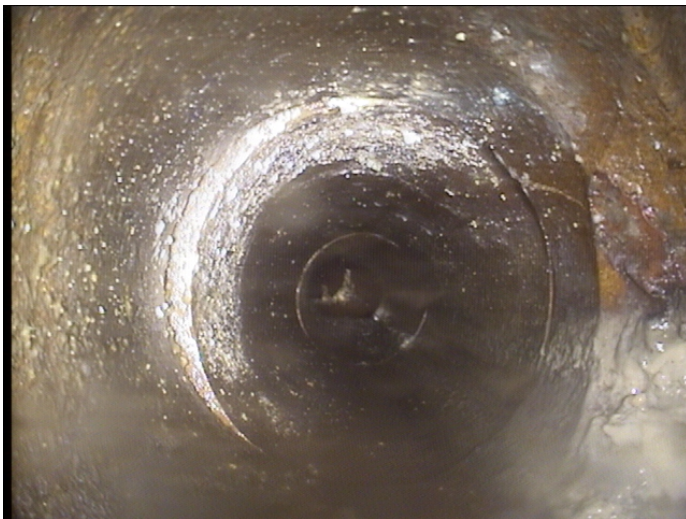
Code:	TF
Description:	Tap Factory
Distance (ft):	37.2
Structural Grade:	0
O&M Grade:	0
Clock Start/From:	10
Clock To:	
1st Value:	4.000
2nd Value:	
Value Percent:	
Continuous Index:	
Within 8" of Joint:	NO
Remarks:

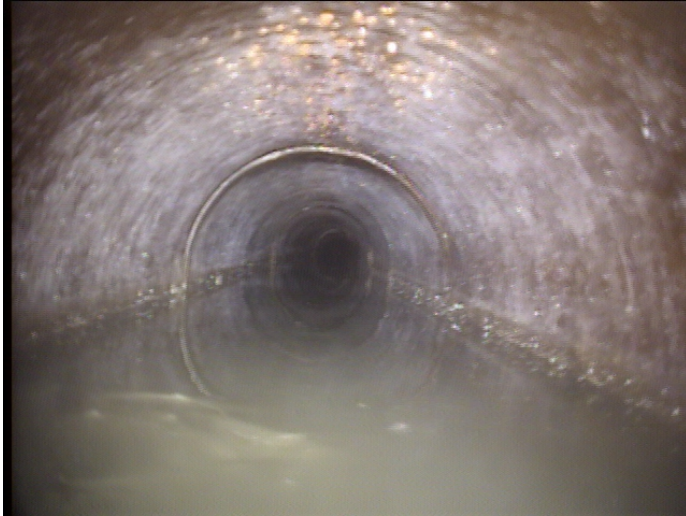
Code: **DSF**
Description: **Deposits Settled Fine**

Distance (ft): **41.3**
Structural Grade: **0**
O&M Grade: **2**
Clock Start/From: **5**
Clock To: **7**
1st Value:
2nd Value:
Value Percent: **10.000**
Continuous Index: **S01**
Within 8" of Joint: **NO**
Remarks:

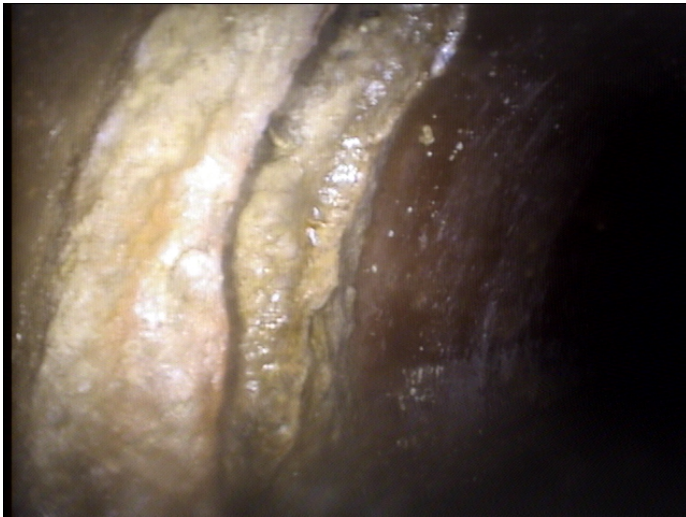
Code: **DAE**
Description: **Deposits Attached Encrustation**

Distance (ft): **62.8**
Structural Grade: **0**
O&M Grade: **2**
Clock Start/From: **8**
Clock To: **11**
1st Value:
2nd Value:
Value Percent: **5.000**
Continuous Index:
Within 8" of Joint: **YES**
Remarks:

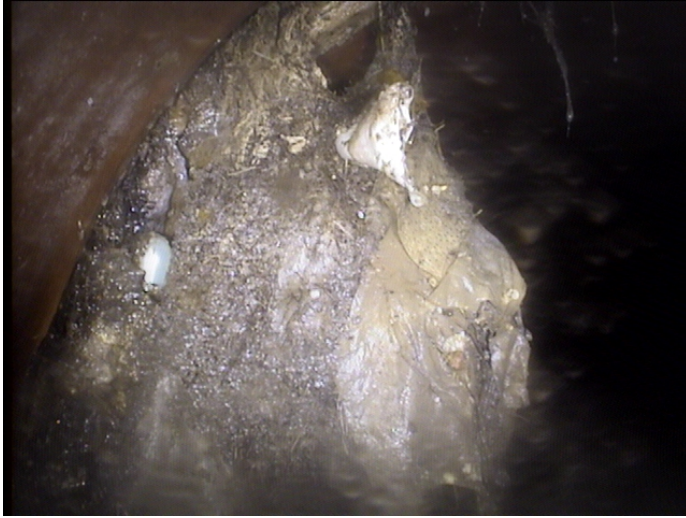
Code: **RMJ**
Description: **Roots Medium Joint**

Distance (ft): **77.4**
Structural Grade: **0**
O&M Grade: **3**
Clock Start/From: **8**
Clock To: **12**
1st Value:
2nd Value:
Value Percent: **20.000**
Continuous Index:
Within 8" of Joint: **YES**
Remarks:

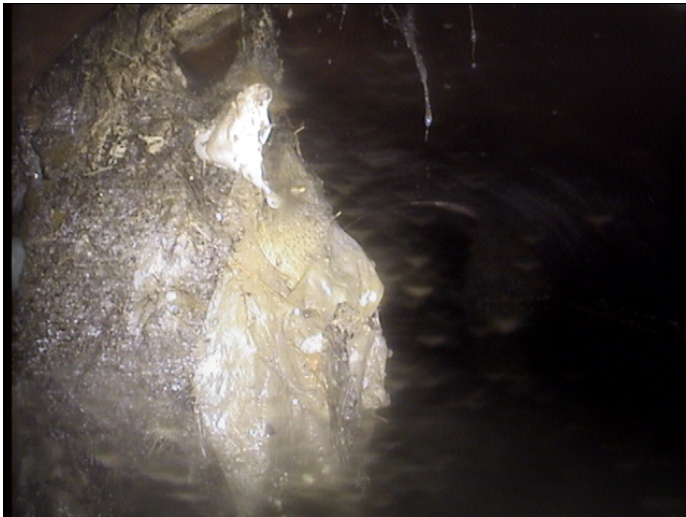
Code: **DSF**
Description: **Deposits Settled Fine**

Distance (ft): **77.4**
Structural Grade: **0**
O&M Grade: **2**
Clock Start/From: **5**
Clock To: **7**
1st Value:
2nd Value:
Value Percent: **10.000**
Continuous Index: **F01**
Within 8" of Joint: **NO**
Remarks:

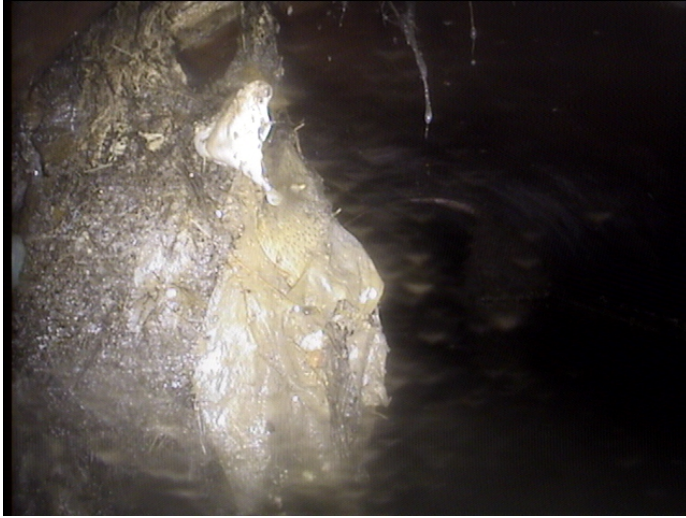
Code:	MSA
Description:	Abandoned Survey
Distance (ft):	77.4
Structural Grade:	0
O&M Grade:	0
Clock Start/From:	
Clock To:	
1st Value:	
2nd Value:	
Value Percent:	
Continuous Index:	
Within 8" of Joint:	NO
Remarks:	Roots
