Profile/Ph	oto Observatior	n Report				RedZor
Date:	03/20/2018	Weather:			Coding:	PACP 6.0
Pipe Length (ft	:): <b>207.0</b>	Owner:	NA		Pre Clean:	No Pre-Cleaning
P.O.#:		Surveyor:	John Kugl	maier	PSR:	P-108-054-021
Customer:		Clean Date:	: 01/01/19	00	Shape:	С
Street:	W 61ST AVE & S L	ST AVE & S LIVERPOOL RD		Flow Control:		
City:	Hobart, IN		Year Renev	ved:		
Location:	Light Highway		Tape/Medi	a #:		
Purpose:	Routine Assessme	nt	Dia/Height:	:	10"	
Use:	Sanitary		Material:		PVC	
Drain Area:	NA		Lining:			
Category:	NA

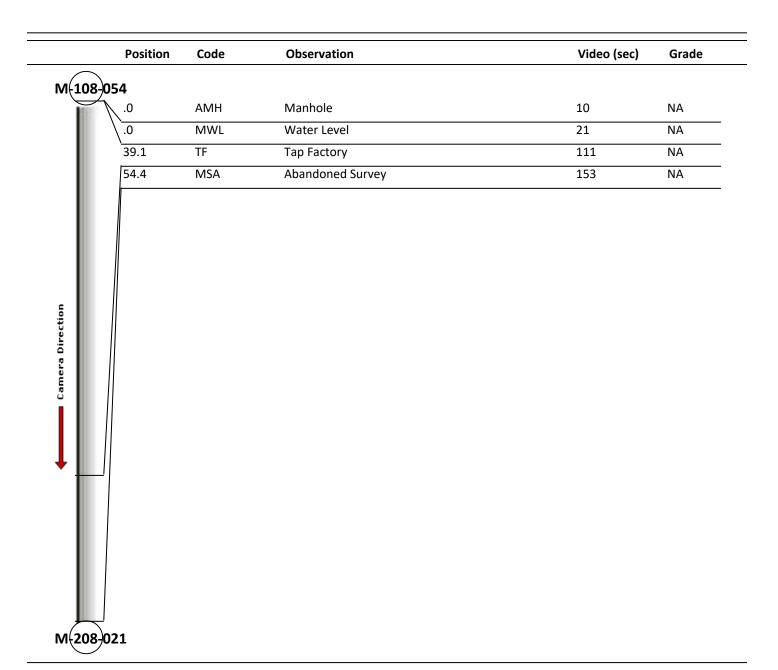
Comment:	P_C at 53 ft nothir	ng visible .Flow d	lirection wron	g		
Location Detai	ls:		Direction o	f Survey:	Upstream	
US MH:	M-208-021	DS MH:	M-108-054	-	Fotal Length Surveyed (ft)	: <b>54.4</b>
D&M Index:	0.00	O&M Quick:	:	0000	O&M Rating:	0.00
Structural Index:	0.00	Structural Q	uick:	0000	Structural Rating:	0.00
Overall Index:	0.00	Overall Quic	:k:	0000	Overall Rating:	0.00
