Profile/Photo Observation Report

Date:	12/03/2024	Weather:		Coding:	PACP 7.0
Pipe Length (ft):	217.0	Owner:	City of Hobart	Pre Clean:	Heavy Cleaning
P.O.#:	YES502259	Surveyor:	S. Bucklin	PSR:	P-209-025-021
Customer:	City of Hobart	Clean Date:	07/16/2024	Shape:	C

Street:	Liverpool Road	Flow Control:	Not Controlled
City:	Hobart, IN	Year Renewed:	
Location:	Local rural streets with light traffic, t	Tape/Media #:	
Purpose:	Sewer System Evaluation Survey (SS	Dia/Height:	18"
Use:	Sanitary Sewage Pipe	Material:	VCP
Drain Area:		Lining:	None
Category:	NA		
Comment:			
Location Details:		Direction of Survey:	Downstream
US MH:	M-208-021	DS MH:	M-209-025
		Total Length Surveyed (ft):	216.8

O&M Index:	2.38	O&M Quick:	4A2G	O&M Rating:	131.00
Structural Index:	3.67	Structural Quick:	4231	Structural Rating:	11.00
Overall Index:	2.45	Overall Quick:	4A31	Overall Rating:	142.00

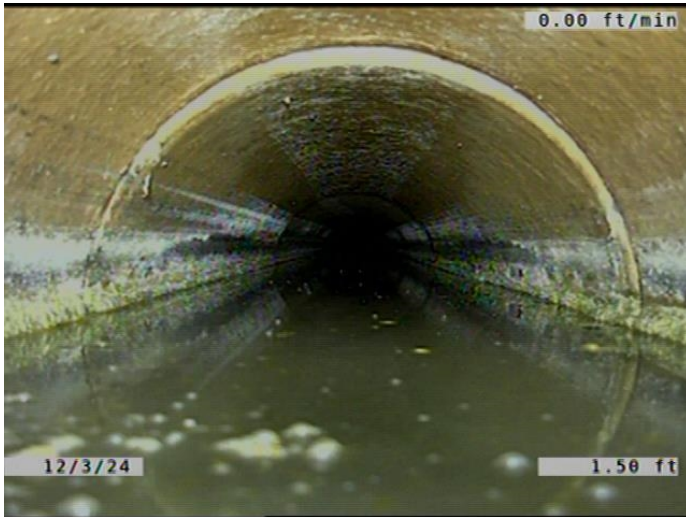
Code:	MGO
Description:	Miscellaneous General Observation
Distance (ft):	1.5
Structural Grade:	0
O&M Grade:	0
Clock Start/From:	
Clock To:	
1st Value:	
2nd Value:	
Value Percent:	
Continuous Index:	
Within 8" of Joint:	NO
Remarks:	DROP INTO THE MAINHOLE. HAD TO START IN THE PIPE.

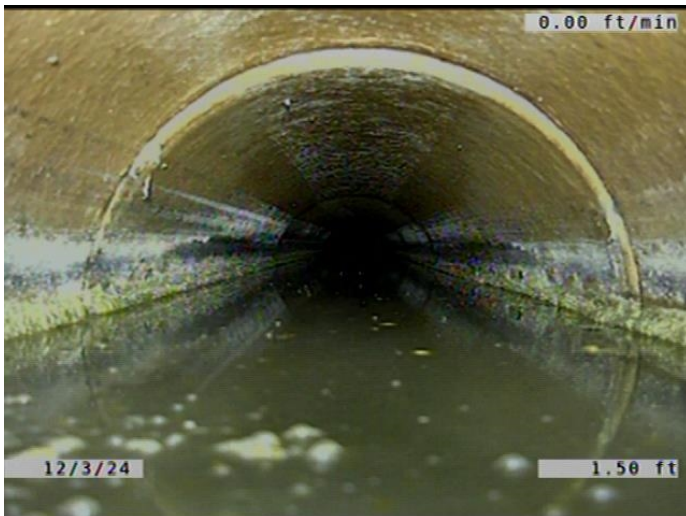
Code:	DAGS
Description:	Deposits Attached Grease
Distance (ft):	1.5
Structural Grade:	0
O&M Grade:	2
Clock Start/From:	9
Clock To:	3
1st Value:	
2nd Value:	
Value Percent:	5.000
Continuous Index:	S01
Within 8" of Joint:	YES
Remarks:

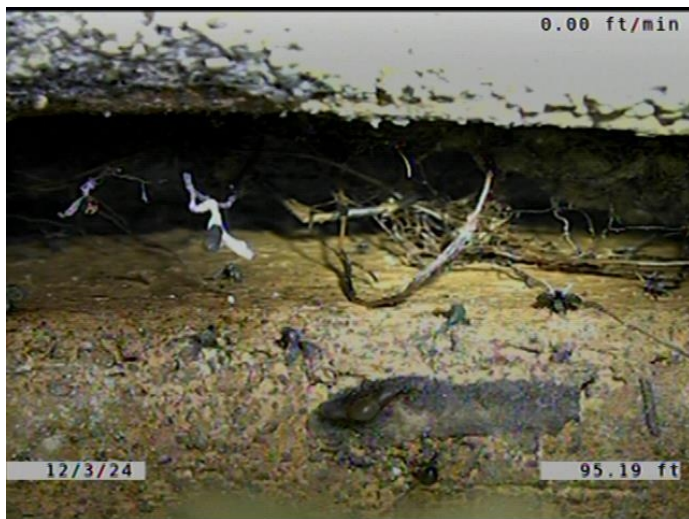
Code:	RFJ
Description:	Roots Fine Joint
Distance (ft):	95.2
Structural Grade:	0
O&M Grade:	1
Clock Start/From:	10
Clock To:	2
1st Value:	
2nd Value:	
Value Percent:	
Continuous Index:	
Within 8" of Joint:	YES
Remarks:

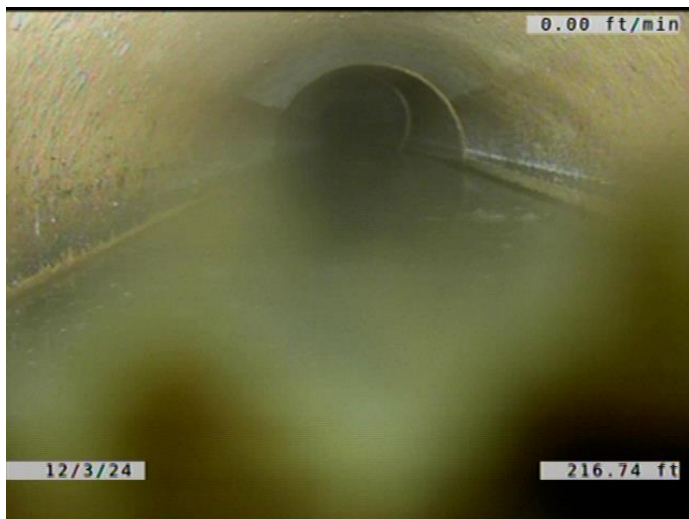
Code: **DAGS**
Description: **Deposits Attached Grease**

Distance (ft): **216.7**
Structural Grade: **0**
O&M Grade: **2**
Clock Start/From: **9**
Clock To: **3**
1st Value:
2nd Value:
Value Percent: **5.000**
Continuous Index: **F01**
Within 8" of Joint: **YES**
Remarks:

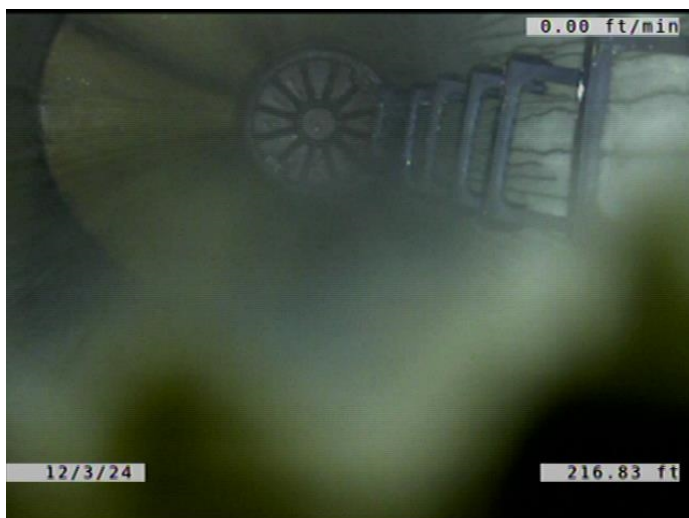
Code: **AMH**
Description: **Manhole**

Distance (ft): **216.8**
Structural Grade: **0**
O&M Grade: **0**
Clock Start/From:
Clock To:
1st Value:
2nd Value:
Value Percent:
Continuous Index:
Within 8" of Joint: **NO**
Remarks: **M-209-025**
