Profile/Photo Observation Report

Date:	01/17/2025	Weather:		Coding:	PACP 7.0
Pipe Length (ft):	217.0	Owner:	City of Hobart	Pre Clean:	Heavy Cleaning
P.O.#:	YES502259	Surveyor:	S. Bucklin	PSR:	P-209-025-021
Customer:	City of Hobart	Clean Date:	07/16/2024	Shape:	C

Street:	Liverpool Road	Flow Control:	De-watered Using Jetter
City:	Hobart, IN	Year Renewed:	
Location:	Local rural streets with light traffic, t	Tape/Media #:	
Purpose:	Sewer System Evaluation Survey (SS	Dia/Height:	15"
Use:	Sanitary Sewage Pipe	Material:	VCP
Drain Area:		Lining:	None
Category:	NA		
Comment:			
Location Details:		Direction of Survey:	Downstream
US MH:	M-209-025	DS MH:	M-208-021
		Total Length Surveyed (ft):	217.0

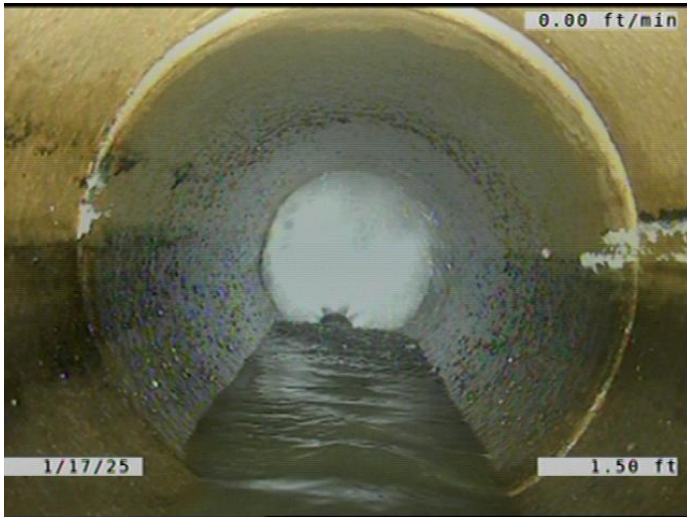
Code: **MGO**
Description: **Miscellaneous General Observation**

Distance (ft): **1.5**
Structural Grade: **0**
O&M Grade: **0**
Clock Start/From:
Clock To:
1st Value:
2nd Value:
Value Percent:
Continuous Index:
Within 8" of Joint: **NO**
Remarks: **DROP INTO THE MANHOLE. HAD TO START IN THE PIPE.**

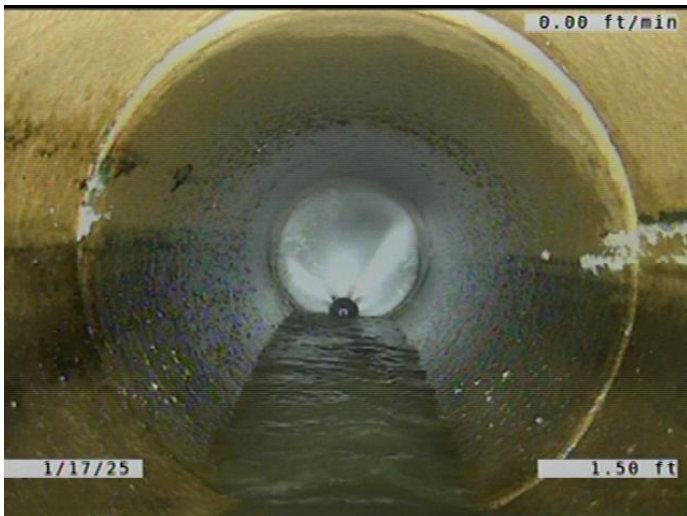
Code: **MGO**
Description: **Miscellaneous General Observation**

Distance (ft): **1.5**
Structural Grade: **0**
O&M Grade: **0**
Clock Start/From:
Clock To:
1st Value:
2nd Value:
Value Percent:
Continuous Index:
Within 8" of Joint: **NO**
Remarks: **DEWATERING THE PIPE WITH THE JETTER TO GET A BETTER INSPECTIO**

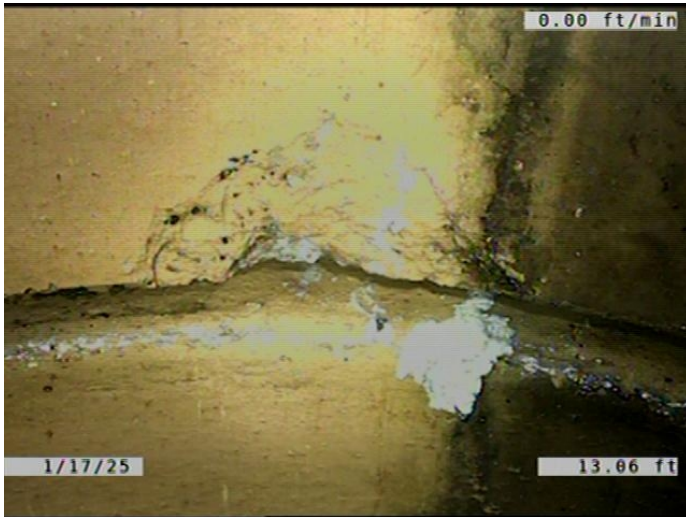
Code: **SZ**
Description: **Surface Damage Other**

Distance (ft): **13.1**
Structural Grade: **0**
O&M Grade: **0**
Clock Start/From: **3**
Clock To:
1st Value:
2nd Value:
Value Percent:
Continuous Index:
Within 8" of Joint: **YES**
Remarks: **CHIP OUT OF THE JOINT.**

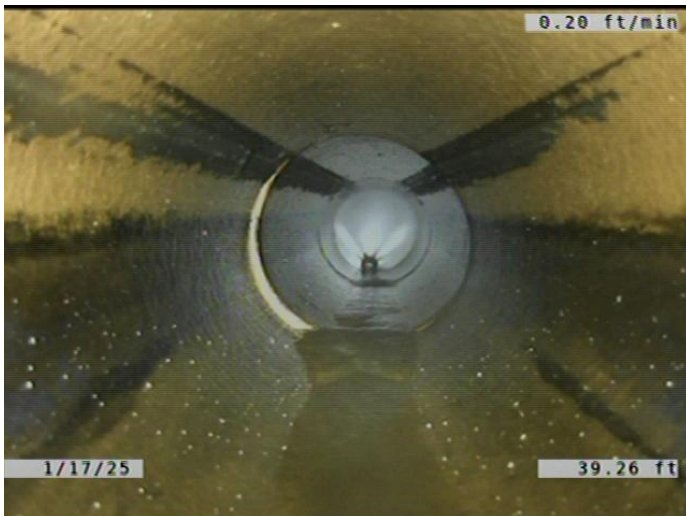
Code: **MWM**
Description: **Miscellaneous Water Mark**

Distance (ft): **39.2**
Structural Grade: **0**
O&M Grade: **0**
Clock Start/From:
Clock To:
1st Value:
2nd Value:
Value Percent: **90.000**
Continuous Index:
Within 8" of Joint: **NO**
Remarks:

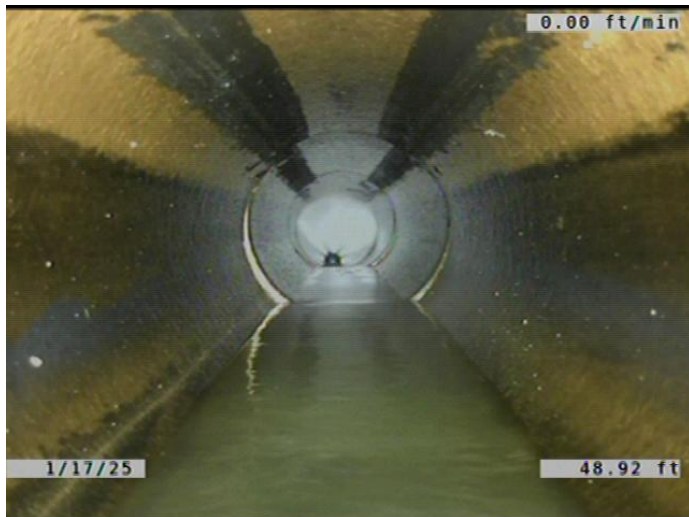
Code: **MWLS**
Description: **Miscellaneous Water Level Sag**

Distance (ft): **48.9**
Structural Grade: **2**
O&M Grade: **0**
Clock Start/From:
Clock To:
1st Value:
2nd Value:
Value Percent: **15.000**
Continuous Index: **S01**
Within 8" of Joint: **NO**
Remarks:

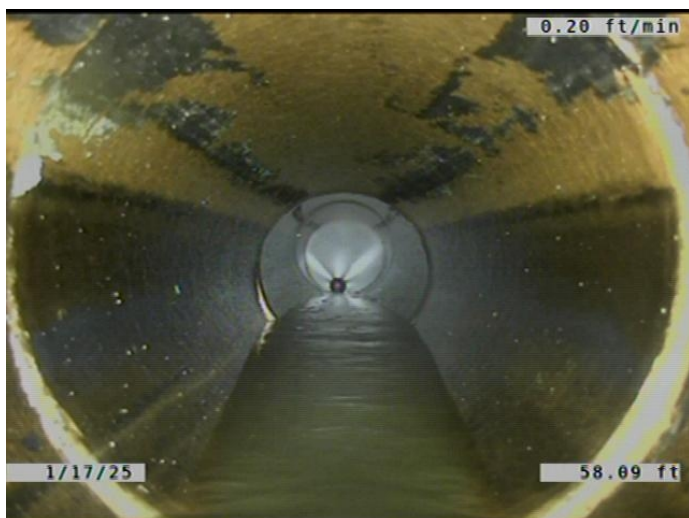
Code: **MWLS**
Description: **Miscellaneous Water Level Sag**

Distance (ft): **58.1**
Structural Grade: **2**
O&M Grade: **0**
Clock Start/From:
Clock To:
1st Value:
2nd Value:
Value Percent: **15.000**
Continuous Index: **F01**
Within 8" of Joint: **NO**
Remarks:

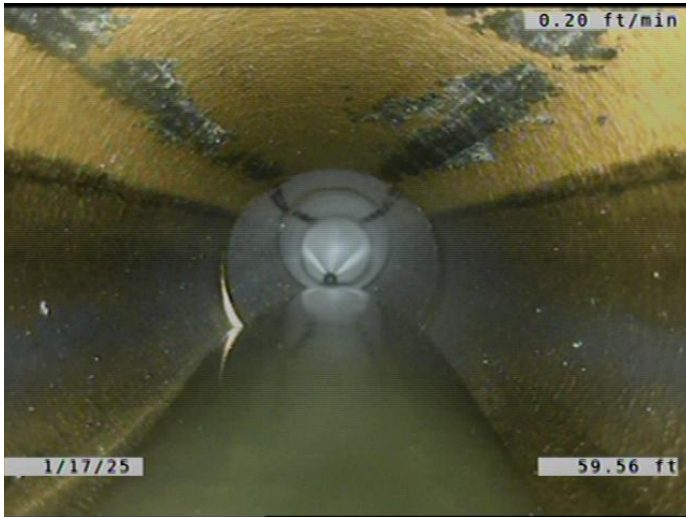
Code: **MWLS**
Description: **Miscellaneous Water Level Sag**

Distance (ft): **59.5**
Structural Grade: **2**
O&M Grade: **0**
Clock Start/From:
Clock To:
1st Value:
2nd Value:
Value Percent: **15.000**
Continuous Index: **S02**
Within 8" of Joint: **NO**
Remarks:

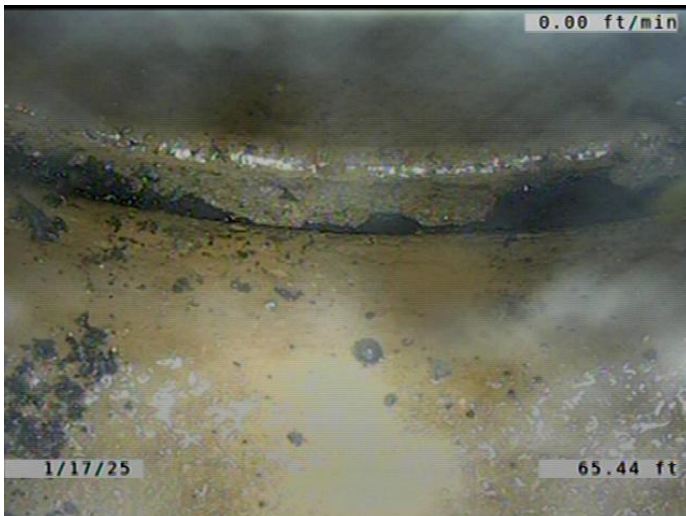
Code: **JOMD**
Description: **Joint Offset Medium Defective**

Distance (ft): **65.4**
Structural Grade: **3**
O&M Grade: **0**
Clock Start/From:
Clock To:
1st Value:
2nd Value:
Value Percent:
Continuous Index:
Within 8" of Joint: **NO**
Remarks:

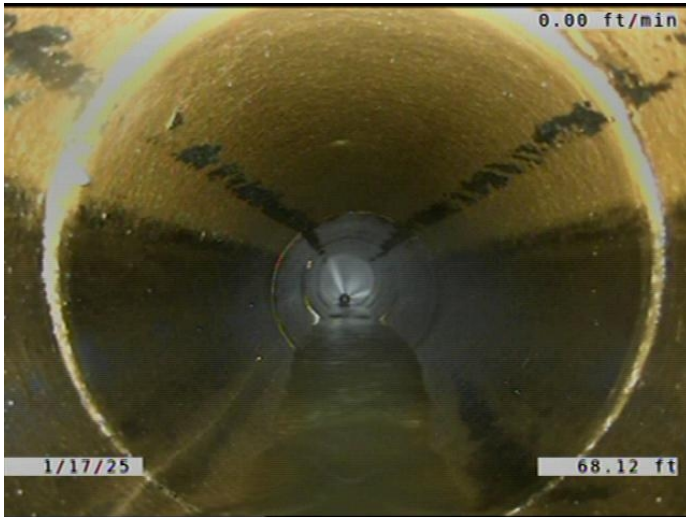
Code: **MWLS**
Description: **Miscellaneous Water Level Sag**

Distance (ft): **68.1**
Structural Grade: **2**
O&M Grade: **0**
Clock Start/From:
Clock To:
1st Value:
2nd Value:
Value Percent: **15.000**
Continuous Index: **F02**
Within 8" of Joint: **NO**
Remarks:

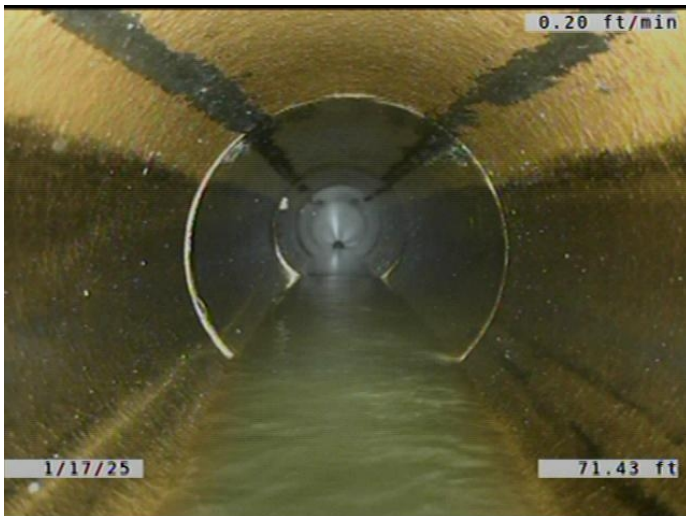
Code: **MWLS**
Description: **Miscellaneous Water Level Sag**

Distance (ft): **71.4**
Structural Grade: **2**
O&M Grade: **0**
Clock Start/From:
Clock To:
1st Value:
2nd Value:
Value Percent: **15.000**
Continuous Index: **S03**
Within 8" of Joint: **NO**
Remarks:

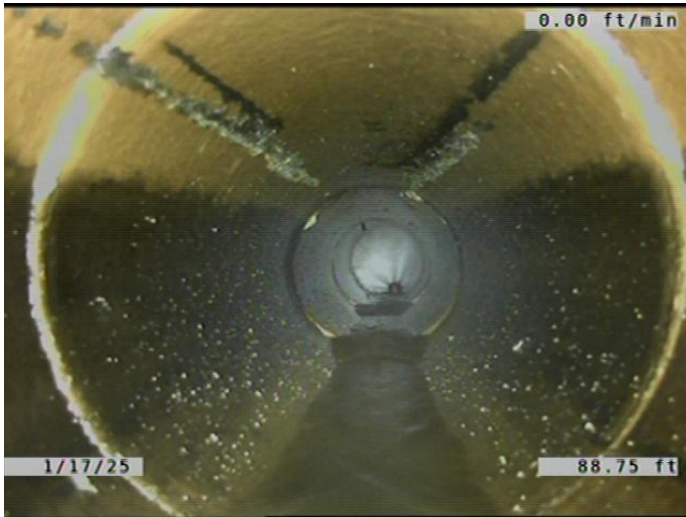
Code: **MWLS**
Description: **Miscellaneous Water Level Sag**

Distance (ft): **88.7**
Structural Grade: **2**
O&M Grade: **0**
Clock Start/From:
Clock To:
1st Value:
2nd Value:
Value Percent: **15.000**
Continuous Index: **F03**
Within 8" of Joint: **NO**
Remarks:

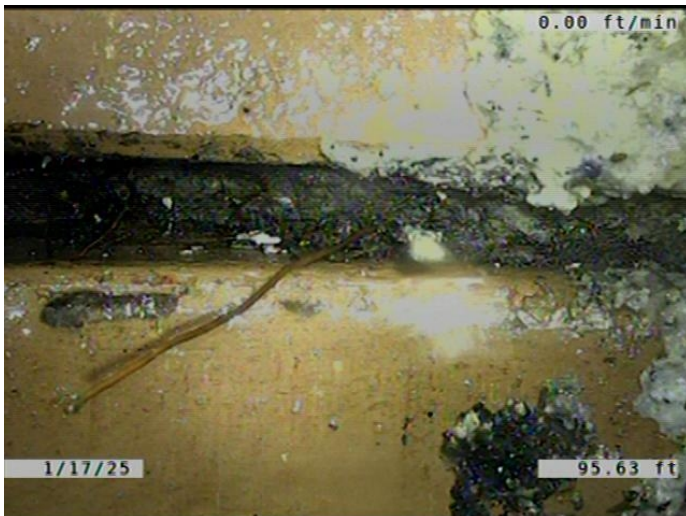
Code: **RFJ**
Description: **Roots Fine Joint**

Distance (ft): **95.6**
Structural Grade: **0**
O&M Grade: **1**
Clock Start/From: **10**
Clock To: **2**
1st Value:
2nd Value:
Value Percent:
Continuous Index:
Within 8" of Joint: **YES**
Remarks:

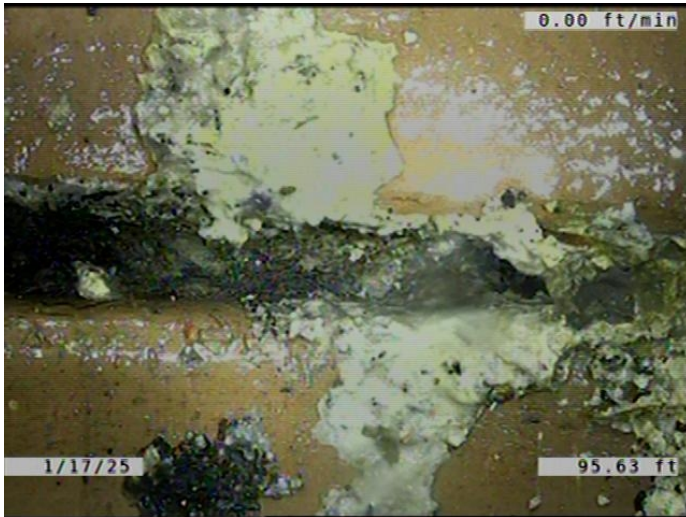
Code: **DAGS**
 Description: **Deposits Attached Grease**

Distance (ft): **95.6**
 Structural Grade: **0**
 O&M Grade: **2**
 Clock Start/From: **10**
 Clock To: **2**
 1st Value:
 2nd Value:
 Value Percent: **5.000**
 Continuous Index:
 Within 8" of Joint: **YES**
 Remarks:

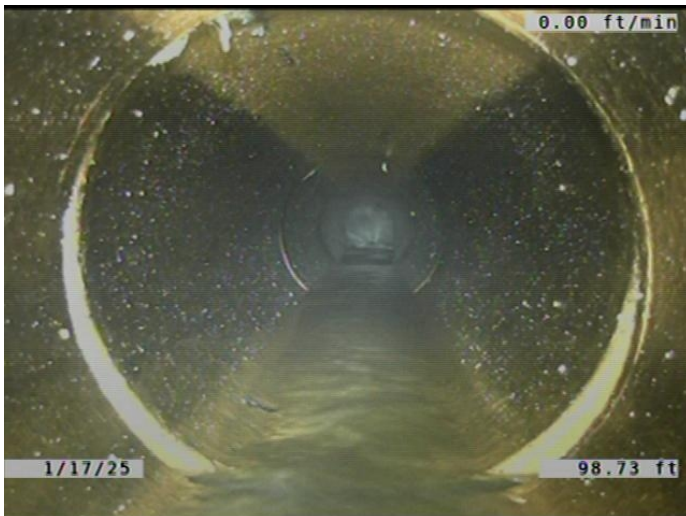
Code: **MWM**
 Description: **Miscellaneous Water Mark**

Distance (ft): **98.7**
 Structural Grade: **0**
 O&M Grade: **0**
 Clock Start/From:
 Clock To:
 1st Value:
 2nd Value:
 Value Percent: **100.000**
 Continuous Index:
 Within 8" of Joint: **NO**
 Remarks:

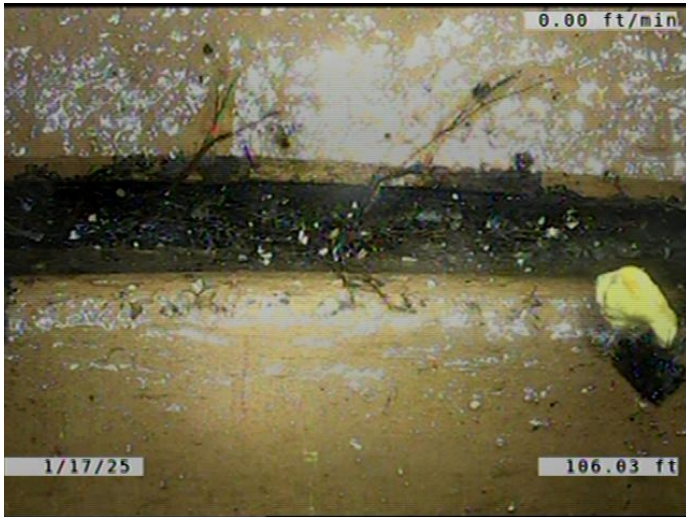
Code: **RFJ**
 Description: **Roots Fine Joint**

Distance (ft): **106.0**
 Structural Grade: **0**
 O&M Grade: **1**
 Clock Start/From: **10**
 Clock To: **2**
 1st Value:
 2nd Value:
 Value Percent:
 Continuous Index:
 Within 8" of Joint: **YES**
 Remarks:

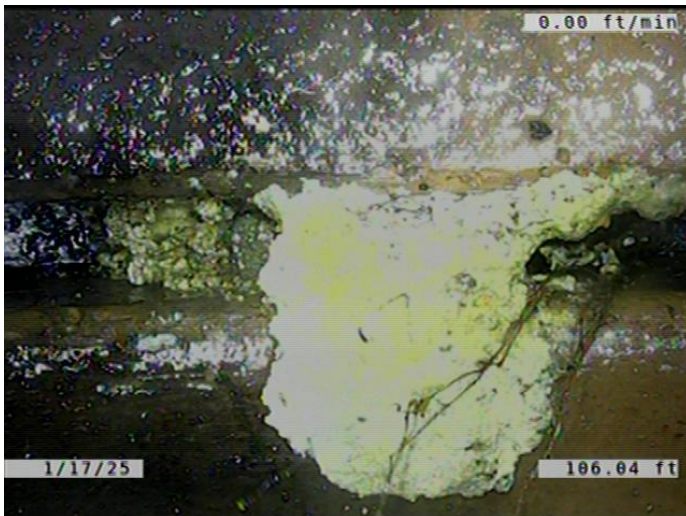
Code: **DAGS**
 Description: **Deposits Attached Grease**

Distance (ft): **106.0**
 Structural Grade: **0**
 O&M Grade: **2**
 Clock Start/From: **10**
 Clock To: **2**
 1st Value:
 2nd Value:
 Value Percent: **5.000**
 Continuous Index:
 Within 8" of Joint: **YES**
 Remarks:

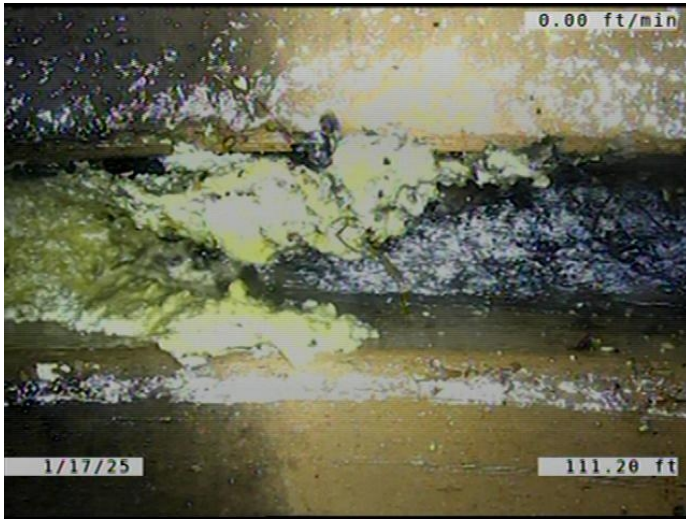
Code: **RFJ**
Description: **Roots Fine Joint**

Distance (ft): **111.2**
Structural Grade: **0**
O&M Grade: **1**
Clock Start/From: **10**
Clock To: **2**
1st Value:
2nd Value:
Value Percent:
Continuous Index:
Within 8" of Joint: **YES**
Remarks:

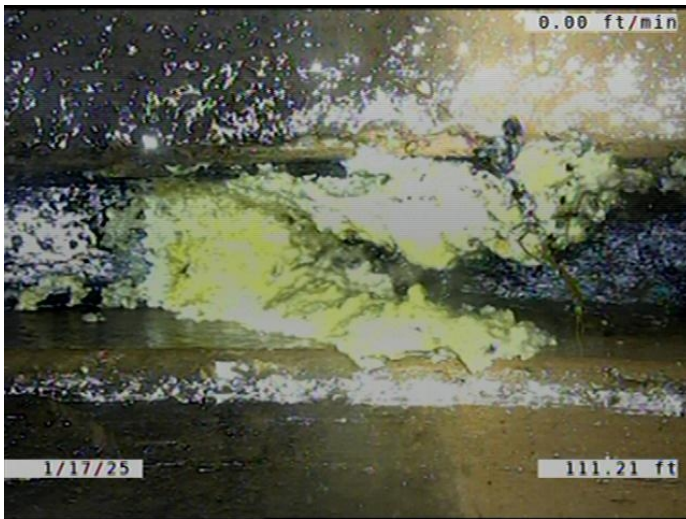
Code: **DAGS**
Description: **Deposits Attached Grease**

Distance (ft): **111.2**
Structural Grade: **0**
O&M Grade: **2**
Clock Start/From: **10**
Clock To: **2**
1st Value:
2nd Value:
Value Percent: **5.000**
Continuous Index:
Within 8" of Joint: **YES**
Remarks:

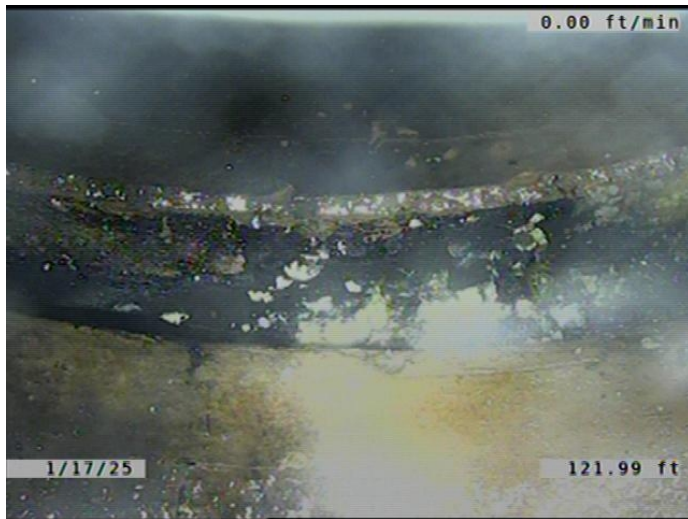
Code: **JOMD**
Description: **Joint Offset Medium Defective**

Distance (ft): **122.0**
Structural Grade: **3**
O&M Grade: **0**
Clock Start/From:
Clock To:
1st Value:
2nd Value:
Value Percent:
Continuous Index:
Within 8" of Joint: **NO**
Remarks:

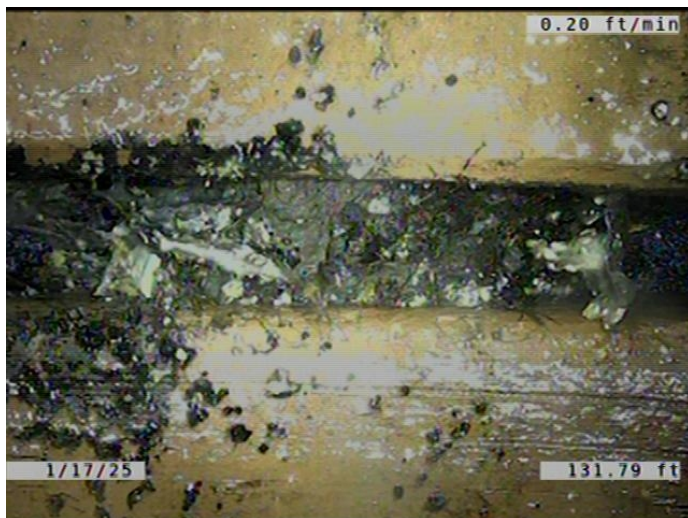
Code: **RFJ**
Description: **Roots Fine Joint**

Distance (ft): **131.8**
Structural Grade: **0**
O&M Grade: **1**
Clock Start/From: **12**
Clock To: **2**
1st Value:
2nd Value:
Value Percent:
Continuous Index:
Within 8" of Joint: **YES**
Remarks:

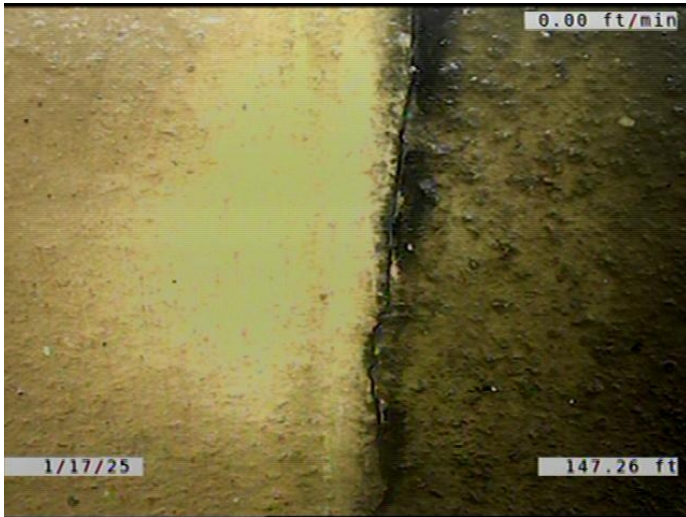
Code: **FM**
Description: **Fracture Multiple**

Distance (ft): **147.3**
Structural Grade: **4**
O&M Grade: **0**
Clock Start/From: **2**
Clock To: **6**
1st Value:
2nd Value:
Value Percent:
Continuous Index:
Within 8" of Joint: **YES**
Remarks:

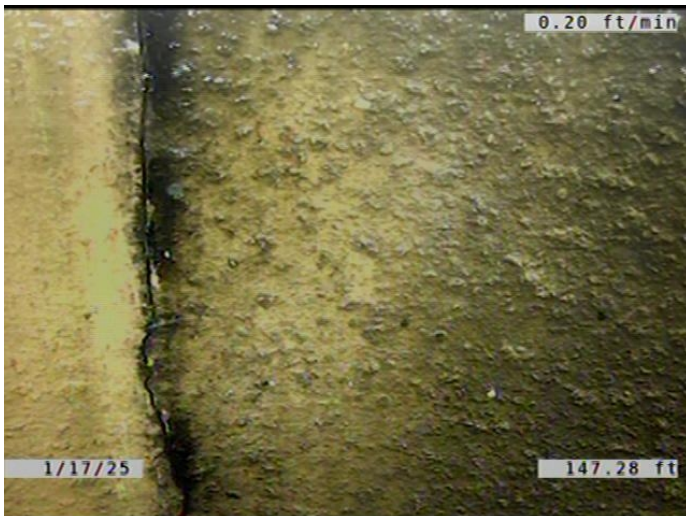
Code: **ISB**
Description: **Infiltration Stain Barrel**

Distance (ft): **147.3**
Structural Grade: **0**
O&M Grade: **1**
Clock Start/From: **2**
Clock To: **5**
1st Value:
2nd Value:
Value Percent:
Continuous Index:
Within 8" of Joint: **YES**
Remarks:

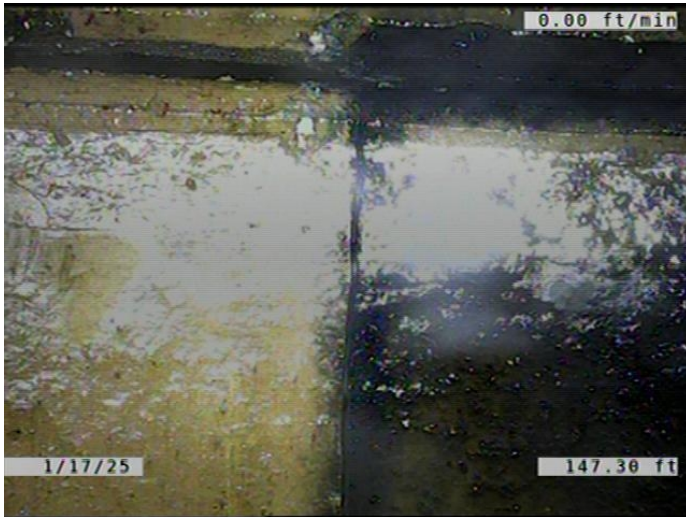
Code: **IWB**
Description: **Infiltration Weeper Barrel**

Distance (ft): **147.3**
Structural Grade: **0**
O&M Grade: **2**
Clock Start/From: **2**
Clock To:
1st Value:
2nd Value:
Value Percent:
Continuous Index:
Within 8" of Joint: **YES**
Remarks:

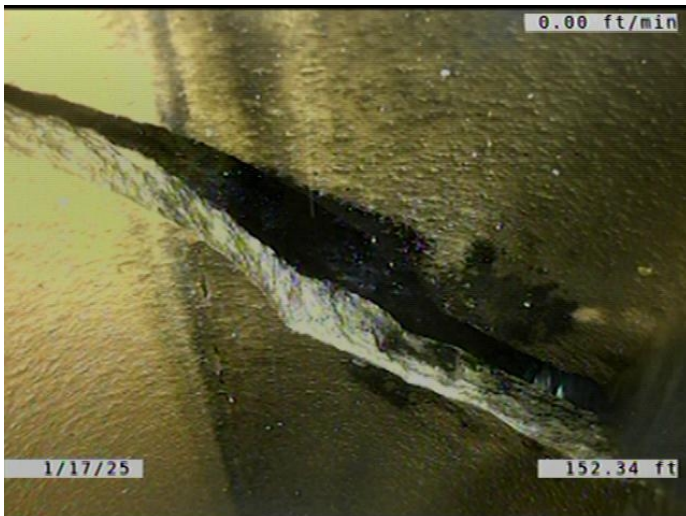
Code: **BVV**
Description: **Broken Void Visible**

Distance (ft): **152.3**
Structural Grade: **5**
O&M Grade: **0**
Clock Start/From: **1**
Clock To: **6**
1st Value:
2nd Value:
Value Percent:
Continuous Index:
Within 8" of Joint: **YES**
Remarks:

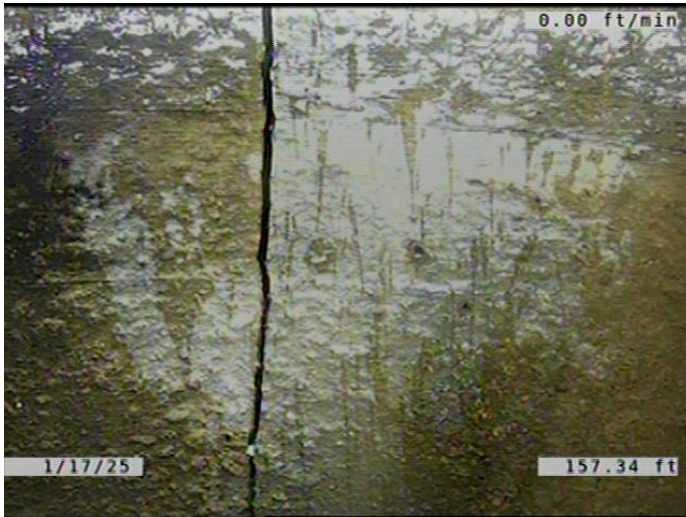
Code: **FM**
Description: **Fracture Multiple**

Distance (ft): **157.3**
Structural Grade: **4**
O&M Grade: **0**
Clock Start/From: **11**
Clock To: **4**
1st Value:
2nd Value:
Value Percent:
Continuous Index:
Within 8" of Joint: **YES**
Remarks:

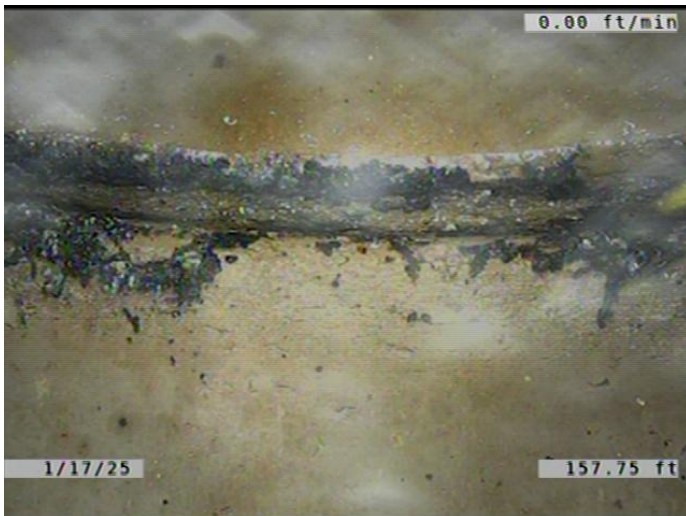
Code: **JOMD**
Description: **Joint Offset Medium Defective**

Distance (ft): **157.7**
Structural Grade: **3**
O&M Grade: **0**
Clock Start/From:
Clock To:
1st Value:
2nd Value:
Value Percent:
Continuous Index:
Within 8" of Joint: **NO**
Remarks:

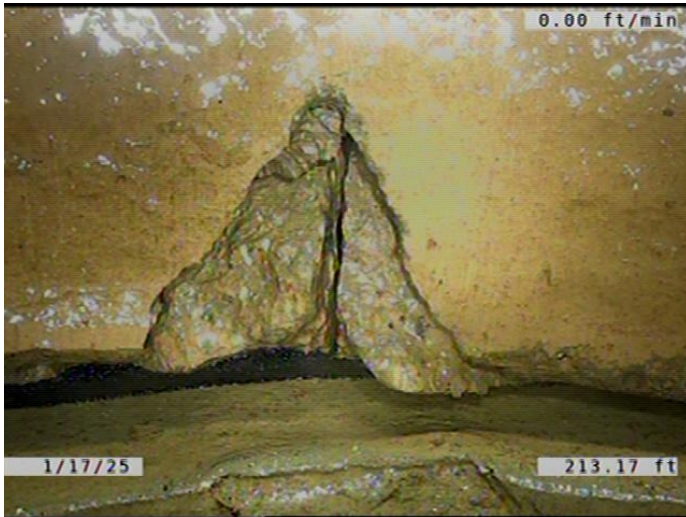
Code: **B**
 Description: **Broken**

Distance (ft): **213.2**
 Structural Grade: **4**
 O&M Grade: **0**
 Clock Start/From: **12**
 Clock To:
 1st Value:
 2nd Value:
 Value Percent:
 Continuous Index:
 Within 8" of Joint: **YES**
 Remarks:
