Profile/Photo Observation Report

| Street: | Wisconsin Street | Flow Control: | Not Controlled |
| Comment: | YES501824 Submittal 2 | | |
| US MH: | M-208-023 | DS MH: | M-208-022 |

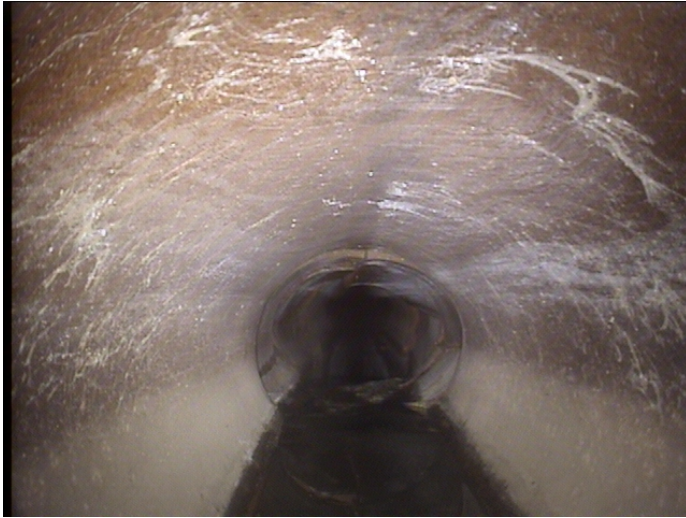
Code: **MWL**
Description: **Water Level**

Distance (ft): **.0**
Structural Grade: **0**
O&M Grade: **0**
Clock Start/From:
Clock To:
1st Value:
2nd Value:
Value Percent: **5.000**
Continuous Index:
Within 8" of Joint: **NO**
Remarks:

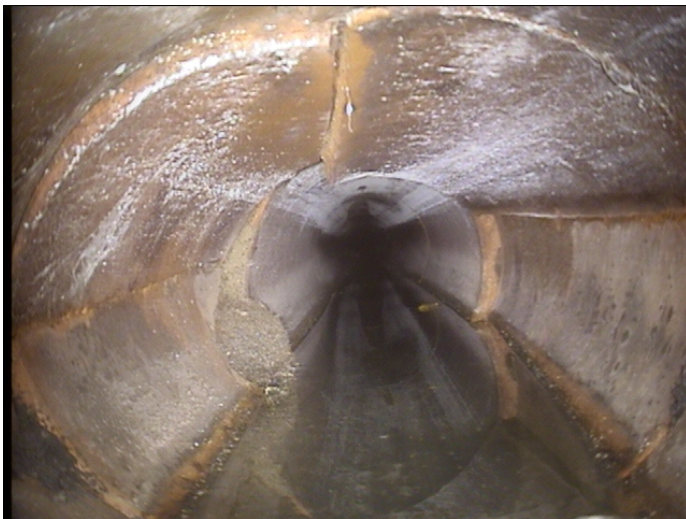
| Position | Code | Observation | Video (sec) | Grade |
|---|---|---|---|---|
| 4.2 | FH3 | Fracture Longitudinal Hinge, 3 | 133 | S 5 |

Code: **FH3**
Description: **Fracture Longitudinal Hinge, 3**

Distance (ft): **4.2**
Structural Grade: **5**
O&M Grade: **0**
Clock Start/From: **9**
Clock To: **3**
1st Value:
2nd Value:
Value Percent:
Continuous Index:
Within 8" of Joint: **NO**
Remarks:

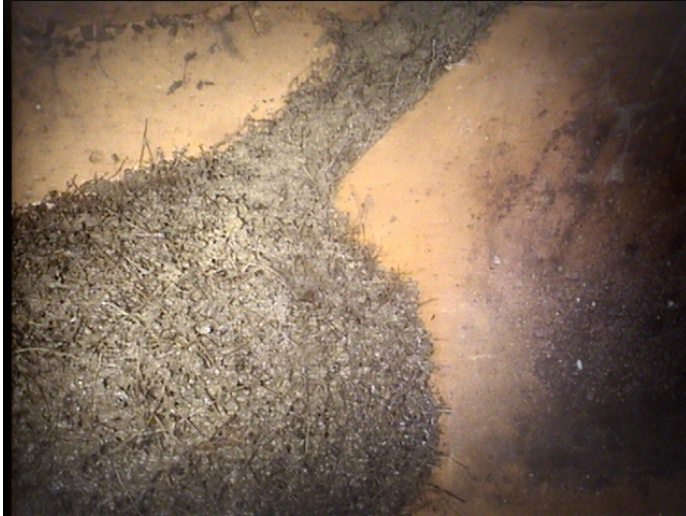
| Position | Code | Observation | Video (sec) | Grade |
|---|---|---|---|---|
| 7.8 | RFJ | Roots Fine Joint | 220 | M 1 |

Code: **RFJ**
Description: **Roots Fine Joint**

Distance (ft): **7.8**
Structural Grade: **0**
O&M Grade: **1**
Clock Start/From: **7**
Clock To: **10**
1st Value:
2nd Value:
Value Percent:
Continuous Index:
Within 8" of Joint: **YES**
Remarks:

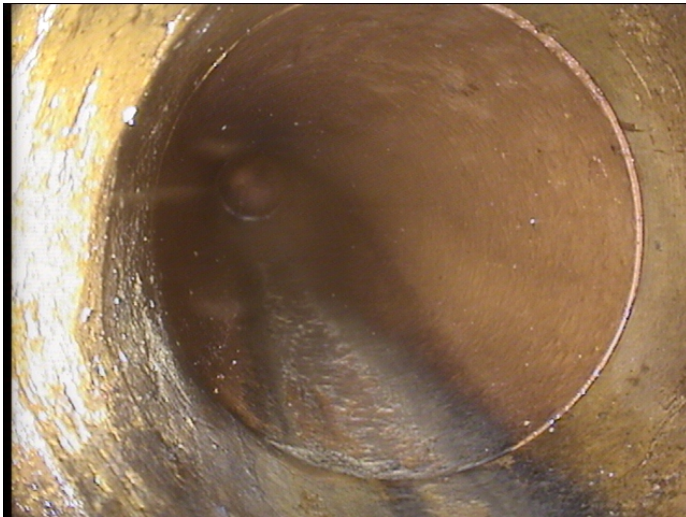
Code: **TF**
Description: **Tap Factory**

Distance (ft): **41.1**
Structural Grade: **0**
O&M Grade: **0**
Clock Start/From: **10**
Clock To:
1st Value: **4.000**
2nd Value:
Value Percent:
Continuous Index:
Within 8" of Joint: **NO**
Remarks:

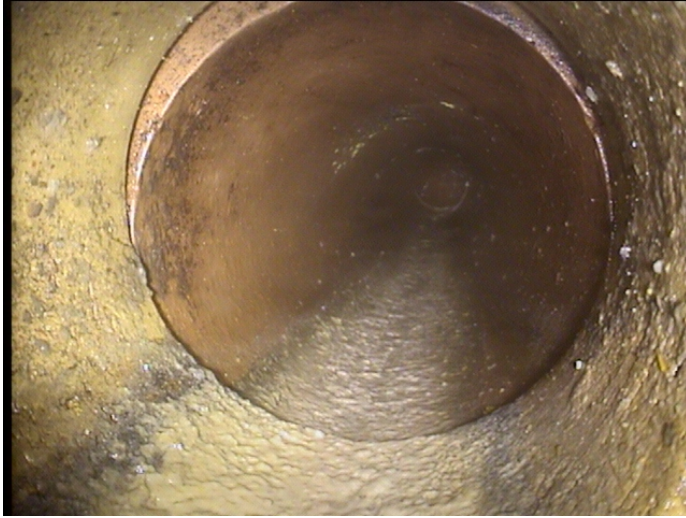
Code: **TF**
Description: **Tap Factory**

Distance (ft): **44.3**
Structural Grade: **0**
O&M Grade: **0**
Clock Start/From: **2**
Clock To:
1st Value: **4.000**
2nd Value:
Value Percent:
Continuous Index:
Within 8" of Joint: **NO**
Remarks:

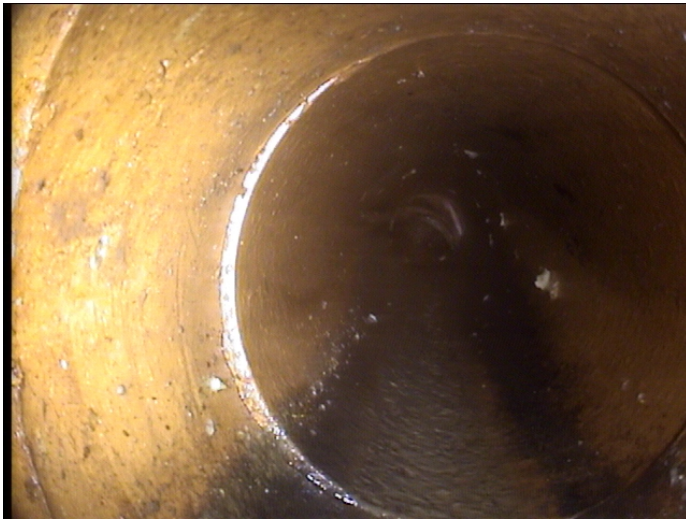
Code: **TF**
Description: **Tap Factory**

Distance (ft): **95.1**
Structural Grade: **0**
O&M Grade: **0**
Clock Start/From: **2**
Clock To:
1st Value: **4.000**
2nd Value:
Value Percent:
Continuous Index:
Within 8" of Joint: **NO**
Remarks:

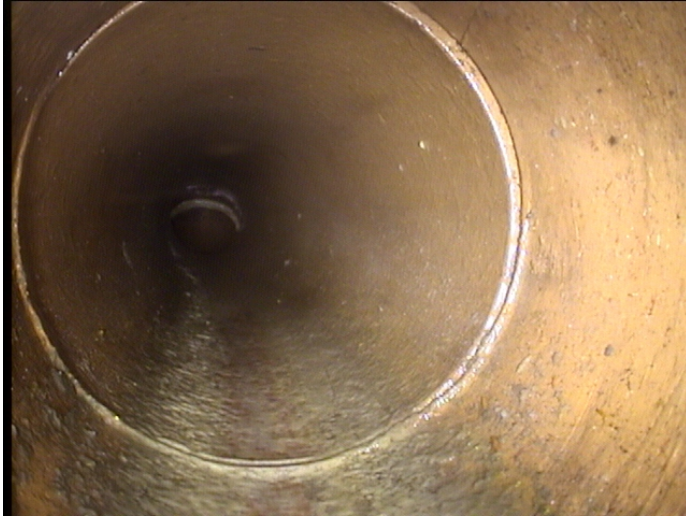
Code: **TF**
Description: **Tap Factory**

Distance (ft): **98.1**
Structural Grade: **0**
O&M Grade: **0**
Clock Start/From: **10**
Clock To:
1st Value: **4.000**
2nd Value:
Value Percent:
Continuous Index:
Within 8" of Joint: **NO**
Remarks:

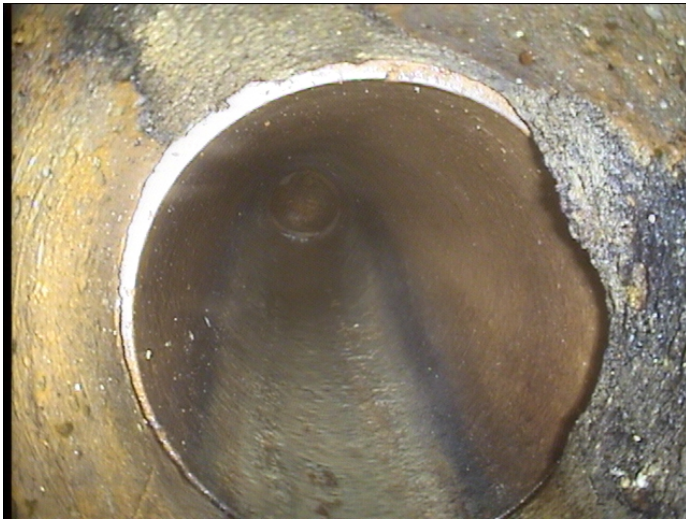
Code: **TF**
Description: **Tap Factory**

Distance (ft): **157.7**
Structural Grade: **0**
O&M Grade: **0**
Clock Start/From: **10**
Clock To:
1st Value: **4.000**
2nd Value:
Value Percent:
Continuous Index:
Within 8" of Joint: **NO**
Remarks:

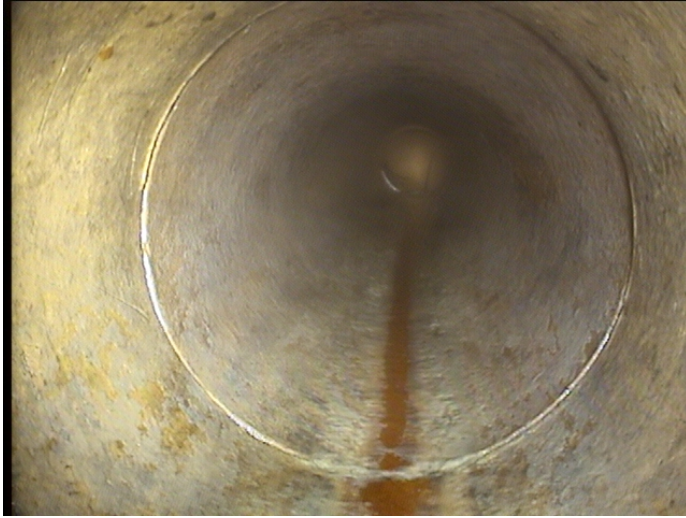
Code: **TF**
Description: **Tap Factory**

Distance (ft): **160.9**
Structural Grade: **0**
O&M Grade: **0**
Clock Start/From: **2**
Clock To:
1st Value: **4.000**
2nd Value:
Value Percent:
Continuous Index:
Within 8" of Joint: **NO**
Remarks:

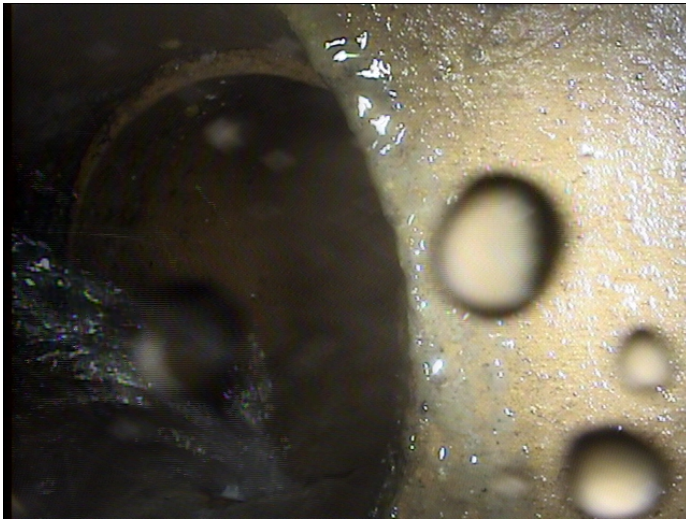
Code: **TFA**
Description: **Tap Factory Active**

Distance (ft): **220.8**
Structural Grade: **0**
O&M Grade: **0**
Clock Start/From: **10**
Clock To:
1st Value: **4.000**
2nd Value:
Value Percent:
Continuous Index:
Within 8" of Joint: **NO**
Remarks:

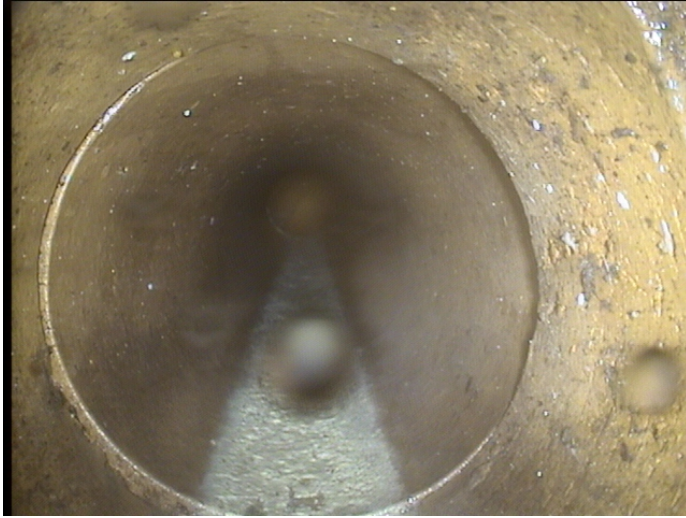
Code: **TF**
Description: **Tap Factory**

Distance (ft): **223.5**
Structural Grade: **0**
O&M Grade: **0**
Clock Start/From: **2**
Clock To:
1st Value: **4.000**
2nd Value:
Value Percent:
Continuous Index:
Within 8" of Joint: **NO**
Remarks:

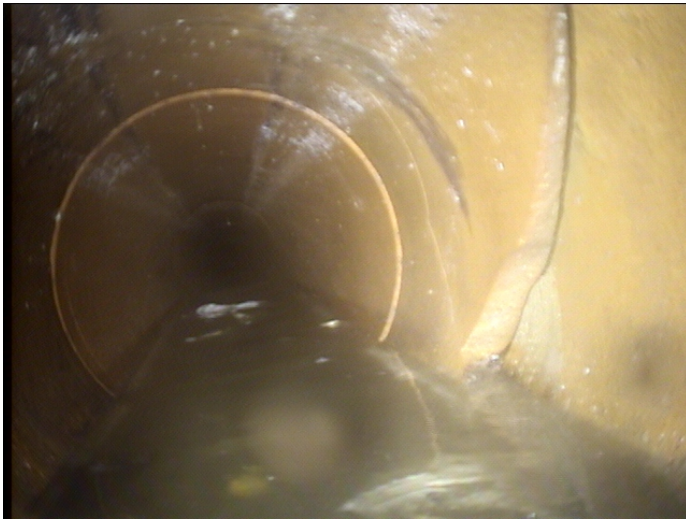
| Position | Code | Observation | Video (sec) | Grade |
|---|---|---|---|---|
| 229.6 | FS | Fracture Spiral | 1006 | S 3 |

Code: **FS**
Description: **Fracture Spiral**

Distance (ft): **229.6**
Structural Grade: **3**
O&M Grade: **0**
Clock Start/From: **7**
Clock To: **5**
1st Value:
2nd Value:
Value Percent:
Continuous Index:
Within 8" of Joint: **NO**
Remarks:

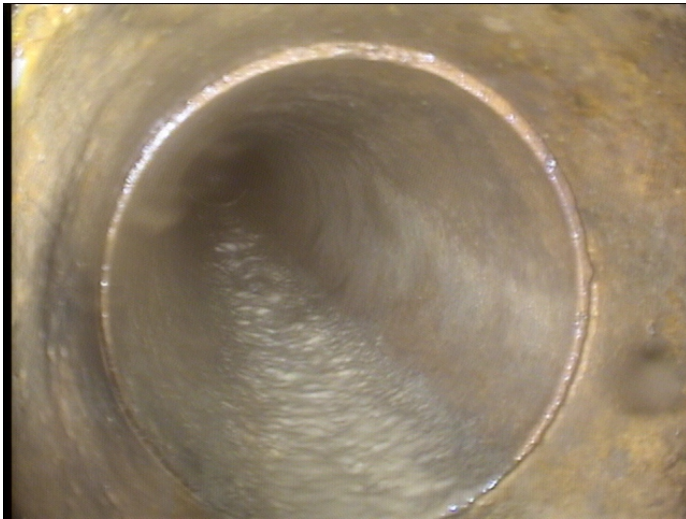
Code: **TF**
Description: **Tap Factory**

Distance (ft): **269.2**
Structural Grade: **0**
O&M Grade: **0**
Clock Start/From: **10**
Clock To:
1st Value: **4.000**
2nd Value:
Value Percent:
Continuous Index:
Within 8" of Joint: **NO**
Remarks:

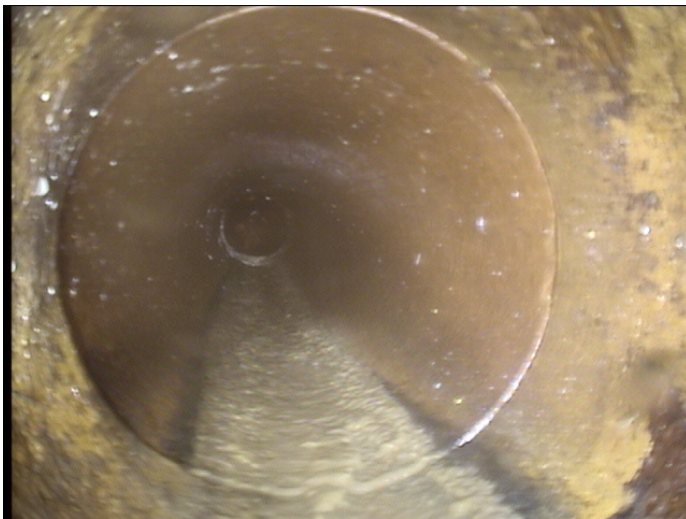
Code: **TF**
Description: **Tap Factory**

Distance (ft): **272.5**
Structural Grade: **0**
O&M Grade: **0**
Clock Start/From: **2**
Clock To:
1st Value: **4.000**
2nd Value:
Value Percent:
Continuous Index:
Within 8" of Joint: **NO**
Remarks:
