Profile/Photo Observation Report

Date:	01/17/2025	Weather:		Coding:	PACP 7.0
Pipe Length (ft):		Owner:	City of Hobart	Pre Clean:	Heavy Cleaning
P.O.#:	YES502259	Surveyor:	S. Bucklin	PSR:	M-208-021-M-208-021.1
Customer:	City of Hobart	Clean Date:	07/18/2024	Shape:	C

Street:	South Liverpool Road	Flow Control:	Not Controlled
City:	Hobart, IN	Year Renewed:	
Location:	Local rural streets with light traffic, t	Tape/Media #:	
Purpose:	Sewer System Evaluation Survey (SS	Dia/Height:	15"
Use:	Sanitary Sewage Pipe	Material:	VCP
Drain Area:		Lining:	None
Category:	NA		
Comment:			
Location Details:		Direction of Survey:	Downstream
US MH:	M-208-021	DS MH:	M-208-021.1
		Total Length Surveyed (ft):	76.7

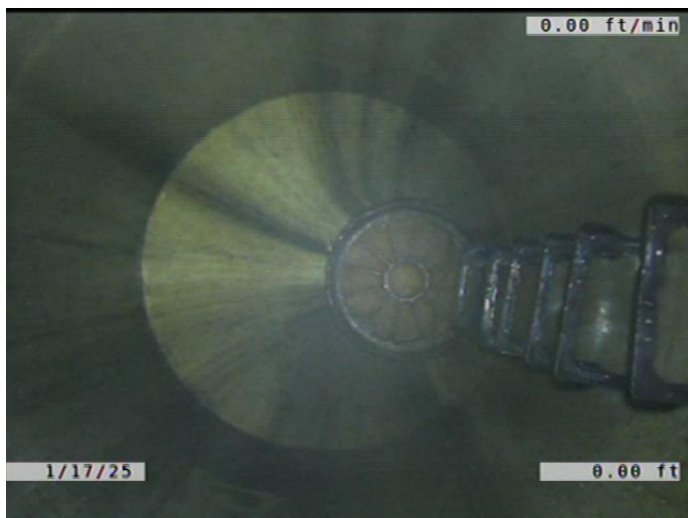
Code: **AMH**
Description: **Manhole**

Distance (ft): **.0**
Structural Grade: **0**
O&M Grade: **0**
Clock Start/From:
Clock To:
1st Value:
2nd Value:
Value Percent:
Continuous Index:
Within 8" of Joint: **NO**
Remarks: **M-208-021**

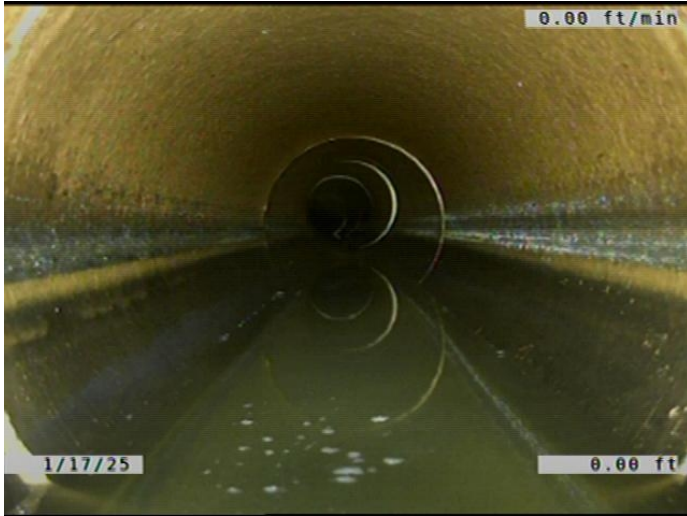
Code:	MWL
Description:	Miscellaneous Water Level
Distance (ft):	.0
Structural Grade:	0
O&M Grade:	0
Clock Start/From:	
Clock To:	
1st Value:	
2nd Value:	
Value Percent:	15.000
Continuous Index:	
Within 8" of Joint:	NO
Remarks:

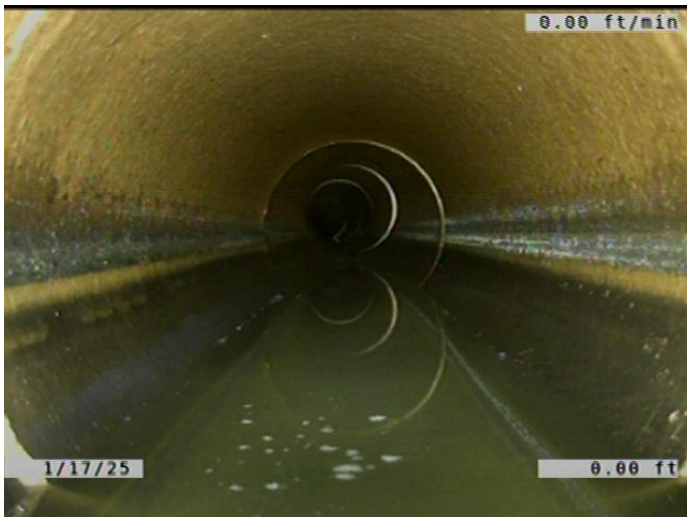
Code:	MWM
Description:	Miscellaneous Water Mark
Distance (ft):	.0
Structural Grade:	0
O&M Grade:	0
Clock Start/From:	
Clock To:	
1st Value:	
2nd Value:	
Value Percent:	55.000
Continuous Index:	
Within 8" of Joint:	NO
Remarks:

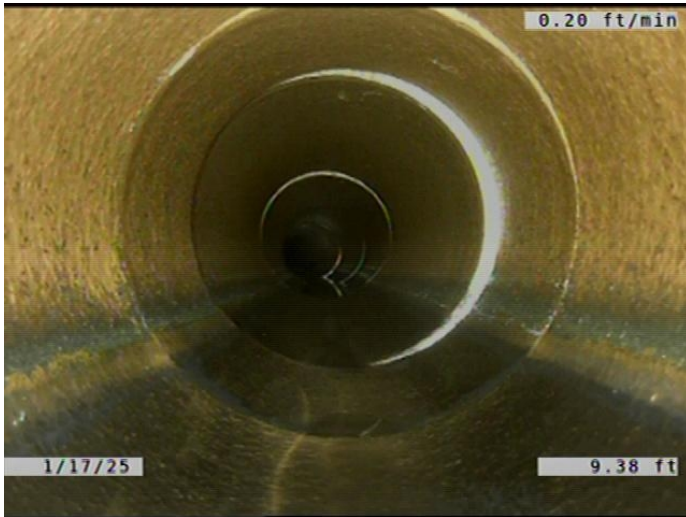
Code: **MWL**
Description: **Miscellaneous Water Level**

Distance (ft): **9.4**
Structural Grade: **0**
O&M Grade: **0**
Clock Start/From:
Clock To:
1st Value:
2nd Value:
Value Percent: **5.000**
Continuous Index:
Within 8" of Joint: **NO**
Remarks:

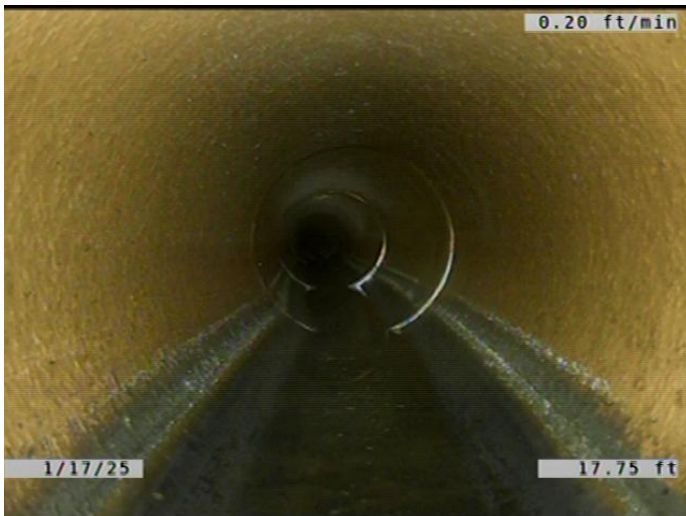
Code: **MWLS**
Description: **Miscellaneous Water Level Sag**

Distance (ft): **17.7**
Structural Grade: **2**
O&M Grade: **0**
Clock Start/From:
Clock To:
1st Value:
2nd Value:
Value Percent: **10.000**
Continuous Index: **S01**
Within 8" of Joint: **NO**
Remarks:

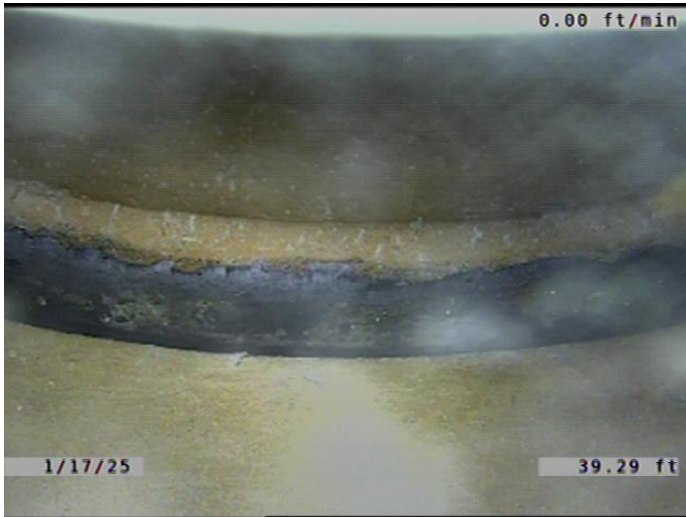
Code: **JOMD**
Description: **Joint Offset Medium Defective**

Distance (ft): **39.3**
Structural Grade: **3**
O&M Grade: **0**
Clock Start/From:
Clock To:
1st Value:
2nd Value:
Value Percent:
Continuous Index:
Within 8" of Joint: **NO**
Remarks:

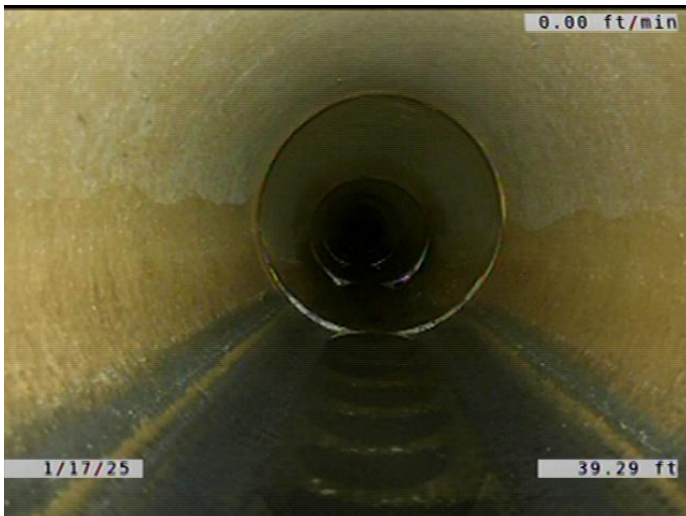
Code: **MWLS**
Description: **Miscellaneous Water Level Sag**

Distance (ft): **39.3**
Structural Grade: **2**
O&M Grade: **0**
Clock Start/From:
Clock To:
1st Value:
2nd Value:
Value Percent: **10.000**
Continuous Index: **F01**
Within 8" of Joint: **NO**
Remarks:

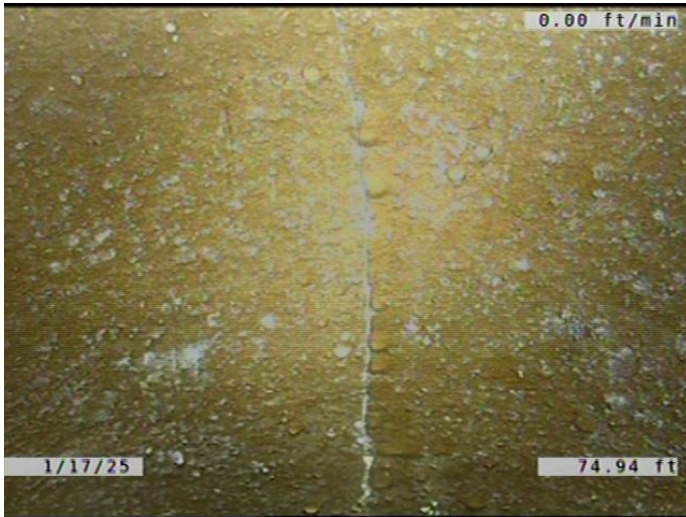
Code: **CL**
 Description: **Crack Longitudinal**

Distance (ft): **74.9**
 Structural Grade: **2**
 O&M Grade: **0**
 Clock Start/From: **12**
 Clock To:
 1st Value:
 2nd Value:
 Value Percent:
 Continuous Index:
 Within 8" of Joint: **YES**
 Remarks:

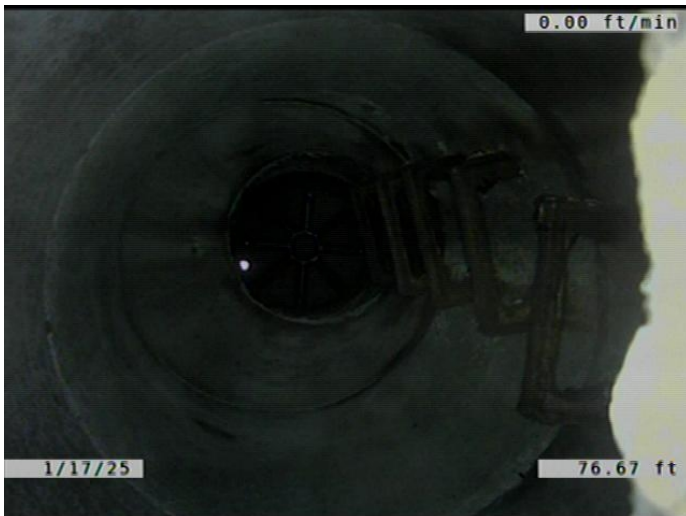
Code: **AMH**
 Description: **Manhole**

Distance (ft): **76.7**
 Structural Grade: **0**
 O&M Grade: **0**
 Clock Start/From:
 Clock To:
 1st Value:
 2nd Value:
 Value Percent:
 Continuous Index:
 Within 8" of Joint: **NO**
 Remarks: **M-208-021.1**
