Profile/Photo Observation Report

| Pipe Length (ft): | 354.0 | Owner: | City of Hobart | Pre Clean: | Heavy Cleaning |

| Street: | South Liverpool Road | Flow Control: | Not Controlled |
| US MH: | M-208-021.1 | DS MH: | M-208-022 |

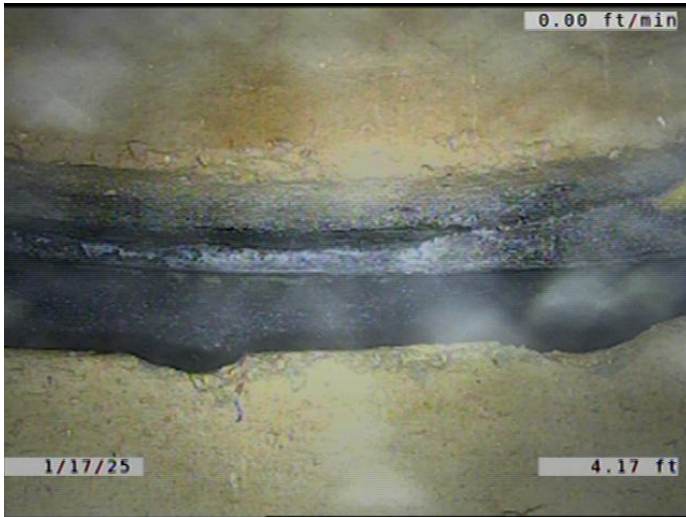
| | Position | Code | Observation | Video (sec) | Grade |
|---|---|---|---|---|---|
| | 4.2 | JOMD(S01) | Joint Offset Medium Defective | 115 | S 3 |

Code: **JOMD**
Description: **Joint Offset Medium Defective**

Distance (ft): **4.2**
Structural Grade: **3**
O&M Grade: **0**
Clock Start/From:
Clock To:
1st Value:
2nd Value:
Value Percent:
Continuous Index: **S01**
Within 8" of Joint: **NO**
Remarks:

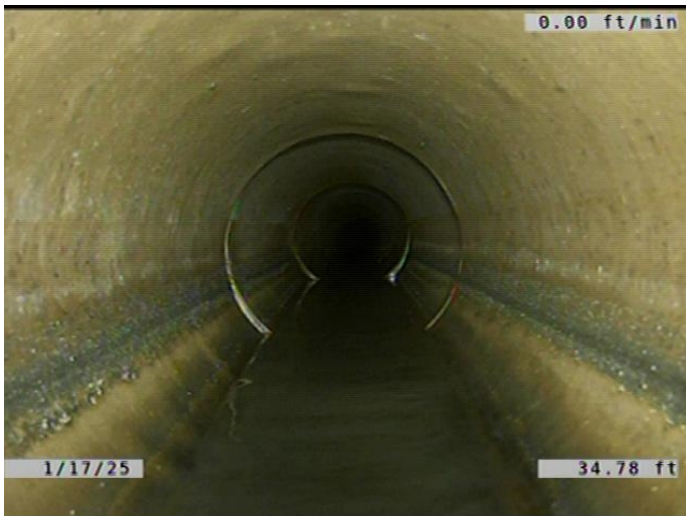
| | Position | Code | Observation | Video (sec) | Grade |
|---|---|---|---|---|---|
| | 34.8 | MWLS(S02) | Miscellaneous Water Level Sag | 248 | S 2 |

Code: **MWLS**
Description: **Miscellaneous Water Level Sag**

Distance (ft): **34.8**
Structural Grade: **2**
O&M Grade: **0**
Clock Start/From:
Clock To:
1st Value:
2nd Value:
Value Percent: **15.000**
Continuous Index: **S02**
Within 8" of Joint: **NO**
Remarks:

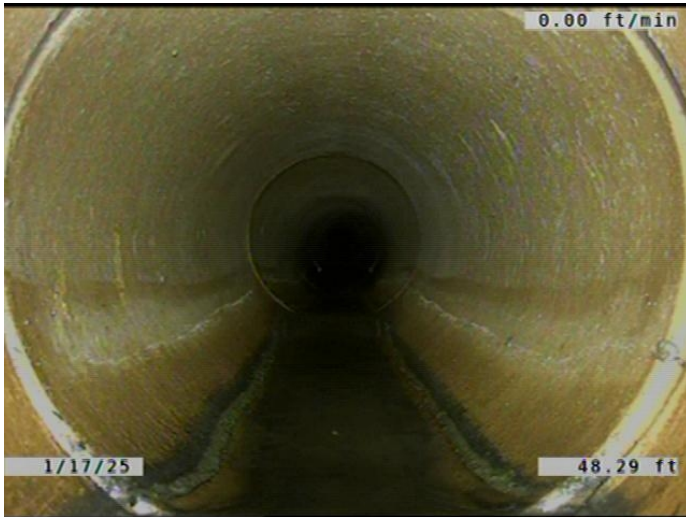
| | Position | Code | Observation | Video (sec) | Grade |
|---|---|---|---|---|---|
| | 48.3 | MWLS(F02) | Miscellaneous Water Level Sag | 311 | S 2 |

Code: **MWLS**
Description: **Miscellaneous Water Level Sag**

Distance (ft): **48.3**
Structural Grade: **2**
O&M Grade: **0**
Clock Start/From:
Clock To:
1st Value:
2nd Value:
Value Percent: **15.000**
Continuous Index: **F02**
Within 8" of Joint: **NO**
Remarks:

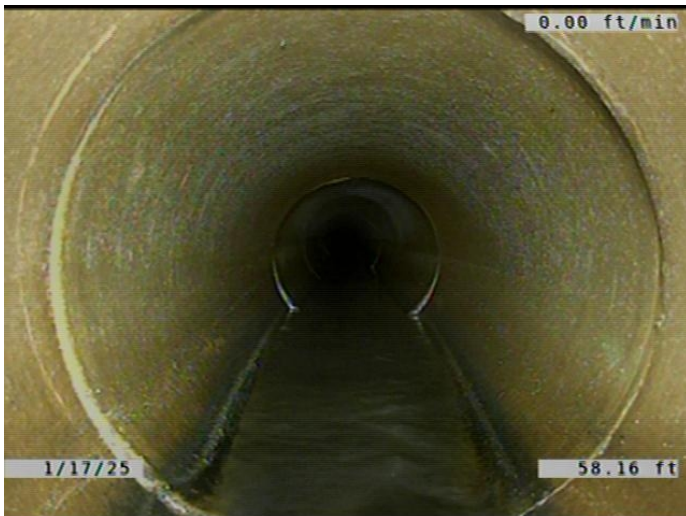
| | Position | Code | Observation | Video (sec) | Grade |
|---|---|---|---|---|---|
| | 58.2 | MWLS(S03) | Miscellaneous Water Level Sag | 354 | S 2 |

Code: **MWLS**
Description: **Miscellaneous Water Level Sag**

Distance (ft): **58.2**
Structural Grade: **2**
O&M Grade: **0**
Clock Start/From:
Clock To:
1st Value:
2nd Value:
Value Percent: **15.000**
Continuous Index: **S03**
Within 8" of Joint: **NO**
Remarks:

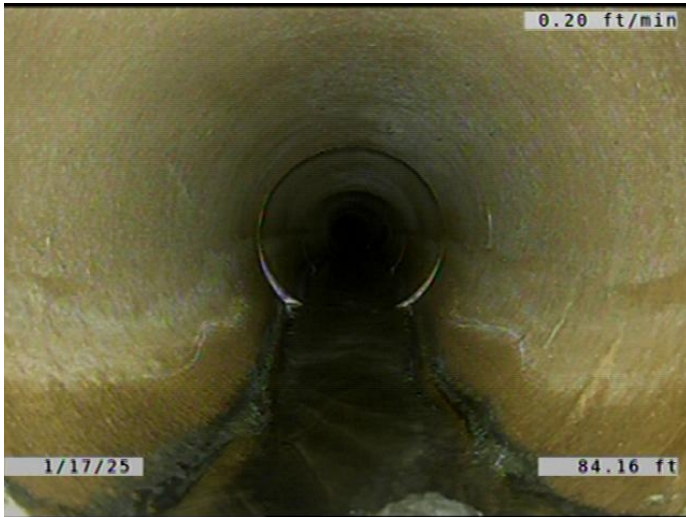
| | Position | Code | Observation | Video (sec) | Grade |
|---|---|---|---|---|---|
| | 84.1 | MWLS(F03) | Miscellaneous Water Level Sag | 464 | S 2 |

Code: **MWLS**
Description: **Miscellaneous Water Level Sag**

Distance (ft): **84.1**
Structural Grade: **2**
O&M Grade: **0**
Clock Start/From:
Clock To:
1st Value:
2nd Value:
Value Percent: **15.000**
Continuous Index: **F03**
Within 8" of Joint: **NO**
Remarks:

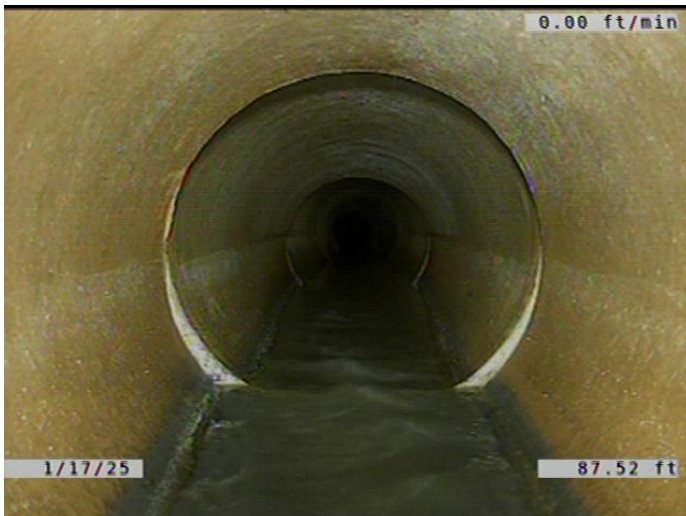
| | Position | Code | Observation | Video (sec) | Grade |
|---|---|---|---|---|---|
| | 87.5 | MWLS(S04) | Miscellaneous Water Level Sag | 489 | S 2 |

Code: **MWLS**
Description: **Miscellaneous Water Level Sag**

Distance (ft): **87.5**
Structural Grade: **2**
O&M Grade: **0**
Clock Start/From:
Clock To:
1st Value:
2nd Value:
Value Percent: **15.000**
Continuous Index: **S04**
Within 8" of Joint: **NO**
Remarks:

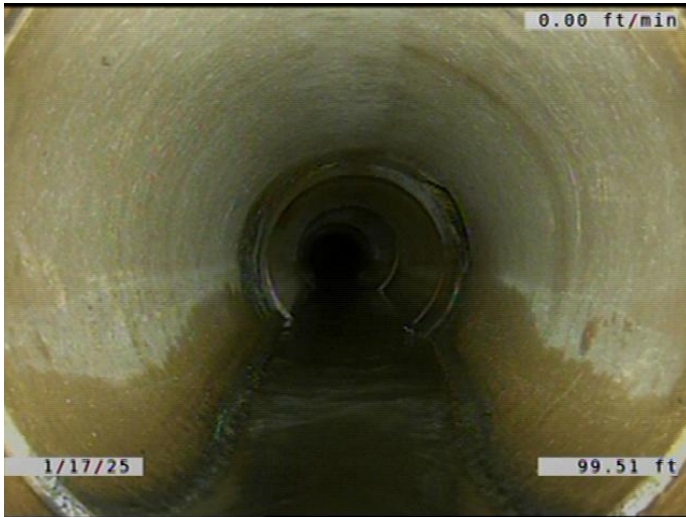
| | Position | Code | Observation | Video (sec) | Grade |
|---|---|---|---|---|---|
| | 99.5 | MWLS(F04) | Miscellaneous Water Level Sag | 548 | S 2 |

Code: **MWLS**
Description: **Miscellaneous Water Level Sag**

Distance (ft): **99.5**
Structural Grade: **2**
O&M Grade: **0**
Clock Start/From:
Clock To:
1st Value:
2nd Value:
Value Percent: **15.000**
Continuous Index: **F04**
Within 8" of Joint: **NO**
Remarks:

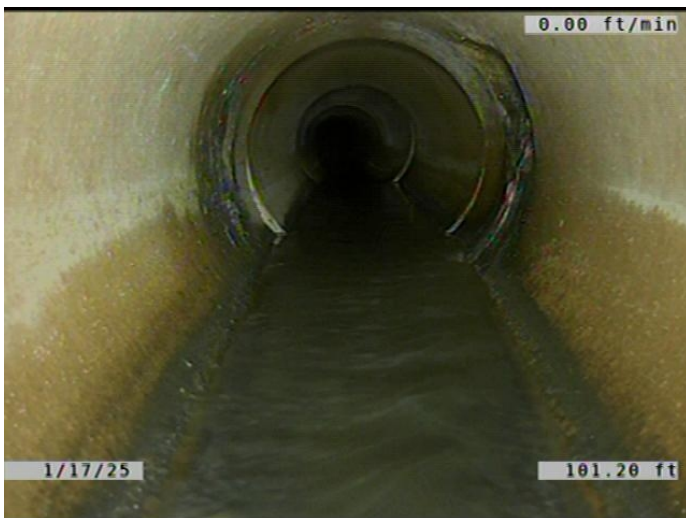
| | Position | Code | Observation | Video (sec) | Grade |
|---|---|---|---|---|---|
| | 101.2 | MWLS(S05) | Miscellaneous Water Level Sag | 568 | S 2 |

Code: **MWLS**
Description: **Miscellaneous Water Level Sag**

Distance (ft): **101.2**
Structural Grade: **2**
O&M Grade: **0**
Clock Start/From:
Clock To:
1st Value:
2nd Value:
Value Percent: **10.000**
Continuous Index: **S05**
Within 8" of Joint: **NO**
Remarks:

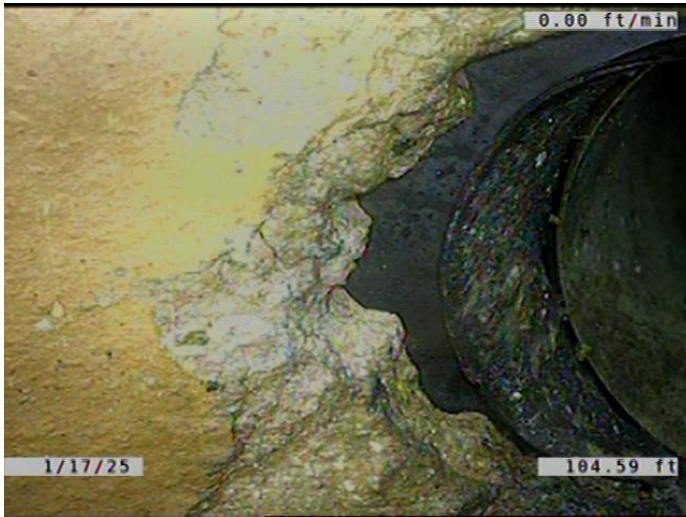
| | Position | Code | Observation | Video (sec) | Grade |
|---|---|---|---|---|---|
| | 104.6 | SSS | Surface Damage Surface Spalling | 609 | S 2 |

Code: **SSS**
 Description: **Surface Damage Surface Spalling**

Distance (ft): **104.6**
 Structural Grade: **2**
 O&M Grade: **0**
 Clock Start/From: **1**
 Clock To: **3**
 1st Value:
 2nd Value:
 Value Percent:
 Continuous Index:
 Within 8" of Joint: **NO**
 Remarks:

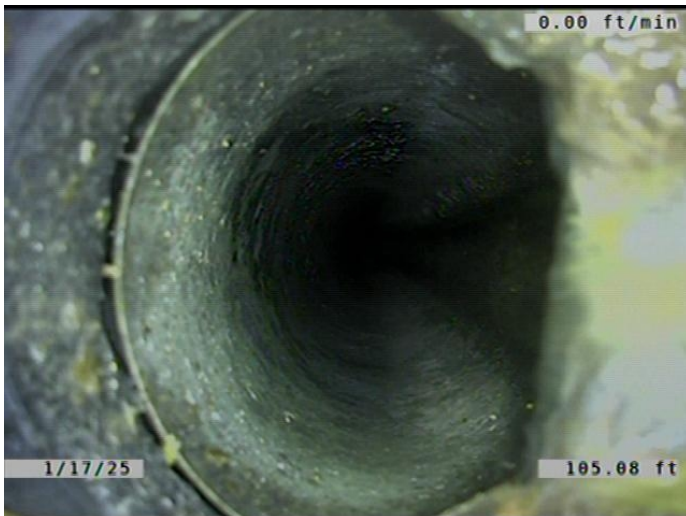
Code: **TSA**
 Description: **Tap Saddle Activity**

Distance (ft): **105.1**
 Structural Grade: **0**
 O&M Grade: **0**
 Clock Start/From: **2**
 Clock To:
 1st Value: **6.000**
 2nd Value:
 Value Percent:
 Continuous Index:
 Within 8" of Joint: **YES**
 Remarks:

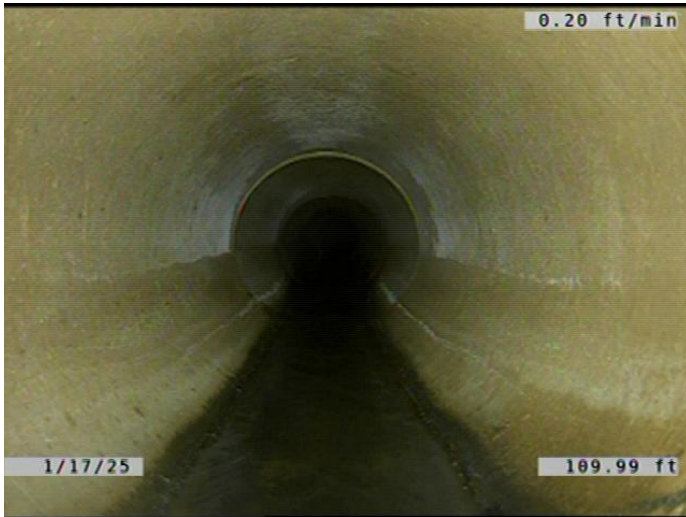
| | Position | Code | Observation | Video (sec) | Grade |
|---|---|---|---|---|---|
| | 110.0 | MWLS(F05) | Miscellaneous Water Level Sag | 662 | S 2 |

Code: **MWLS**
Description: **Miscellaneous Water Level Sag**

Distance (ft): **110.0**
Structural Grade: **2**
O&M Grade: **0**
Clock Start/From:
Clock To:
1st Value:
2nd Value:
Value Percent: **10.000**
Continuous Index: **F05**
Within 8" of Joint: **NO**
Remarks:

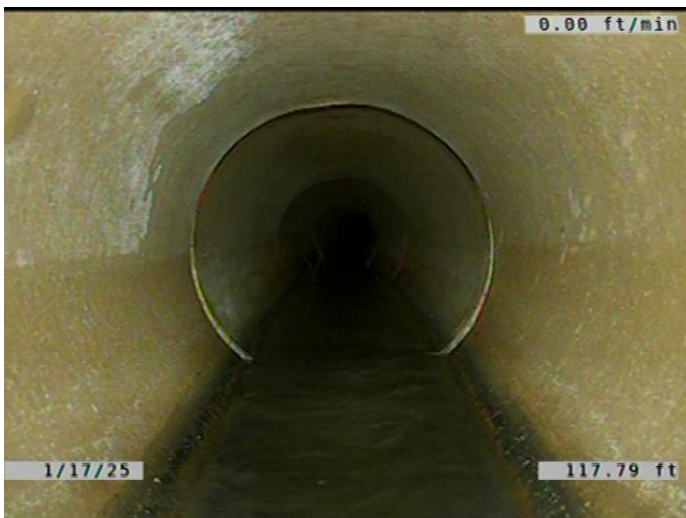
| | Position | Code | Observation | Video (sec) | Grade |
|---|---|---|---|---|---|
| | 117.8 | MWLS(S06) | Miscellaneous Water Level Sag | 696 | S 2 |

Code: **MWLS**
Description: **Miscellaneous Water Level Sag**

Distance (ft): **117.8**
Structural Grade: **2**
O&M Grade: **0**
Clock Start/From:
Clock To:
1st Value:
2nd Value:
Value Percent: **15.000**
Continuous Index: **S06**
Within 8" of Joint: **NO**
Remarks:

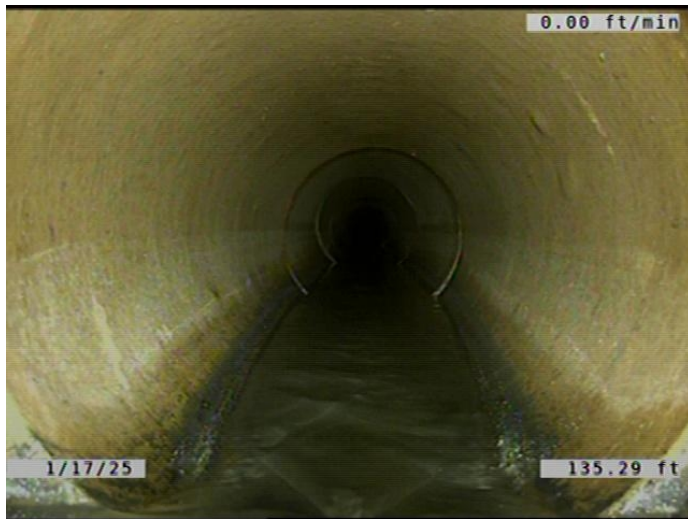
| | Position | Code | Observation | Video (sec) | Grade |
|---|---|---|---|---|---|
| | 135.3 | MWLS(F06) | Miscellaneous Water Level Sag | 766 | S 2 |

Code: **MWLS**
Description: **Miscellaneous Water Level Sag**

Distance (ft): **135.3**
Structural Grade: **2**
O&M Grade: **0**
Clock Start/From:
Clock To:
1st Value:
2nd Value:
Value Percent: **15.000**
Continuous Index: **F06**
Within 8" of Joint: **NO**
Remarks:

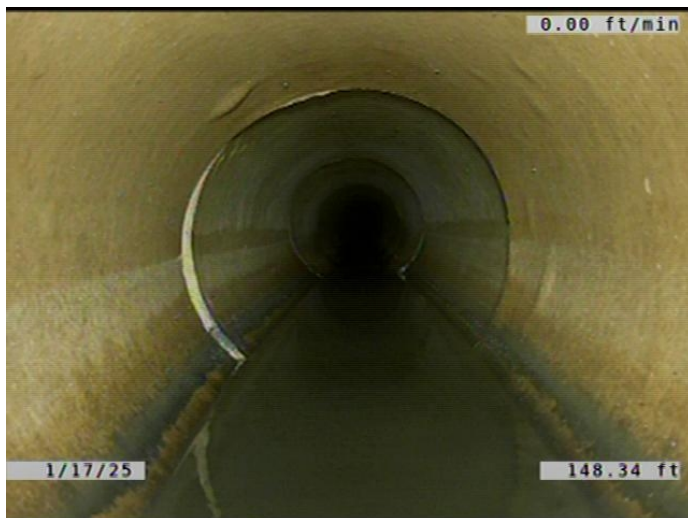
| | Position | Code | Observation | Video (sec) | Grade |
|---|---|---|---|---|---|
| | 148.3 | MWLS(S07) | Miscellaneous Water Level Sag | 829 | S 2 |

Code: **MWLS**
Description: **Miscellaneous Water Level Sag**

Distance (ft): **148.3**
Structural Grade: **2**
O&M Grade: **0**
Clock Start/From:
Clock To:
1st Value:
2nd Value:
Value Percent: **10.000**
Continuous Index: **S07**
Within 8" of Joint: **NO**
Remarks:

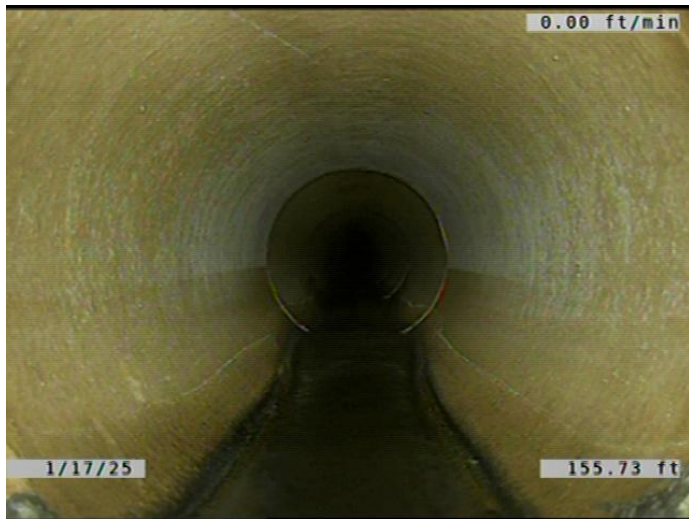
| | Position | Code | Observation | Video (sec) | Grade |
|---|---|---|---|---|---|
| | 155.7 | MWLS(F07) | Miscellaneous Water Level Sag | 864 | S 2 |

Code: **MWLS**
 Description: **Miscellaneous Water Level Sag**

Distance (ft): **155.7**
 Structural Grade: **2**
 O&M Grade: **0**
 Clock Start/From:
 Clock To:
 1st Value:
 2nd Value:
 Value Percent: **10.000**
 Continuous Index: **F07**
 Within 8" of Joint: **NO**
 Remarks:

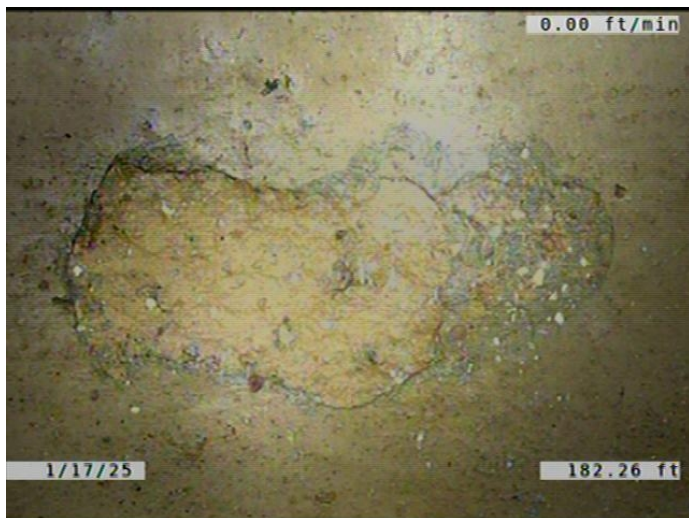
| | Position | Code | Observation | Video (sec) | Grade |
|---|---|---|---|---|---|
| | 182.2 | SSC | Surface Spalling of Damage Coating | 966 | S 1 |

Code: **SSC**
 Description: **Surface Spalling of Damage Coating**

Distance (ft): **182.2**
 Structural Grade: **1**
 O&M Grade: **0**
 Clock Start/From: **9**
 Clock To: **10**
 1st Value:
 2nd Value:
 Value Percent:
 Continuous Index:
 Within 8" of Joint: **YES**
 Remarks:

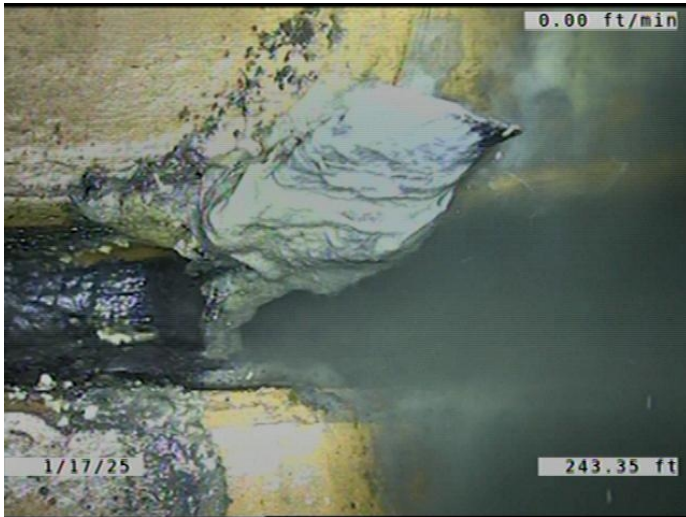
| | Position | Code | Observation | Video (sec) | Grade |
|---|---|---|---|---|---|
| | 243.4 | ISSRH | Intruding Sealing Material Sealing Ring Hanging | 1230 | M 2 |

| Description: | Intruding Sealing Material Sealing Ring Hanging |
| Distance (ft): | 243.4 |
| O&M Grade: | 2 |

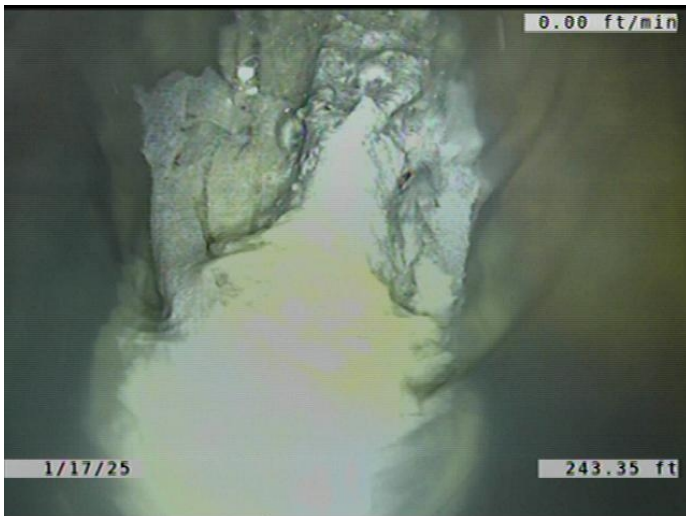
| | Position | Code | Observation | Video (sec) | Grade |
|---|---|---|---|---|---|
| | 243.4 | DAR | Deposits Attached Ragging | 1242 | M 2 |

| Description: | Deposits Attached Ragging |
| Distance (ft): | 243.4 |
| O&M Grade: | 2 |

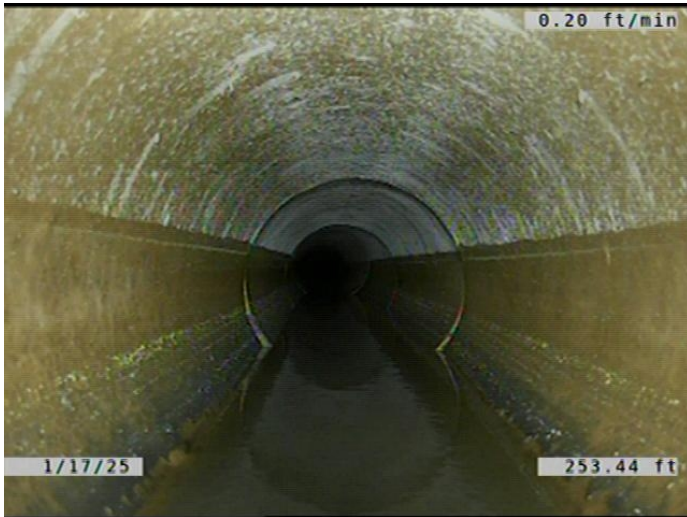
| | Position | Code | Observation | Video (sec) | Grade |
|---|---|---|---|---|---|
| | 253.4 | MWLS(S08) | Miscellaneous Water Level Sag | 1293 | S 2 |

Code: **MWLS**
Description: **Miscellaneous Water Level Sag**

Distance (ft): **253.4**
Structural Grade: **2**
O&M Grade: **0**
Clock Start/From:
Clock To:
1st Value:
2nd Value:
Value Percent: **15.000**
Continuous Index: **S08**
Within 8" of Joint: **NO**
Remarks:

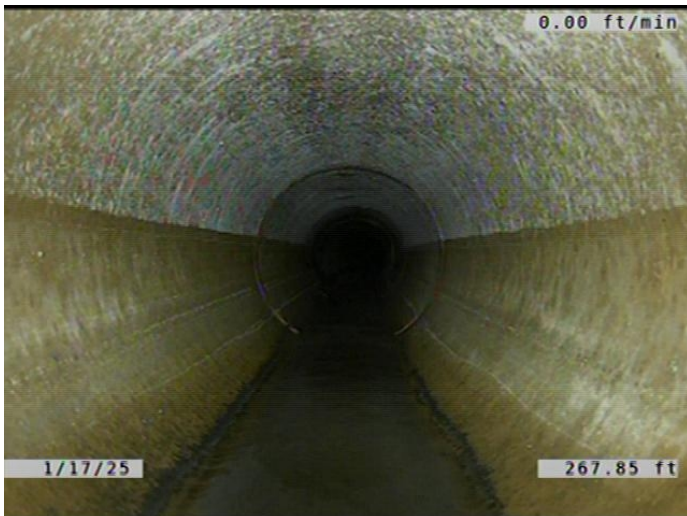
| | Position | Code | Observation | Video (sec) | Grade |
|---|---|---|---|---|---|
| | 267.8 | MWLS(F08) | Miscellaneous Water Level Sag | 1365 | S 2 |

Code: **MWLS**
Description: **Miscellaneous Water Level Sag**

Distance (ft): **267.8**
Structural Grade: **2**
O&M Grade: **0**
Clock Start/From:
Clock To:
1st Value:
2nd Value:
Value Percent: **15.000**
Continuous Index: **F08**
Within 8" of Joint: **NO**
Remarks:

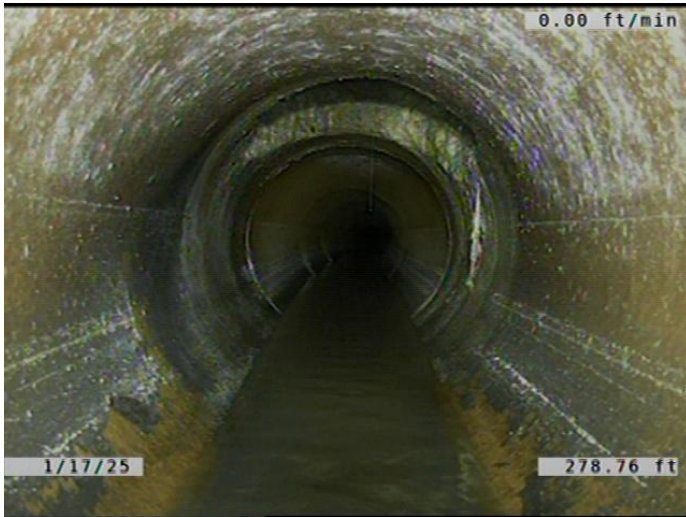
| | Position | Code | Observation | Video (sec) | Grade |
|---|---|---|---|---|---|
| | 278.8 | JOMD(F01) | Joint Offset Medium Defective | 1408 | S 3 |

Code: **JOMD**
Description: **Joint Offset Medium Defective**

Distance (ft): **278.8**
Structural Grade: **3**
O&M Grade: **0**
Clock Start/From:
Clock To:
1st Value:
2nd Value:
Value Percent:
Continuous Index: **F01**
Within 8" of Joint: **NO**
Remarks:
