Profile/Photo Observation Report

Date:	01/28/2025	Weather:		Coding:	PACP 7.0
Pipe Length (ft):	186.0	Owner:	City of Hobart	Pre Clean:	Heavy Cleaning
P.O.#:	YES502259	Surveyor:	S. Bucklin	PSR:	P-208-023-024
Customer:	City of Hobart	Clean Date:	07/22/2024	Shape:	C

Street:	Liverpool Road	Flow Control:	Not Controlled
City:	Hobart, IN	Year Renewed:	
Location:	Yard	Tape/Media #:	
Purpose:	Sewer System Evaluation Survey (SS	Dia/Height:	15"
Use:	Sanitary Sewage Pipe	Material:	VCP
Drain Area:		Lining:	None
Category:	NA		
Comment:			
Location Details:		Direction of Survey:	Upstream
US MH:	M-208-024	DS MH:	M-208-023
		Total Length Surveyed (ft):	78.2

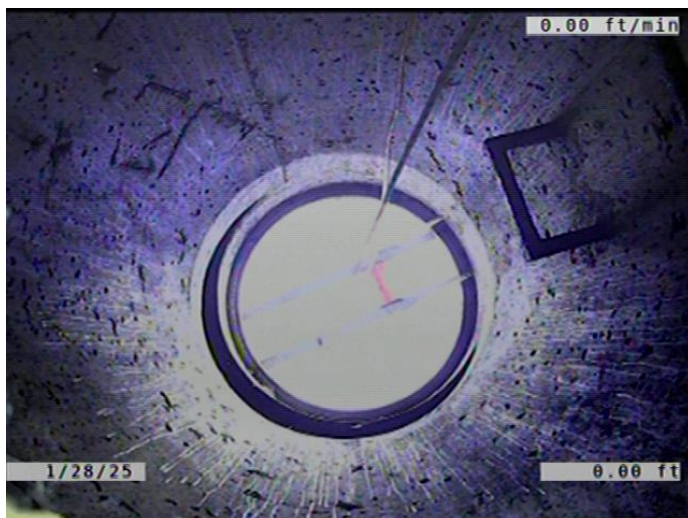
Code: **AMH**
Description: **Manhole**

Distance (ft): **.0**
Structural Grade: **0**
O&M Grade: **0**
Clock Start/From:
Clock To:
1st Value:
2nd Value:
Value Percent:
Continuous Index:
Within 8" of Joint: **NO**
Remarks: **M-208-023**

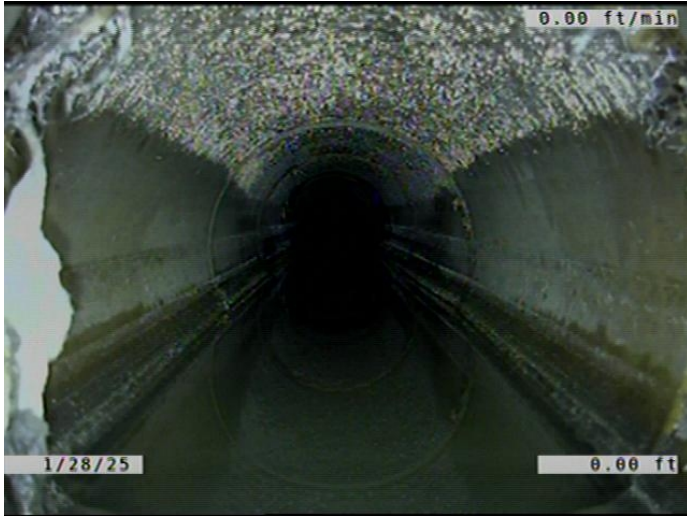
Code: **MWL**
Description: **Miscellaneous Water Level**

Distance (ft): **.0**
Structural Grade: **0**
O&M Grade: **0**
Clock Start/From:
Clock To:
1st Value:
2nd Value:
Value Percent: **25.000**
Continuous Index:
Within 8" of Joint: **NO**
Remarks:

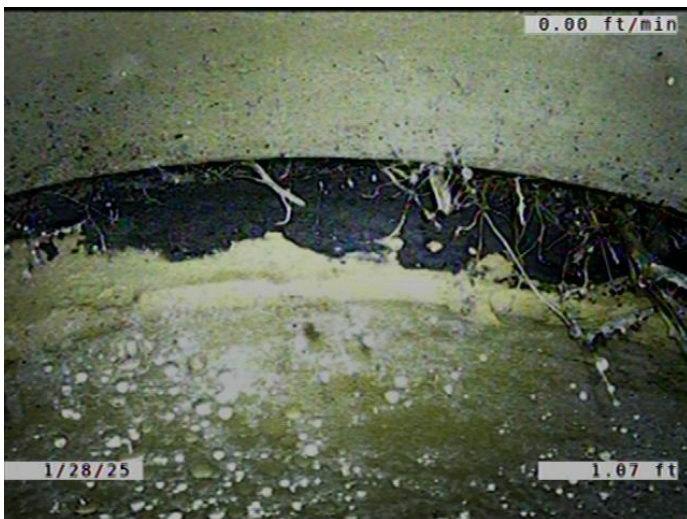
Code: **JOMD**
Description: **Joint Offset Medium Defective**

Distance (ft): **1.1**
Structural Grade: **3**
O&M Grade: **0**
Clock Start/From:
Clock To:
1st Value:
2nd Value:
Value Percent:
Continuous Index:
Within 8" of Joint: **NO**
Remarks:

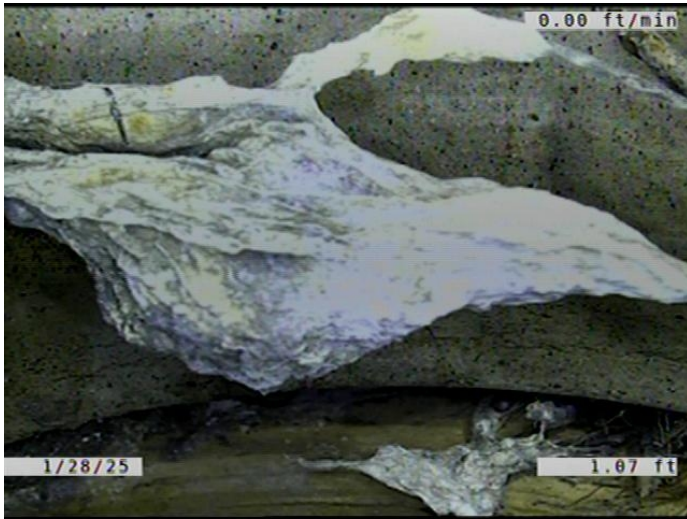
Code: **DAR**
 Description: **Deposits Attached Ragging**

Distance (ft): **1.1**
 Structural Grade: **0**
 O&M Grade: **2**
 Clock Start/From: **7**
 Clock To: **9**
 1st Value:
 2nd Value:
 Value Percent: **5.000**
 Continuous Index:
 Within 8" of Joint: **YES**
 Remarks:

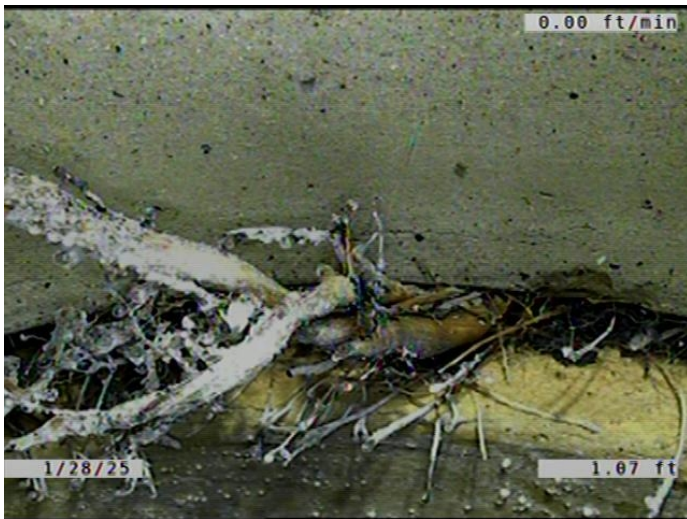
Code: **RFJ**
 Description: **Roots Fine Joint**

Distance (ft): **1.1**
 Structural Grade: **0**
 O&M Grade: **1**
 Clock Start/From: **8**
 Clock To: **4**
 1st Value:
 2nd Value:
 Value Percent:
 Continuous Index: **S01**
 Within 8" of Joint: **YES**
 Remarks:

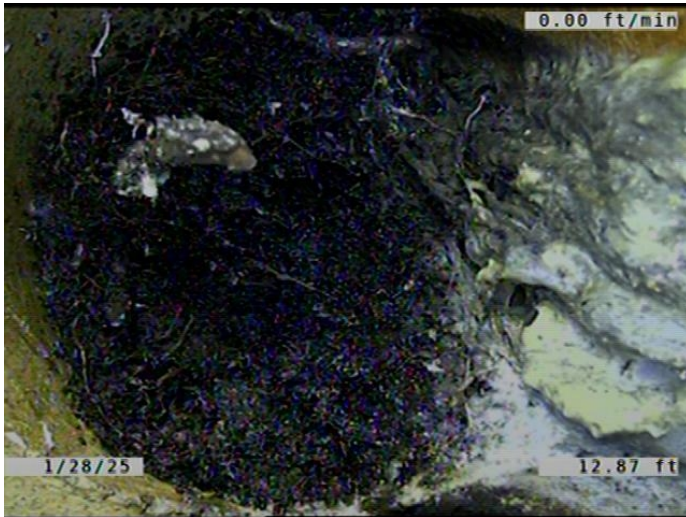
Code: **TFD**
Description: **Tap Factory Defective**

Distance (ft): **12.9**
Structural Grade: **0**
O&M Grade: **3**
Clock Start/From: **2**
Clock To:
1st Value: **6.000**
2nd Value:
Value Percent:
Continuous Index:
Within 8" of Joint: **YES**
Remarks: **100% PLUGGED WITH ROOTS.**

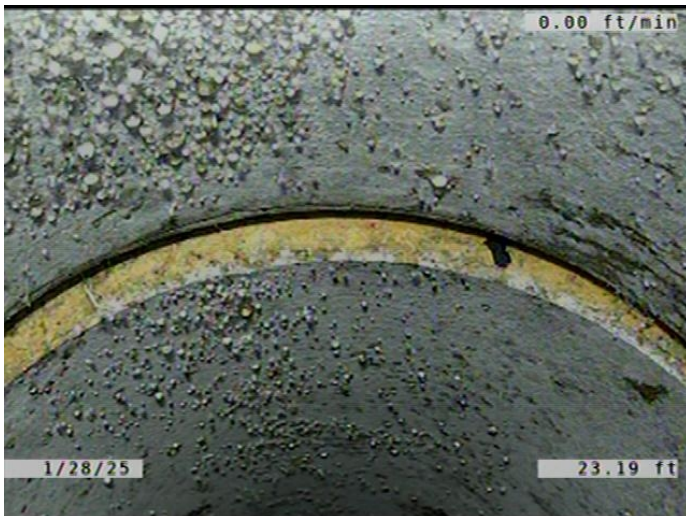
Code: **JOMD**
Description: **Joint Offset Medium Defective**

Distance (ft): **23.2**
Structural Grade: **3**
O&M Grade: **0**
Clock Start/From:
Clock To:
1st Value:
2nd Value:
Value Percent:
Continuous Index:
Within 8" of Joint: **NO**
Remarks:

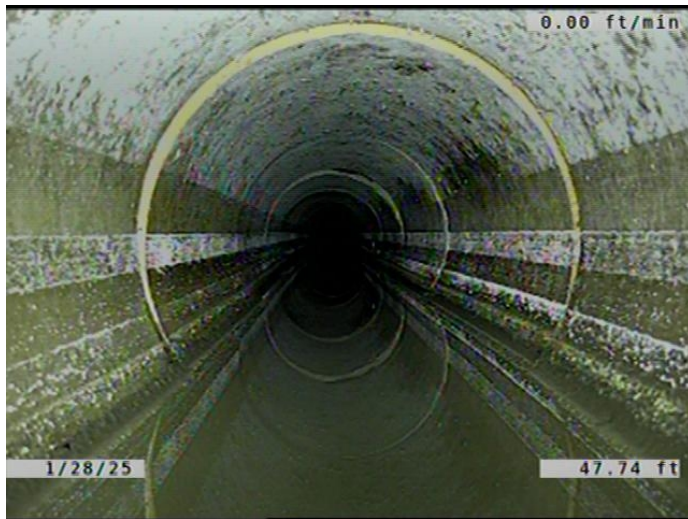
Code: **RFJ**
 Description: **Roots Fine Joint**

Distance (ft): **47.7**
 Structural Grade: **0**
 O&M Grade: **1**
 Clock Start/From: **8**
 Clock To: **4**
 1st Value:
 2nd Value:
 Value Percent:
 Continuous Index: **F01**
 Within 8" of Joint: **YES**
 Remarks:

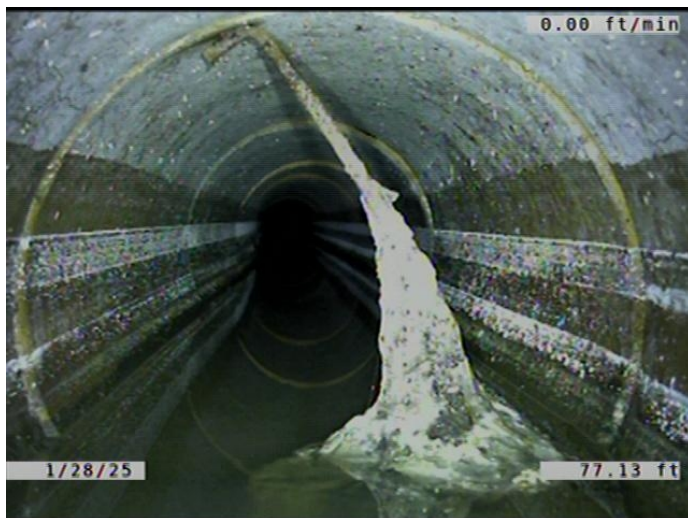
Code: **OBJ**
 Description: **Obstruction Wedged In The Joint**

Distance (ft): **77.1**
 Structural Grade: **0**
 O&M Grade: **2**
 Clock Start/From: **5**
 Clock To: **11**
 1st Value:
 2nd Value:
 Value Percent: **5.000**
 Continuous Index:
 Within 8" of Joint: **YES**
 Remarks:

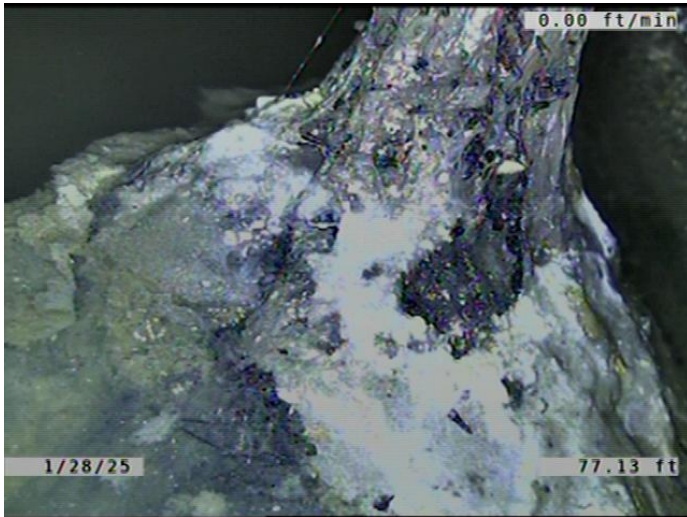
Code: **DAR**
Description: **Deposits Attached Ragging**

Distance (ft): **77.1**
Structural Grade: **0**
O&M Grade: **2**
Clock Start/From: **4**
Clock To: **6**
1st Value:
2nd Value:
Value Percent: **5.000**
Continuous Index:
Within 8" of Joint: **YES**
Remarks:

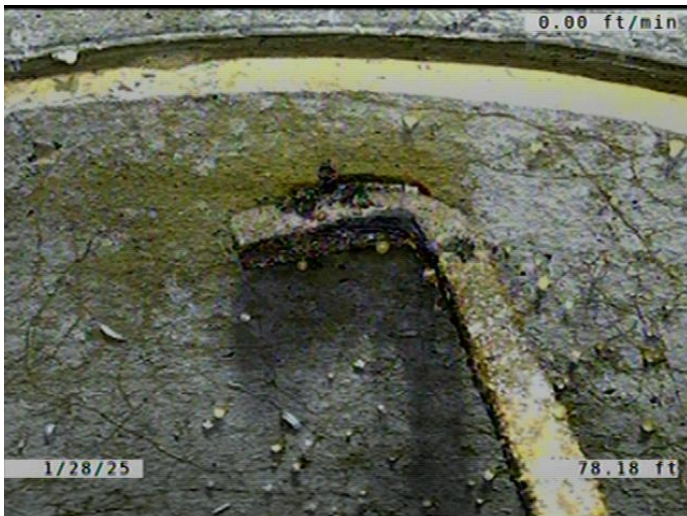
Code: **MGO**
Description: **Miscellaneous General Observation**

Distance (ft): **78.2**
Structural Grade: **0**
O&M Grade: **0**
Clock Start/From:
Clock To:
1st Value:
2nd Value:
Value Percent:
Continuous Index:
Within 8" of Joint: **NO**
Remarks: **LOOKS TO BE SQUARE METAL ROD WEDGED IN THE JOINT.**

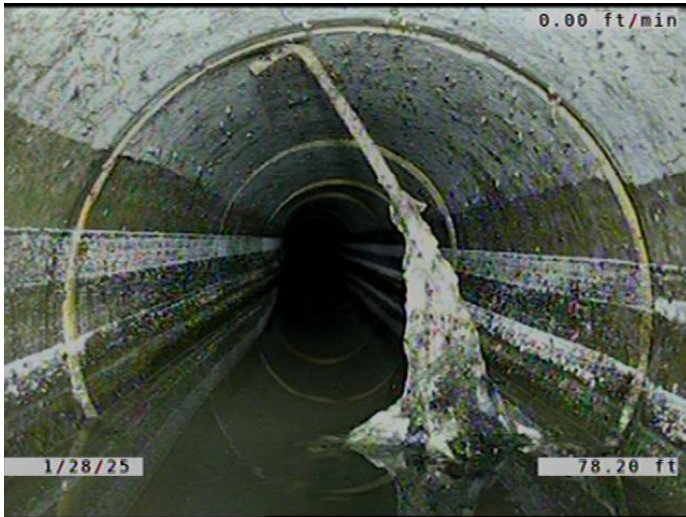
Code:	MSA
Description:	Miscellaneous Survey Abandoned
Distance (ft):	78.2
Structural Grade:	0
O&M Grade:	0
Clock Start/From:	
Clock To:	
1st Value:	
2nd Value:	
Value Percent:	
Continuous Index:	
Within 8" of Joint:	NO
Remarks:	CAMERA NOT ABLE TO MAKE IT PAST METAL ROD IN THE JOINT.
