## Profile/Photo Observation Report

| Street: | <b>Liverpool Road</b> | Flow Control: | <b>Not Controlled</b> |
| Purpose: | <b>Sewer System Evaluation Survey (SS</b> | Dia/Height: | <b>15"</b> |
| US MH: | <b>M-208-024</b> | DS MH: | <b>M-208-023</b> |

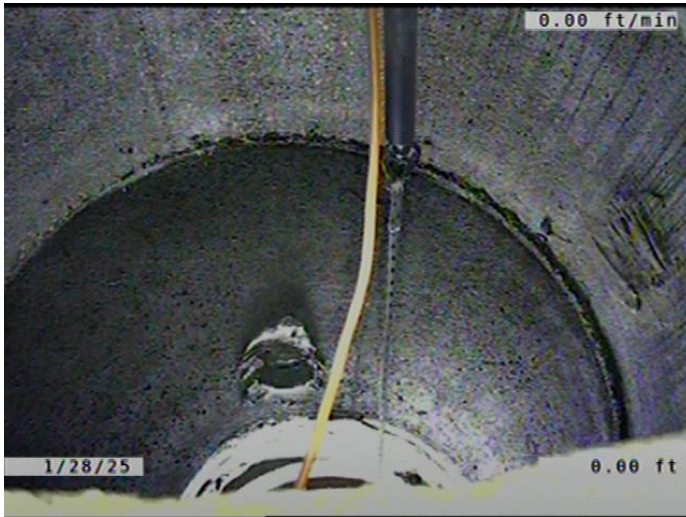
Code: **AMH**  
Description: **Manhole**

Distance (ft): **.0**  
Structural Grade: **0**  
O&M Grade: **0**  
Clock Start/From:  
Clock To:  
1st Value:  
2nd Value:  
Value Percent:  
Continuous Index:  
Within 8" of Joint: **NO**  
Remarks: **M-208-024**

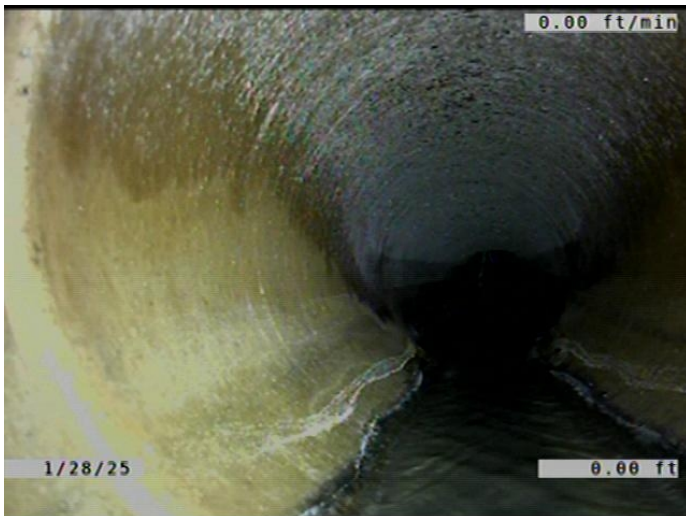
Code: **MWL**  
Description: **Miscellaneous Water Level**

Distance (ft): **.0**  
Structural Grade: **0**  
O&M Grade: **0**  
Clock Start/From:  
Clock To:  
1st Value:  
2nd Value:  
Value Percent: **5.000**  
Continuous Index:  
Within 8" of Joint: **NO**  
Remarks:

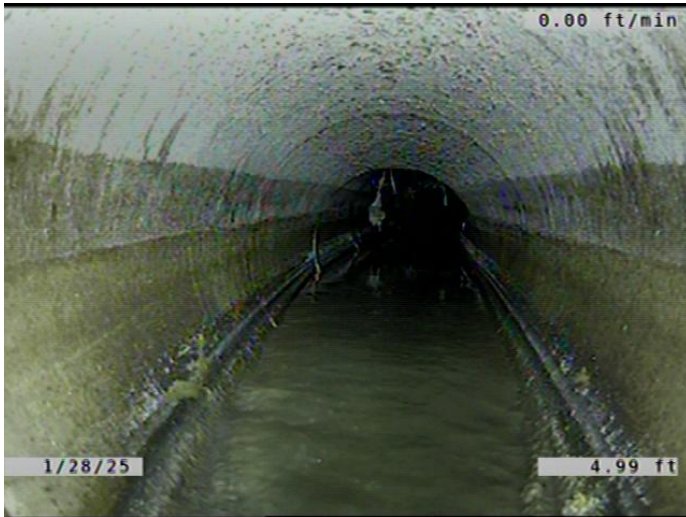
Code: **MWL**  
Description: **Miscellaneous Water Level**

Distance (ft): **5.0**  
Structural Grade: **0**  
O&M Grade: **0**  
Clock Start/From:  
Clock To:  
1st Value:  
2nd Value:  
Value Percent: **25.000**  
Continuous Index:  
Within 8" of Joint: **NO**  
Remarks:

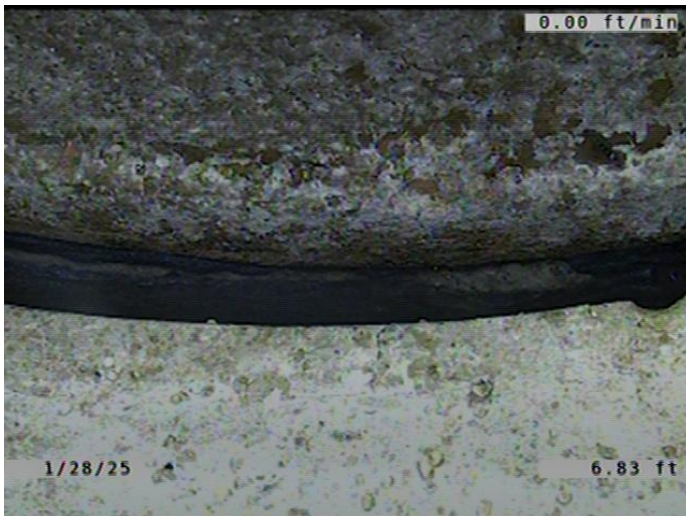
Code: **JOMD**  
Description: **Joint Offset Medium Defective**

Distance (ft): **6.8**  
Structural Grade: **3**  
O&M Grade: **0**  
Clock Start/From:  
Clock To:  
1st Value:  
2nd Value:  
Value Percent:  
Continuous Index:  
Within 8" of Joint: **NO**  
Remarks:

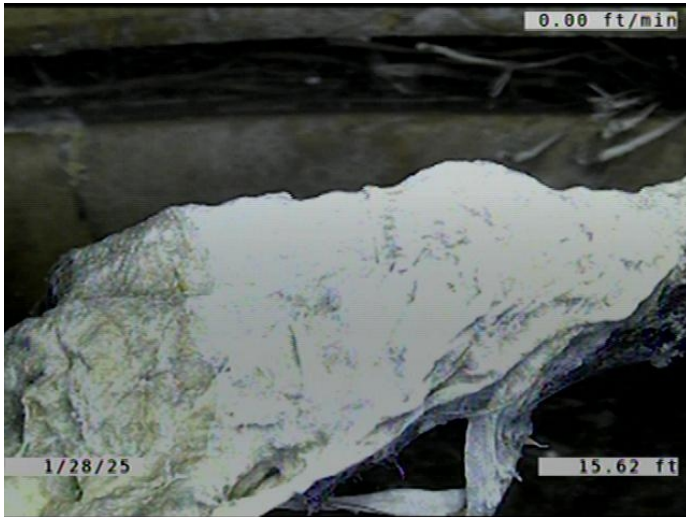
| Code: | <b>DAR</b> |
| Description: | <b>Deposits Attached Ragging</b> |
| Distance (ft): | <b>15.6</b> |
| O&M Grade: | <b>2</b> |

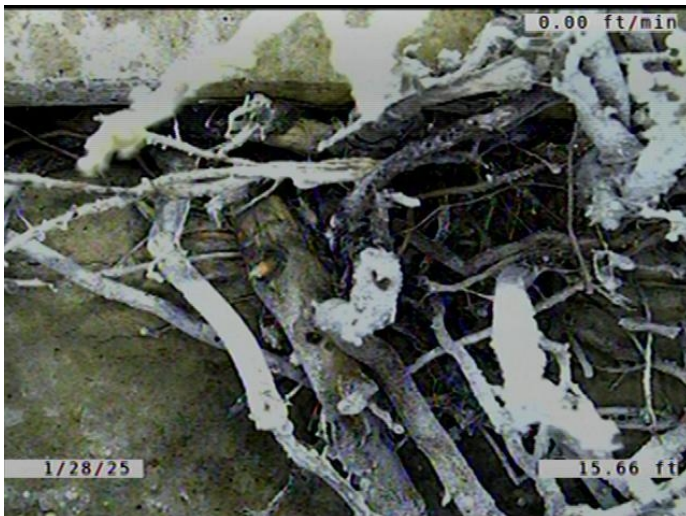
| Code: | <b>RTJ</b> |
| Description: | <b>Roots Tap Joint</b> |
| Distance (ft): | <b>15.6</b> |
| O&M Grade: | <b>2</b> |

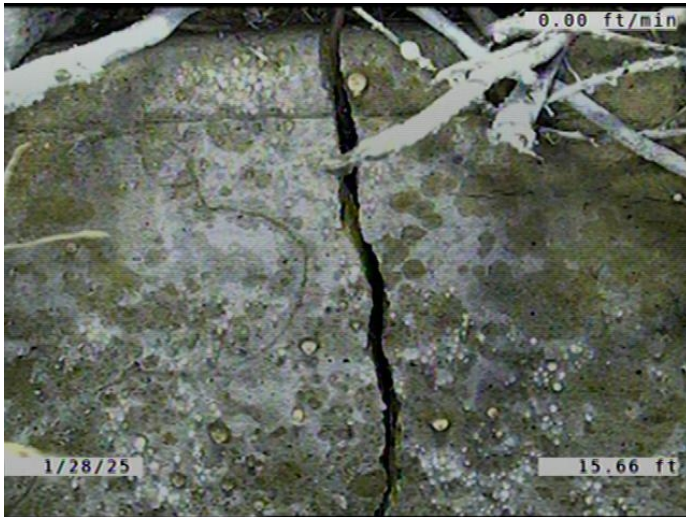
Code: **FS**  
Description: **Fracture Spiral**

Distance (ft): **15.7**  
Structural Grade: **3**  
O&M Grade: **0**  
Clock Start/From: **11**  
Clock To: **12**  
1st Value:  
2nd Value:  
Value Percent:  
Continuous Index:  
Within 8" of Joint: **YES**  
Remarks:

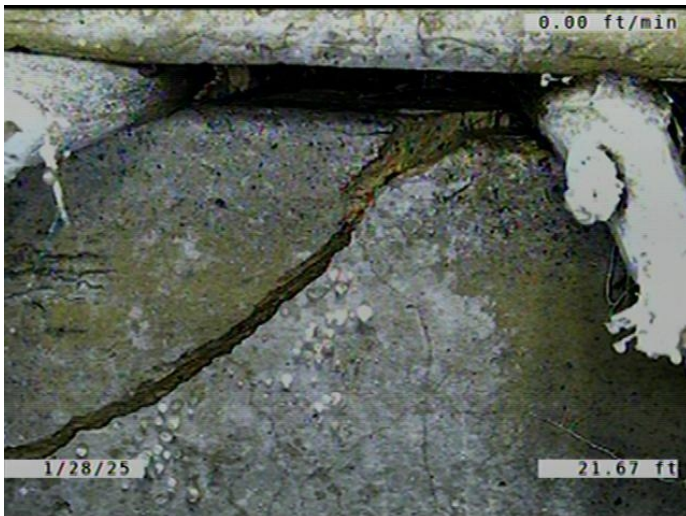
Code: **B**  
Description: **Broken**

Distance (ft): **21.7**  
Structural Grade: **4**  
O&M Grade: **0**  
Clock Start/From: **10**  
Clock To: **12**  
1st Value:  
2nd Value:  
Value Percent:  
Continuous Index:  
Within 8" of Joint: **YES**  
Remarks:

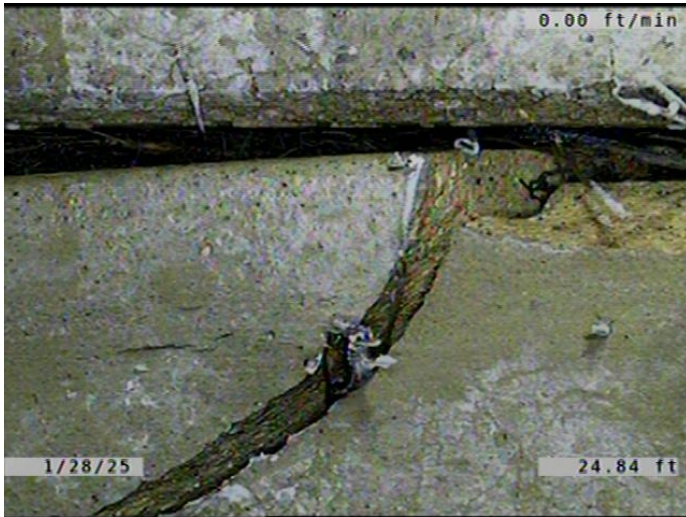
Code: **B**  
Description: **Broken**

Distance (ft): **24.8**  
Structural Grade: **4**  
O&M Grade: **0**  
Clock Start/From: **8**  
Clock To: **11**  
1st Value:  
2nd Value:  
Value Percent:  
Continuous Index:  
Within 8" of Joint: **YES**  
Remarks:

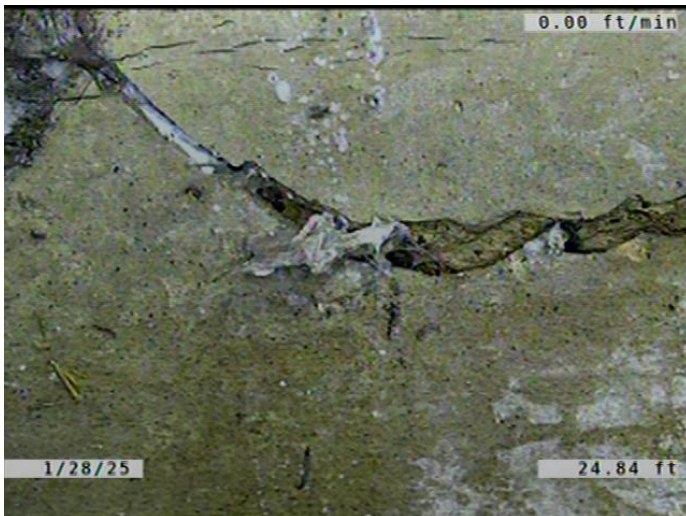
Code: **RFB**  
Description: **Roots Fine Barrel**

Distance (ft): **24.8**  
Structural Grade: **0**  
O&M Grade: **2**  
Clock Start/From: **8**  
Clock To: **11**  
1st Value:  
2nd Value:  
Value Percent:  
Continuous Index:  
Within 8" of Joint: **NO**  
Remarks:

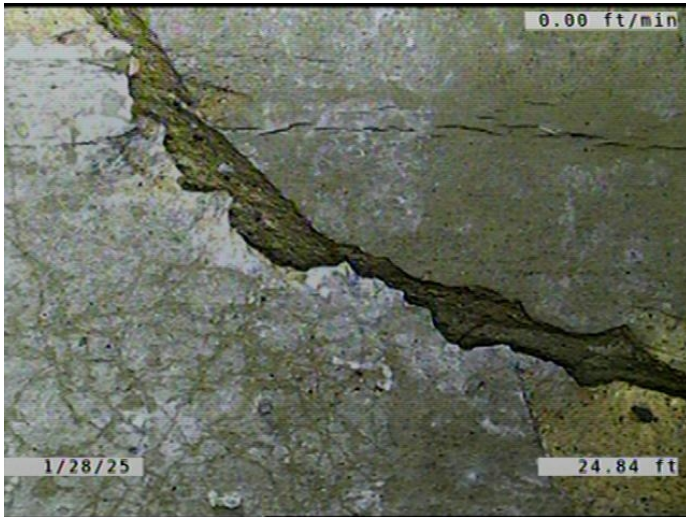
Code: **B**  
Description: **Broken**

Distance (ft): **24.8**  
Structural Grade: **4**  
O&M Grade: **0**  
Clock Start/From: **1**  
Clock To: **4**  
1st Value:  
2nd Value:  
Value Percent:  
Continuous Index:  
Within 8" of Joint: **YES**  
Remarks:

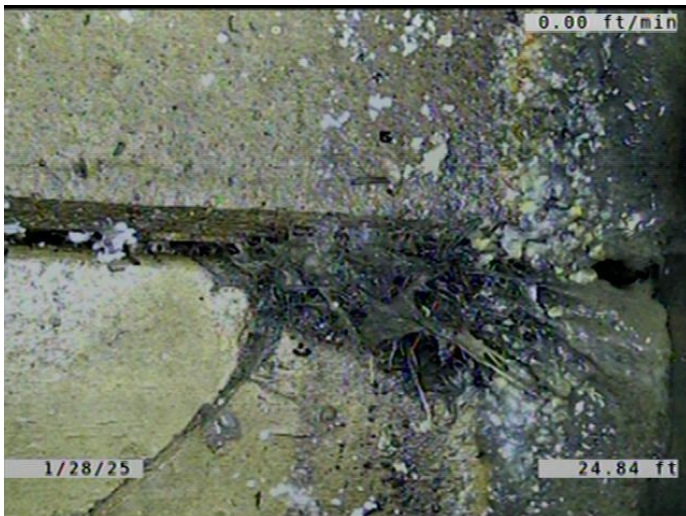
Code: **RFJ**  
Description: **Roots Fine Joint**

Distance (ft): **24.8**  
Structural Grade: **0**  
O&M Grade: **1**  
Clock Start/From: **8**  
Clock To: **4**  
1st Value:  
2nd Value:  
Value Percent:  
Continuous Index: **S02**  
Within 8" of Joint: **YES**  
Remarks:

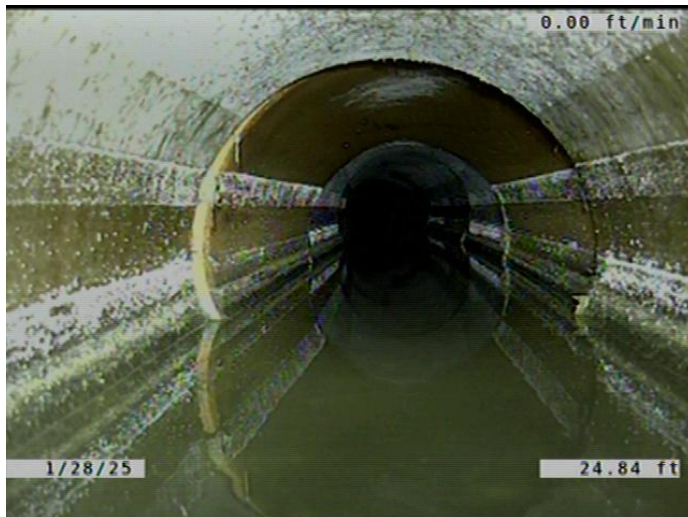
Code: **RTJ**  
Description: **Roots Tap Joint**

Distance (ft): **24.8**  
Structural Grade: **0**  
O&M Grade: **2**  
Clock Start/From: **8**  
Clock To: **4**  
1st Value:  
2nd Value:  
Value Percent: **5.000**  
Continuous Index: **F01**  
Within 8" of Joint: **YES**  
Remarks:

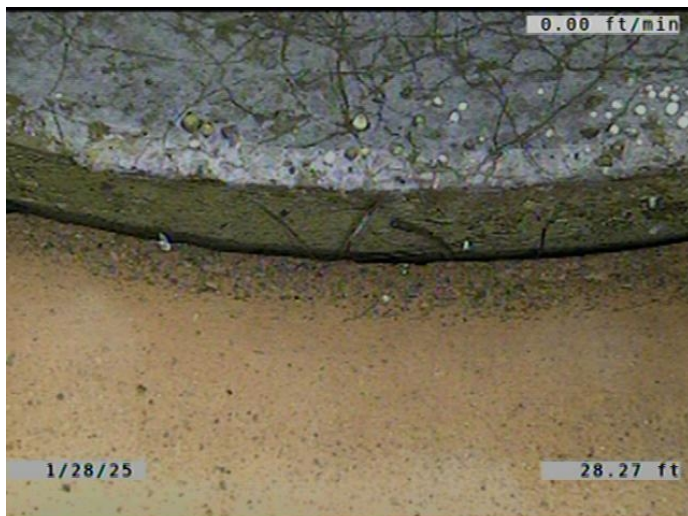
Code: **JOMD**  
Description: **Joint Offset Medium Defective**

Distance (ft): **28.3**  
Structural Grade: **3**  
O&M Grade: **0**  
Clock Start/From:  
Clock To:  
1st Value:  
2nd Value:  
Value Percent:  
Continuous Index:  
Within 8" of Joint: **NO**  
Remarks:

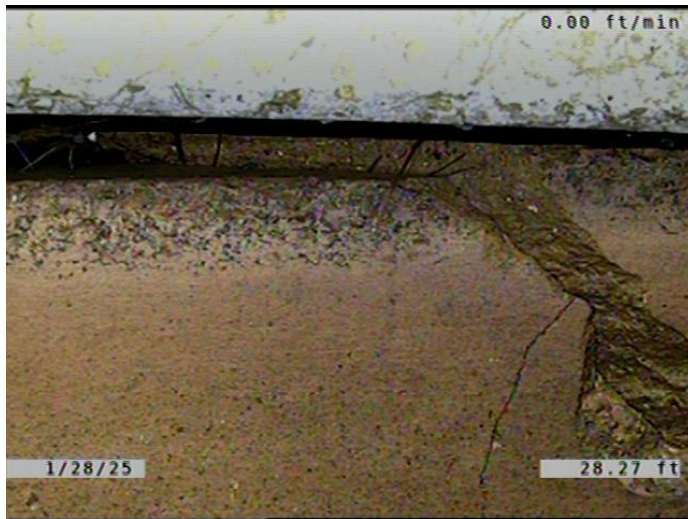
Code: **B**  
Description: **Broken**

Distance (ft): **28.3**  
Structural Grade: **4**  
O&M Grade: **0**  
Clock Start/From: **12**  
Clock To: **3**  
1st Value:  
2nd Value:  
Value Percent:  
Continuous Index:  
Within 8" of Joint: **YES**  
Remarks:

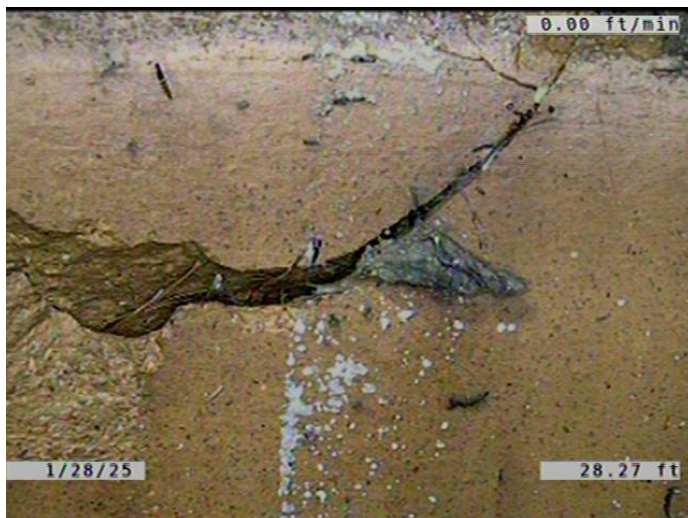
Code: **RFB**  
Description: **Roots Fine Barrel**

Distance (ft): **28.3**  
Structural Grade: **0**  
O&M Grade: **2**  
Clock Start/From: **1**  
Clock To: **3**  
1st Value:  
2nd Value:  
Value Percent:  
Continuous Index:  
Within 8" of Joint: **NO**  
Remarks:

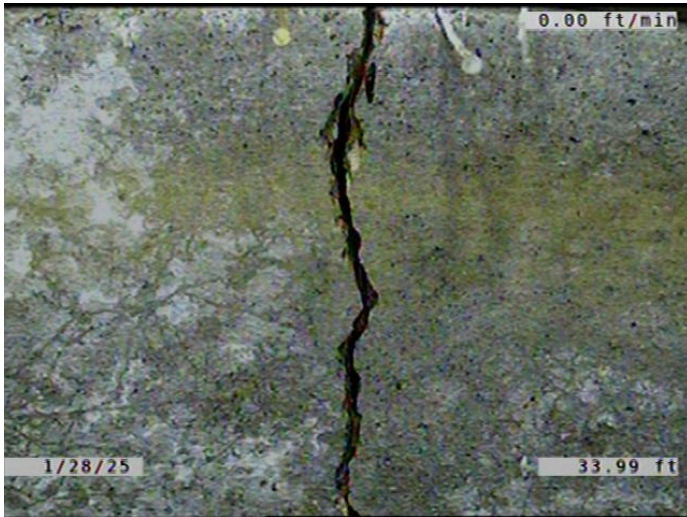
Code: **B**  
Description: **Broken**

Distance (ft): **34.0**  
Structural Grade: **4**  
O&M Grade: **0**  
Clock Start/From: **8**  
Clock To: **4**  
1st Value:  
2nd Value:  
Value Percent:  
Continuous Index: **S03**  
Within 8" of Joint: **YES**  
Remarks:

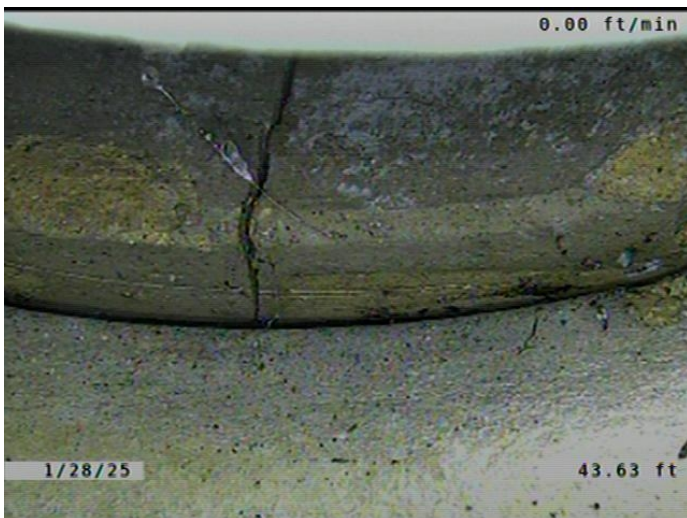
Code: **JOMD**  
Description: **Joint Offset Medium Defective**

Distance (ft): **43.6**  
Structural Grade: **3**  
O&M Grade: **0**  
Clock Start/From:  
Clock To:  
1st Value:  
2nd Value:  
Value Percent:  
Continuous Index:  
Within 8" of Joint: **NO**  
Remarks:

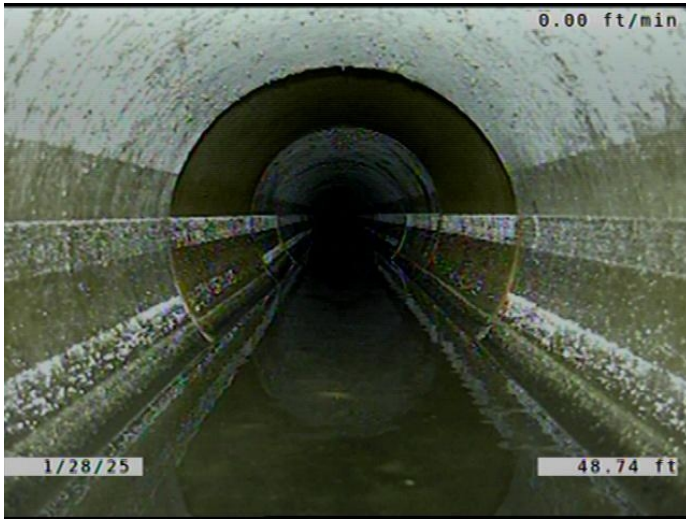
Code: **RFJ**  
Description: **Roots Fine Joint**

Distance (ft): **48.7**  
Structural Grade: **0**  
O&M Grade: **1**  
Clock Start/From: **8**  
Clock To: **4**  
1st Value:  
2nd Value:  
Value Percent:  
Continuous Index: **F02**  
Within 8" of Joint: **YES**  
Remarks:

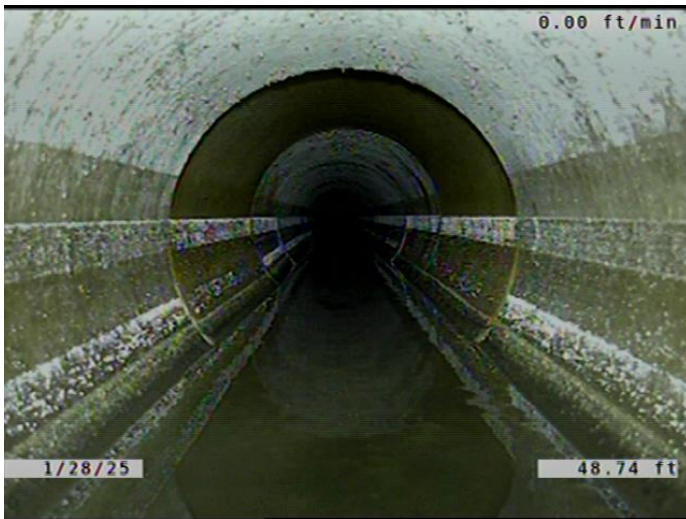
Code: **B**  
Description: **Broken**

Distance (ft): **48.7**  
Structural Grade: **4**  
O&M Grade: **0**  
Clock Start/From: **8**  
Clock To: **4**  
1st Value:  
2nd Value:  
Value Percent:  
Continuous Index: **F03**  
Within 8" of Joint: **YES**  
Remarks:

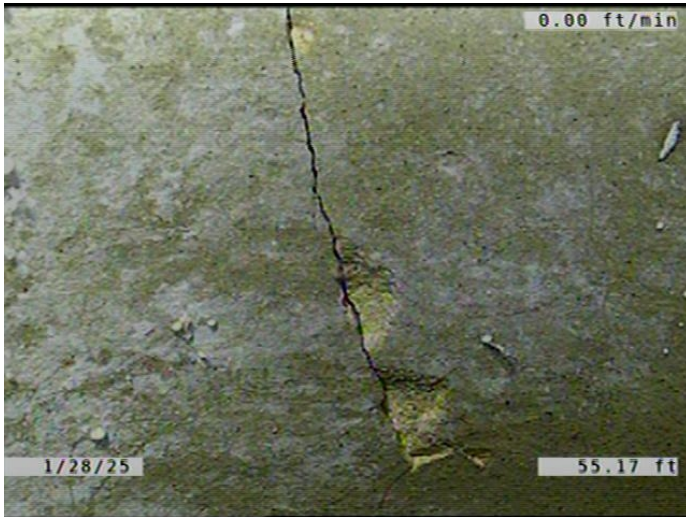
Code: **FM**  
Description: **Fracture Multiple**

Distance (ft): **55.2**  
Structural Grade: **4**  
O&M Grade: **0**  
Clock Start/From: **1**  
Clock To: **4**  
1st Value:  
2nd Value:  
Value Percent:  
Continuous Index:  
Within 8" of Joint: **YES**  
Remarks:

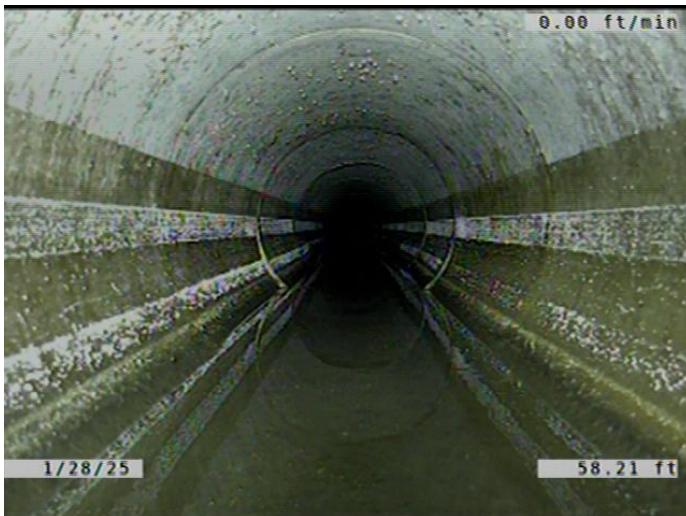
Code: **MWL**  
Description: **Miscellaneous Water Level**

Distance (ft): **58.2**  
Structural Grade: **0**  
O&M Grade: **0**  
Clock Start/From:  
Clock To:  
1st Value:  
2nd Value:  
Value Percent: **15.000**  
Continuous Index:  
Within 8" of Joint: **NO**  
Remarks:

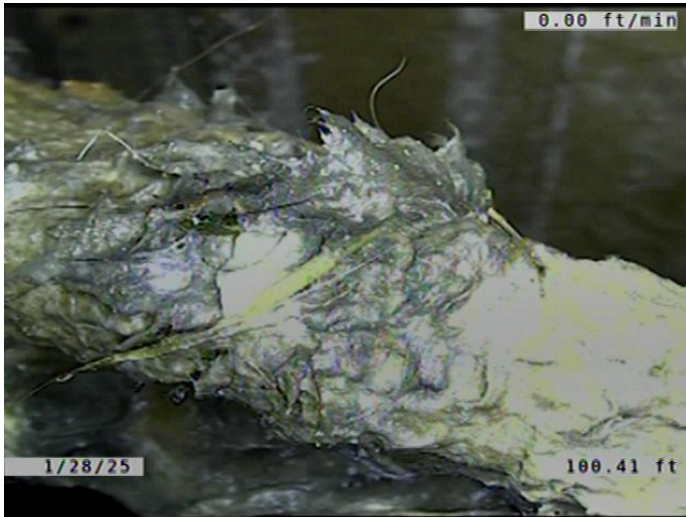
Code: **DAR**  
Description: **Deposits Attached Ragging**

Distance (ft): **100.4**  
Structural Grade: **0**  
O&M Grade: **2**  
Clock Start/From: **6**  
Clock To: **8**  
1st Value:  
2nd Value:  
Value Percent: **5.000**  
Continuous Index:  
Within 8" of Joint: **YES**  
Remarks:

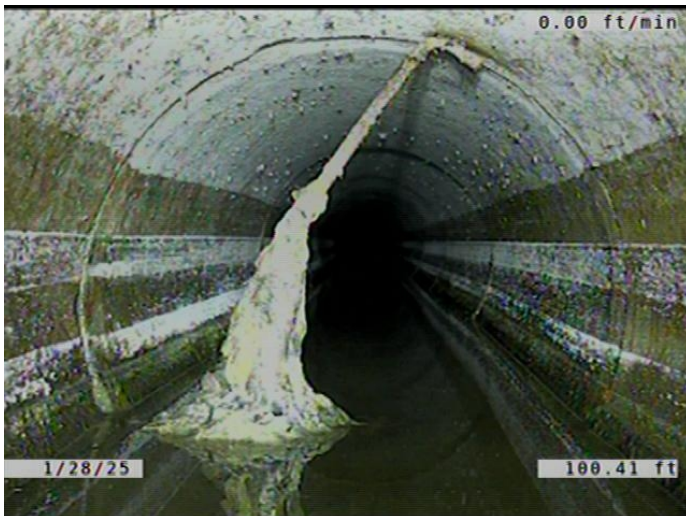
Code: **OBJ**  
Description: **Obstruction Wedged In The Joint**

Distance (ft): **100.4**  
Structural Grade: **0**  
O&M Grade: **2**  
Clock Start/From: **7**  
Clock To: **1**  
1st Value:  
2nd Value:  
Value Percent: **5.000**  
Continuous Index:  
Within 8" of Joint: **YES**  
Remarks: **SQUARE METAL ROD WEDGED IN THE JOINT.**

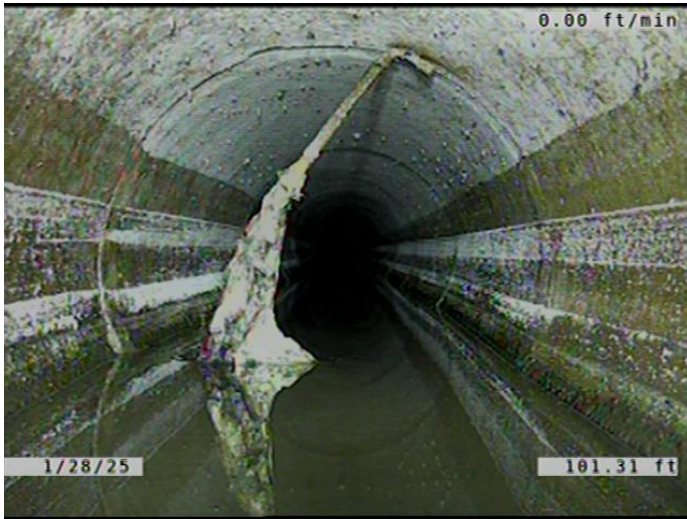
**Miscellaneous Survey Abandoned**

**101.3**

**CAMERA NOT ABLE TO MAKE IT  
PAST METAL ROD IN THE JOINT. MA**
