Profile/Photo Observation Report

Date:	04/14/2018	Weather:		Coding:	PACP 6.0
Pipe Length (ft):		Owner:	City of Hobart	Pre Clean:	No Pre-Cleaning
P.O.#:	47-1	Surveyor:	M. Pielacha	PSR:	M-208-026-M-208-030
Customer:	City of Hobart	Clean Date:		Shape:	C

Location Details:		Direction of Survey:	Downstream
US MH:	M-208-026	DS MH:	M-208-030
		Total Length Surveyed (ft):	320.0

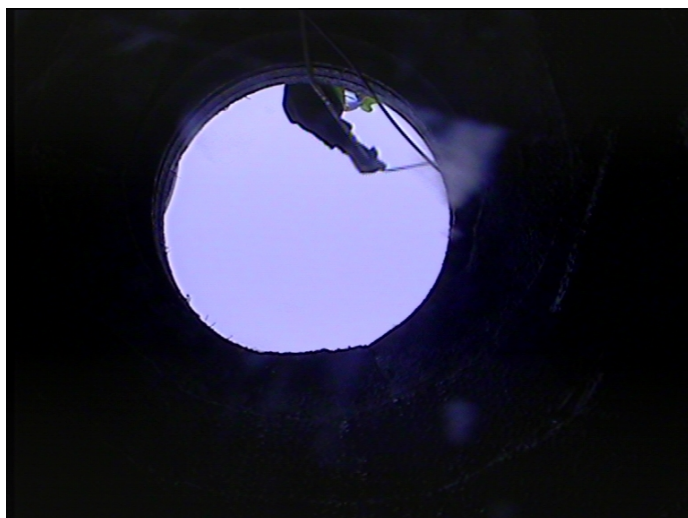
Code: **AMH**
 Description: **Manhole**

Distance (ft): **.0**
 Structural Grade: **0**
 O&M Grade: **0**
 Clock Start/From:
 Clock To:
 1st Value:
 2nd Value:
 Value Percent:
 Continuous Index:
 Within 8" of Joint: **NO**
 Remarks: **M-208-026**

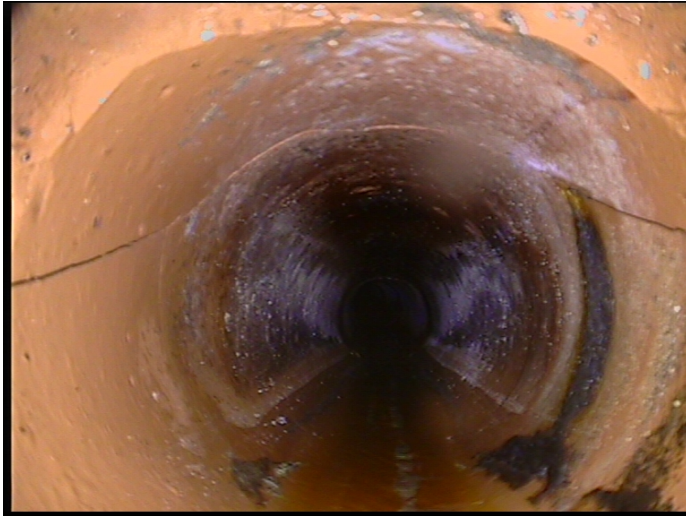
Code: **MWL**
Description: **Water Level**

Distance (ft): **.0**
Structural Grade: **0**
O&M Grade: **0**
Clock Start/From:
Clock To:
1st Value:
2nd Value:
Value Percent: **5.000**
Continuous Index:
Within 8" of Joint: **NO**
Remarks:

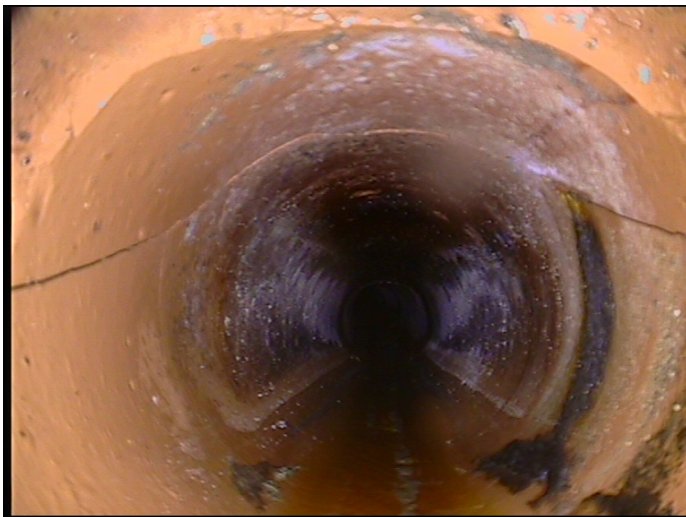
Code: **CC**
Description: **Crack Circumferential**

Distance (ft): **.0**
Structural Grade: **1**
O&M Grade: **0**
Clock Start/From: **9**
Clock To: **3**
1st Value:
2nd Value:
Value Percent:
Continuous Index:
Within 8" of Joint: **YES**
Remarks:

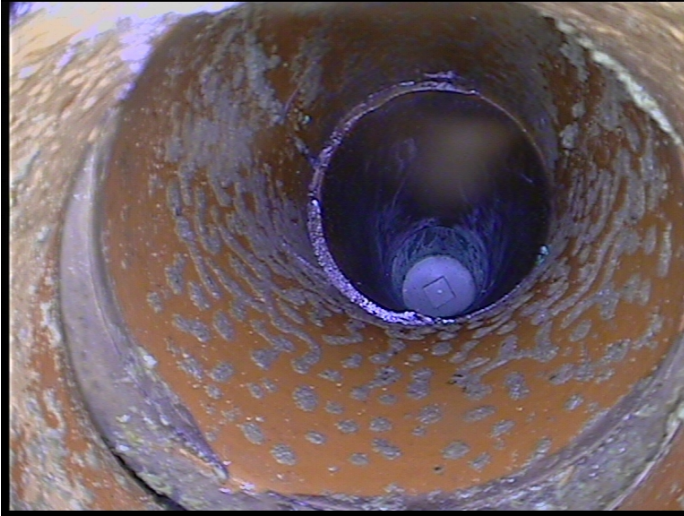
Code:	TFC
Description:	Tap Factory Capped
Distance (ft):	156.3
Structural Grade:	0
O&M Grade:	0
Clock Start/From:	12
Clock To:	
1st Value:	4.000
2nd Value:	
Value Percent:	
Continuous Index:	
Within 8" of Joint:	NO
Remarks:

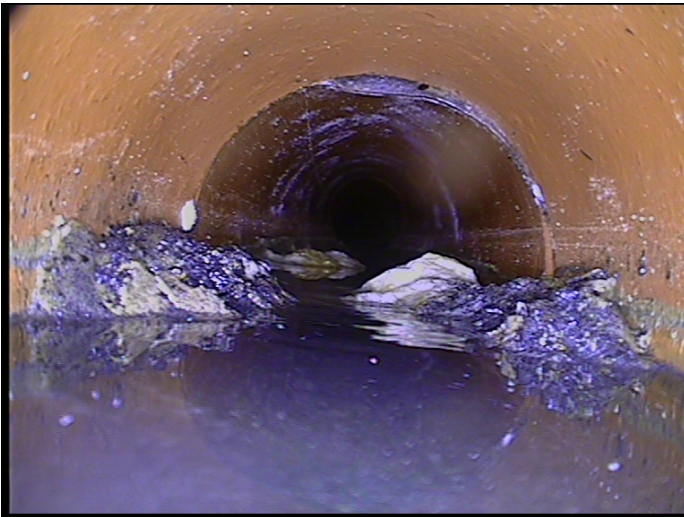
Code:	DSF
Description:	Deposits Settled Fine
Distance (ft):	195.2
Structural Grade:	0
O&M Grade:	3
Clock Start/From:	4
Clock To:	8
1st Value:	
2nd Value:	
Value Percent:	20.000
Continuous Index:	
Within 8" of Joint:	YES
Remarks:

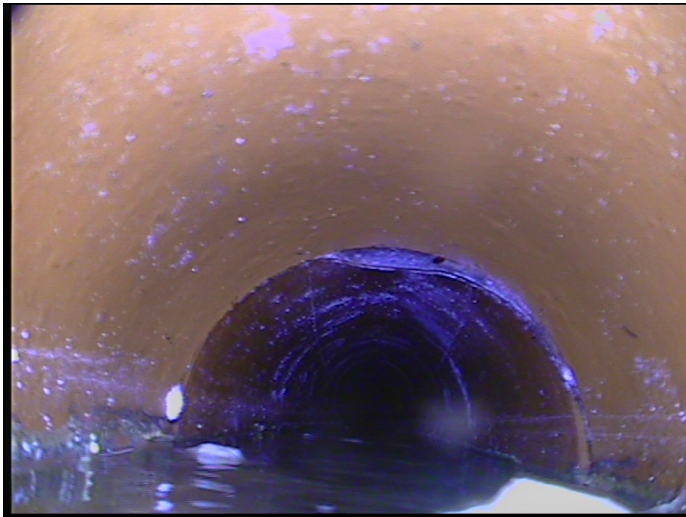
Code: **MWL**
Description: **Water Level**

Distance (ft): **196.9**
Structural Grade: **0**
O&M Grade: **0**
Clock Start/From:
Clock To:
1st Value:
2nd Value:
Value Percent: **35.000**
Continuous Index:
Within 8" of Joint: **NO**
Remarks:

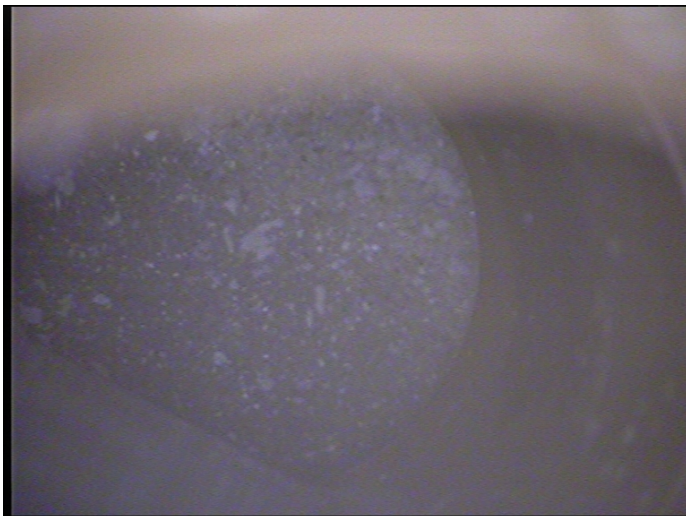
Code: **AMH**
Description: **Manhole**

Distance (ft): **320.0**
Structural Grade: **0**
O&M Grade: **0**
Clock Start/From:
Clock To:
1st Value:
2nd Value:
Value Percent:
Continuous Index:
Within 8" of Joint: **NO**
Remarks: **M-208-030**
