## Profile/Photo Observation Report

Street:	<b>OFF MINNESOTA ST</b>	Flow Control:	<b>Not Controlled</b>
City:	<b>Hobart, IN</b>	Year Renewed:	
Location:	<b>Light Highway</b>	Tape/Media #:	
Purpose:	<b>Routine Assessment</b>	Dia/Height:	<b>8"</b>
Use:	<b>Sanitary</b>	Material:	<b>PVC</b>
Drain Area:	<b>NA</b>	Lining:	
Category:	<b>NA</b>		
Comment:	<b>Flow direction wrong</b>

Location Details:		Direction of Survey:	<b>Downstream</b>
US MH:	<b>M-208-027</b>	DS MH:	<b>M-208-028</b>
		Total Length Surveyed (ft):	<b>274.9</b>

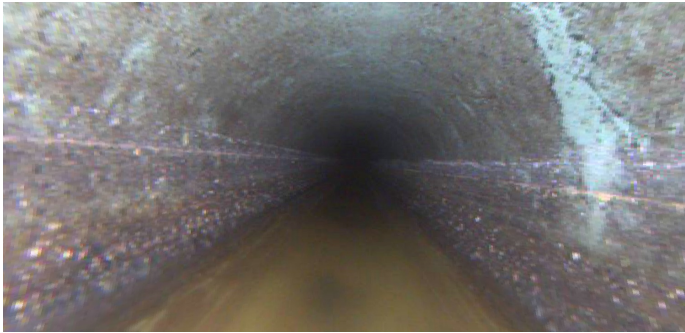
Code:	<b>MWL</b>
Description:	<b>Water Level</b>

Distance (ft):	<b>.0</b>
Structural Grade:	<b>0</b>
O&M Grade:	<b>0</b>
Clock Start/From:	
Clock To:	
1st Value:	
2nd Value:	
Value Percent:	<b>5.000</b>
Continuous Index:	
Within 8" of Joint:	<b>NO</b>
Remarks:

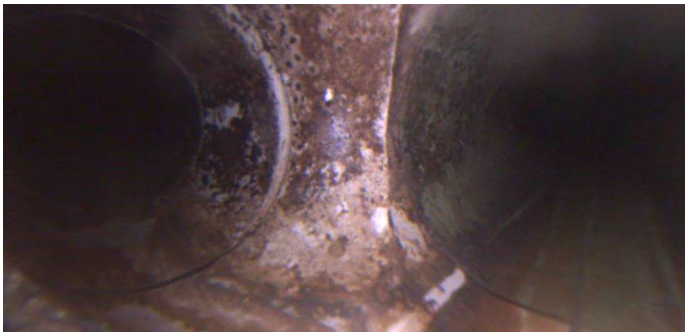
Code:	<b>TF</b>
Description:	<b>Tap Factory</b>

Distance (ft):	<b>29.5</b>
Structural Grade:	<b>0</b>
O&M Grade:	<b>0</b>
Clock Start/From:	<b>3</b>
Clock To:	
1st Value:	<b>4.000</b>
2nd Value:	
Value Percent:	
Continuous Index:	
Within 8" of Joint:	
Remarks:

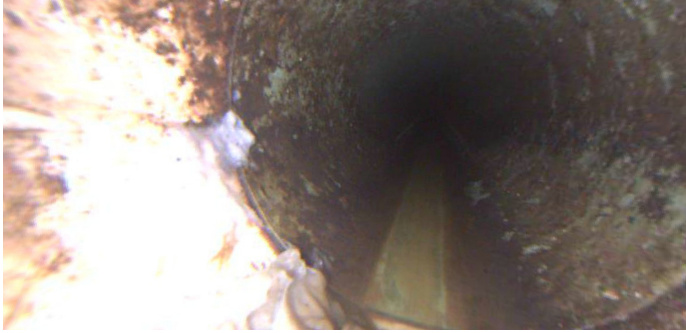
Code: **DAZ**  
Description: **Deposits Attached Other**

Distance (ft): **135.2**  
Structural Grade: **0**  
O&M Grade: **2**  
Clock Start/From: **7**  
Clock To: **9**  
1st Value:  
2nd Value:  
Value Percent: **5.000**  
Continuous Index:  
Within 8" of Joint: **YES**  
Remarks:

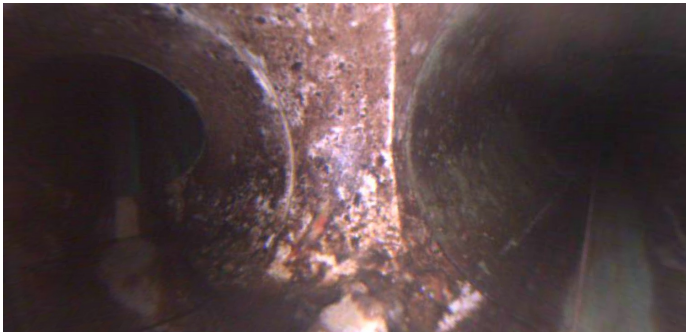
Code: **TFA**  
Description: **Tap Factory Active**

Distance (ft): **135.5**  
Structural Grade: **0**  
O&M Grade: **0**  
Clock Start/From: **3**  
Clock To:  
1st Value: **4.000**  
2nd Value:  
Value Percent:  
Continuous Index:  
Within 8" of Joint:  
Remarks:

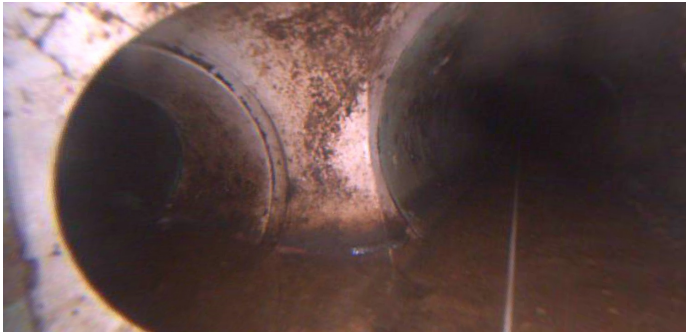
Code: **TFA**  
Description: **Tap Factory Active**

Distance (ft): **268.1**  
Structural Grade: **0**  
O&M Grade: **0**  
Clock Start/From: **3**  
Clock To:  
1st Value: **4.000**  
2nd Value:  
Value Percent:  
Continuous Index:  
Within 8" of Joint:  
Remarks:

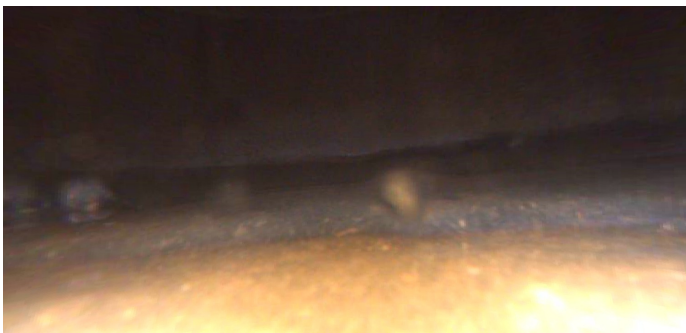
Code: **AMH**  
Description: **Manhole**

Distance (ft): **274.9**  
Structural Grade: **0**  
O&M Grade: **0**  
Clock Start/From:  
Clock To:  
1st Value:  
2nd Value:  
Value Percent:  
Continuous Index:  
Within 8" of Joint: **NO**  
Remarks: **M-208-028**
