## Profile/Photo Observation Report

| Customer: | <b>City of Hobart</b> | Clean Date: | | Shape: | <b>C</b> |

| Street: | <b>16th Street</b> | Flow Control: | <b>Not Controlled</b> |
| US MH: | <b>M-208-029</b> | DS MH: | <b>M-208-020</b> |

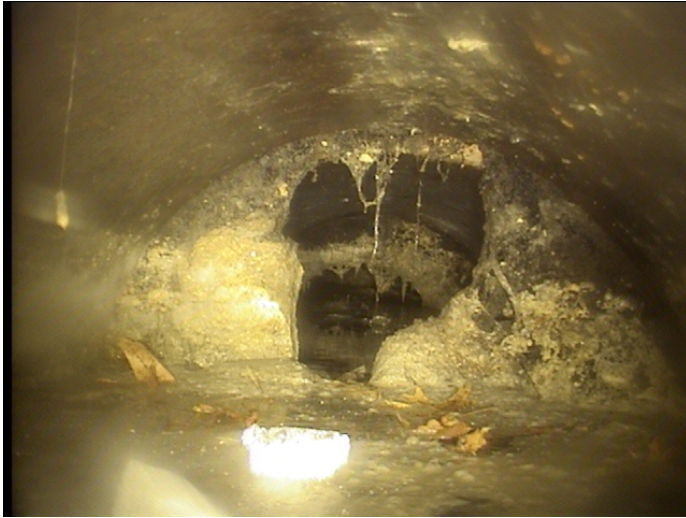
| Code: | AMH |
| Description: | Manhole |
| Remarks: | M-208-029 |

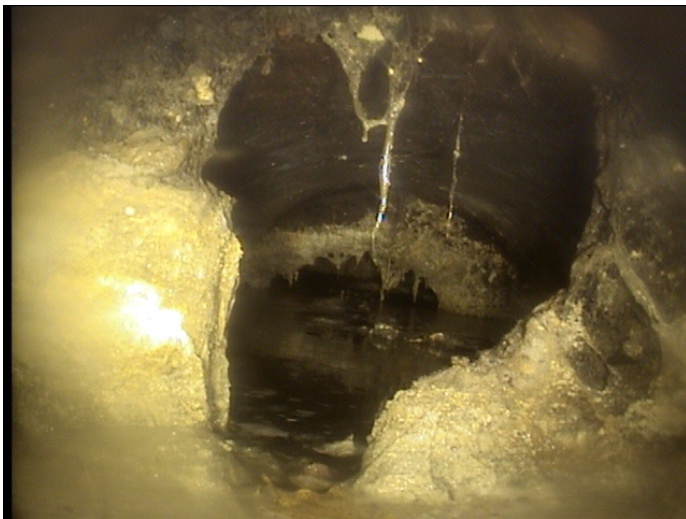
Code: **MWL**  
Description: **Water Level**

Distance (ft): **.0**  
Structural Grade: **0**  
O&M Grade: **0**  
Clock Start/From:  
Clock To:  
1st Value:  
2nd Value:  
Value Percent: **50.000**  
Continuous Index:  
Within 8" of Joint: **NO**  
Remarks:

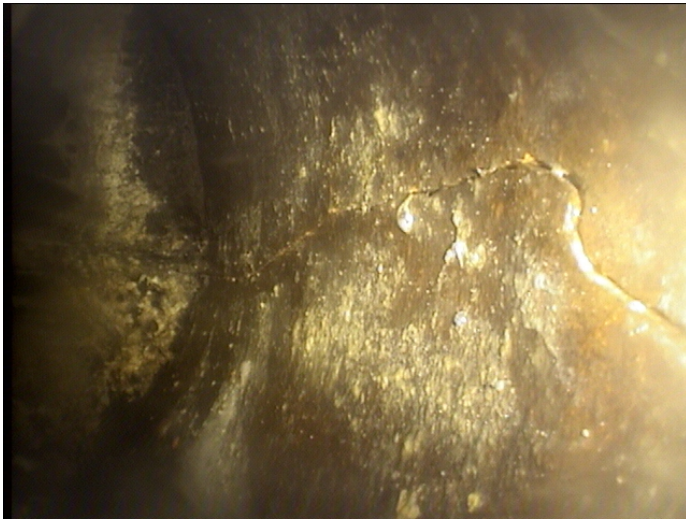
| Position | Code | Observation | Video (sec) | Grade |
|---|---|---|---|---|
| .0 | RMJ | Roots Medium Joint | 63 | M 3 |

Code: **RMJ**  
Description: **Roots Medium Joint**

Distance (ft): **.0**  
Structural Grade: **0**  
O&M Grade: **3**  
Clock Start/From: **9**  
Clock To: **3**  
1st Value:  
2nd Value:  
Value Percent: **30.000**  
Continuous Index:  
Within 8" of Joint: **YES**  
Remarks:

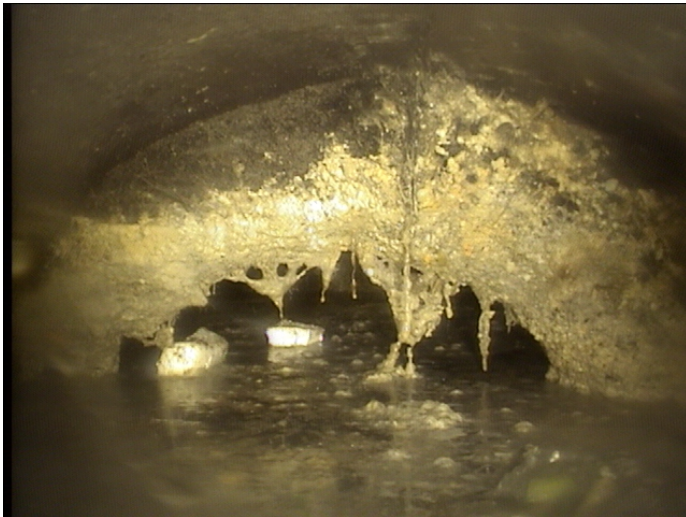
| Position | Code | Observation | Video (sec) | Grade |
|---|---|---|---|---|
| 3.2 | FL | Fracture Longitudinal | 146 | S 3 |

Code: **FL**  
Description: **Fracture Longitudinal**

Distance (ft): **3.2**  
Structural Grade: **3**  
O&M Grade: **0**  
Clock Start/From: **12**  
Clock To:  
1st Value:  
2nd Value:  
Value Percent:  
Continuous Index:  
Within 8" of Joint: **NO**  
Remarks:

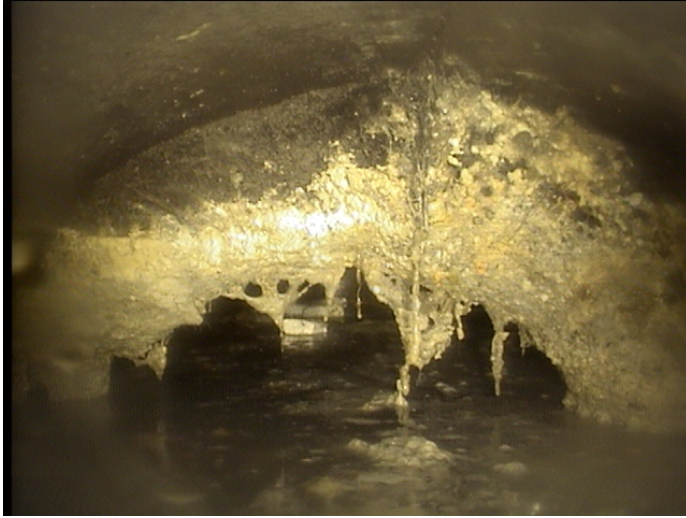
| Position | Code | Observation | Video (sec) | Grade |
|---|---|---|---|---|
| 3.6 | RMJ | Roots Medium Joint | 240 | M 3 |

Code: **RMJ**  
Description: **Roots Medium Joint**

Distance (ft): **3.6**  
Structural Grade: **0**  
O&M Grade: **3**  
Clock Start/From: **9**  
Clock To: **3**  
1st Value:  
2nd Value:  
Value Percent: **25.000**  
Continuous Index:  
Within 8" of Joint: **YES**  
Remarks:
