Profile/Photo Observation Report

Date:	04/11/2018	Weather:		Coding:	PACP 6.0
Pipe Length (ft):		Owner:	City of Hobart	Pre Clean:	Not Known
P.O.#:	233	Surveyor:	B. Helbling	PSR:	P-208-029-020
Customer:	City of Hobart	Clean Date:		Shape:	C

Street:	16th Street	Flow Control:	Not Controlled
City:	Hobart, IN	Year Renewed:	
Location:	Yard	Tape/Media #:	DEP233
Purpose:	Routine Assessment	Dia/Height:	21"
Use:	Sanitary	Material:	VCP
Drain Area:		Lining:	
Category:	NA		
Comment:	YES501824 Submittal 2		
Location Details:		Direction of Survey:	Upstream
US MH:	M-208-029	DS MH:	M-208-020
		Total Length Surveyed (ft):	30.9

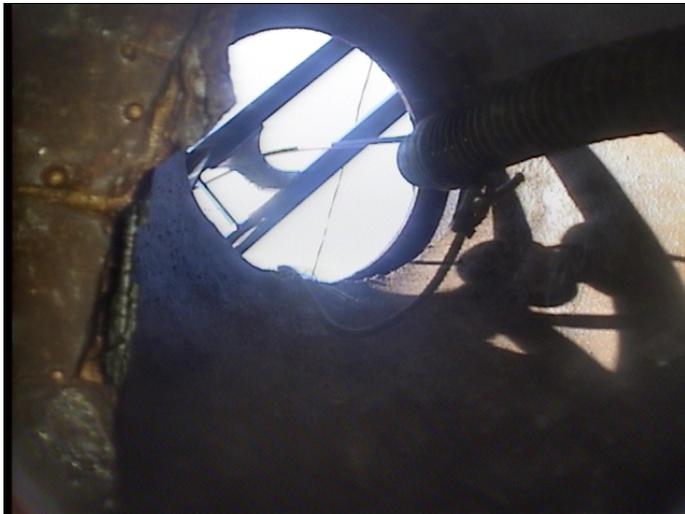
Code: **AMH**
Description: **Manhole**

Distance (ft): **.0**
Structural Grade: **0**
O&M Grade: **0**
Clock Start/From:
Clock To:
1st Value:
2nd Value:
Value Percent:
Continuous Index:
Within 8" of Joint: **NO**
Remarks: **M-208-020**

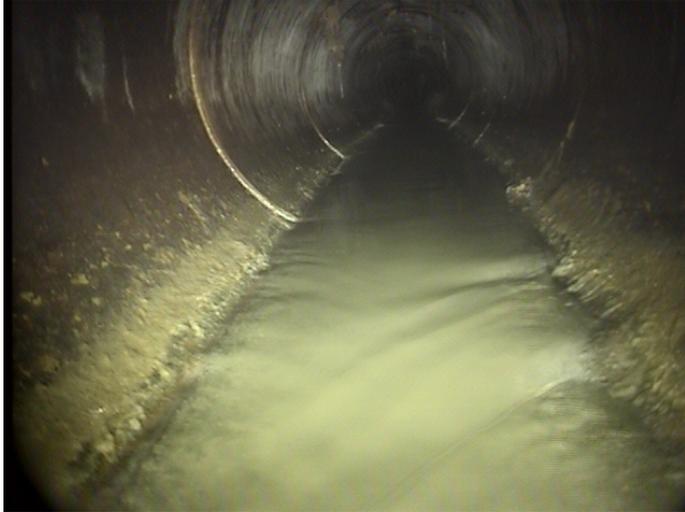
Code: **MWL**
Description: **Water Level**

Distance (ft): **.0**
Structural Grade: **0**
O&M Grade: **0**
Clock Start/From:
Clock To:
1st Value:
2nd Value:
Value Percent: **5.000**
Continuous Index:
Within 8" of Joint: **NO**
Remarks:

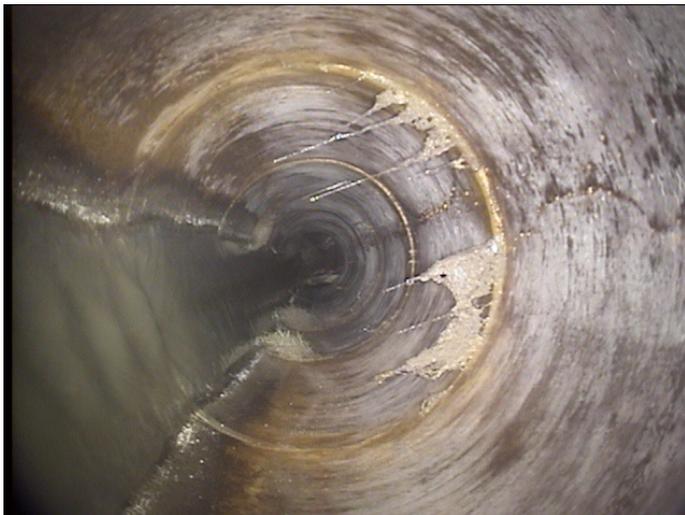
Code: **CL**
Description: **Crack Longitudinal**

Distance (ft): **8.3**
Structural Grade: **2**
O&M Grade: **0**
Clock Start/From: **12**
Clock To:
1st Value:
2nd Value:
Value Percent:
Continuous Index: **S01**
Within 8" of Joint: **NO**
Remarks:

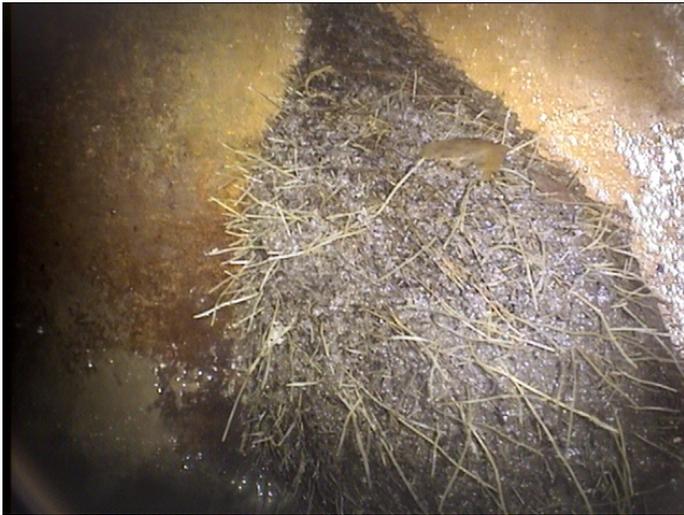
Code: **RFJ**
Description: **Roots Fine Joint**

Distance (ft): **12.3**
Structural Grade: **0**
O&M Grade: **1**
Clock Start/From: **3**
Clock To: **5**
1st Value:
2nd Value:
Value Percent:
Continuous Index:
Within 8" of Joint: **YES**
Remarks:

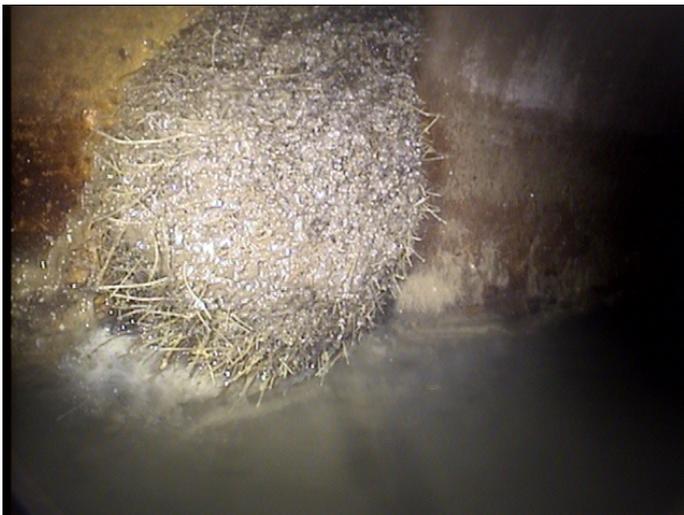
Code: **RFJ**
Description: **Roots Fine Joint**

Distance (ft): **14.9**
Structural Grade: **0**
O&M Grade: **1**
Clock Start/From: **9**
Clock To: **3**
1st Value:
2nd Value:
Value Percent:
Continuous Index:
Within 8" of Joint: **YES**
Remarks:

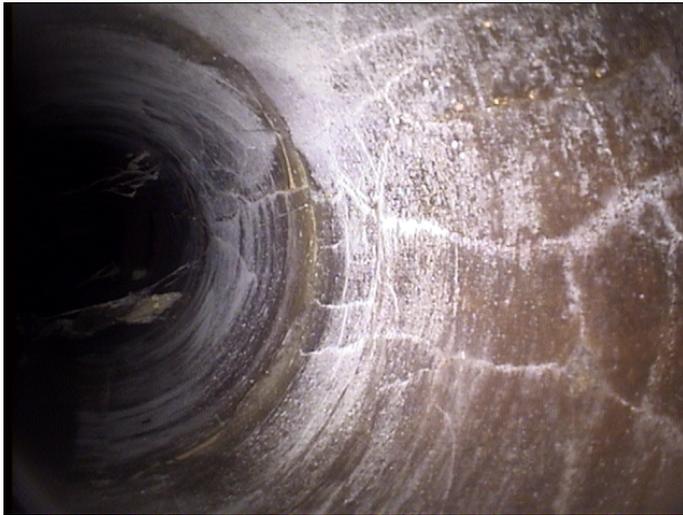
Code: **CL**
Description: **Crack Longitudinal**

Distance (ft): **21.8**
Structural Grade: **2**
O&M Grade: **0**
Clock Start/From: **12**
Clock To:
1st Value:
2nd Value:
Value Percent:
Continuous Index: **F01**
Within 8" of Joint: **NO**
Remarks:

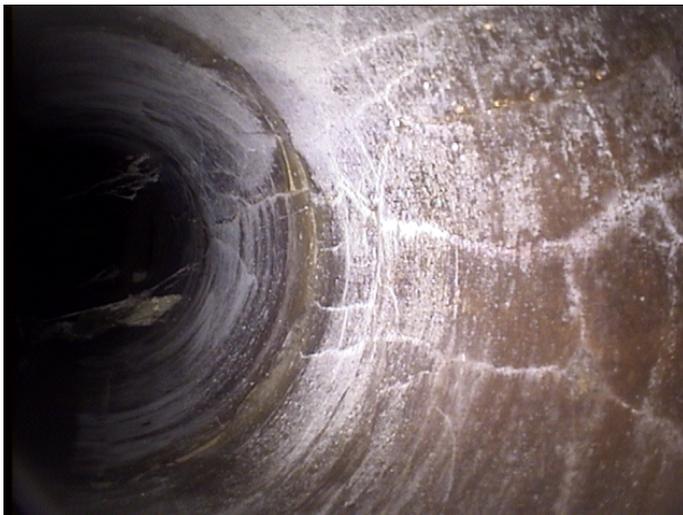
Code: **CM**
Description: **Crack Multiple**

Distance (ft): **21.8**
Structural Grade: **3**
O&M Grade: **0**
Clock Start/From: **10**
Clock To: **2**
1st Value:
2nd Value:
Value Percent:
Continuous Index: **S02**
Within 8" of Joint: **NO**
Remarks:

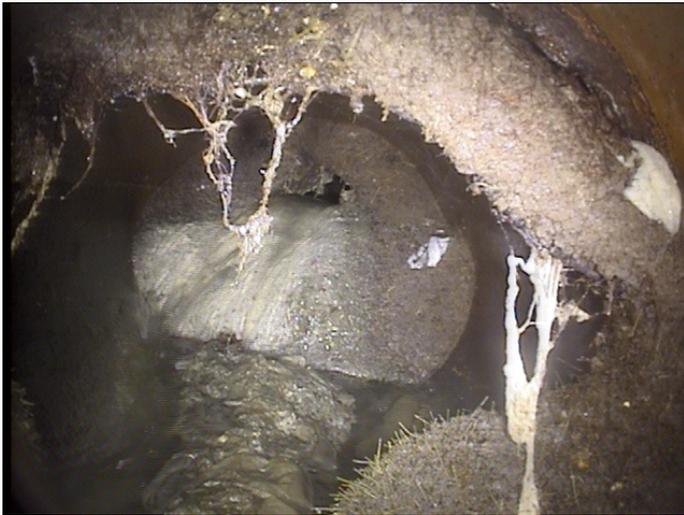
Code: **CM**
Description: **Crack Multiple**

Distance (ft): **29.0**
Structural Grade: **3**
O&M Grade: **0**
Clock Start/From: **10**
Clock To: **2**
1st Value:
2nd Value:
Value Percent:
Continuous Index: **F02**
Within 8" of Joint: **NO**
Remarks:

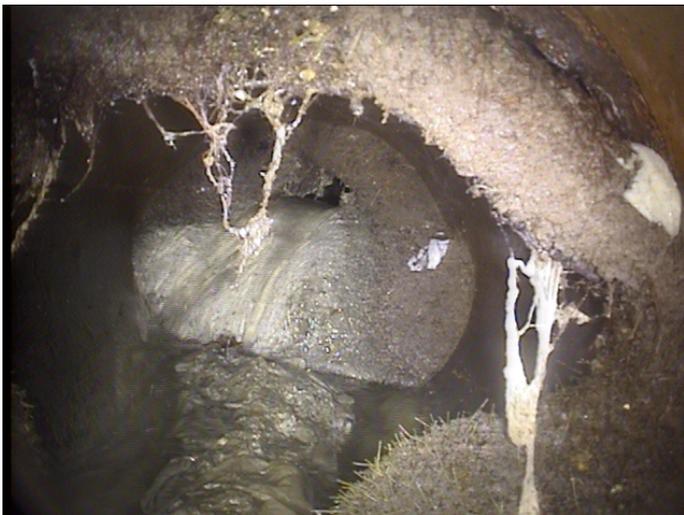
Code: **RMJ**
Description: **Roots Medium Joint**

Distance (ft): **29.0**
Structural Grade: **0**
O&M Grade: **3**
Clock Start/From: **8**
Clock To: **4**
1st Value:
2nd Value:
Value Percent: **15.000**
Continuous Index:
Within 8" of Joint: **YES**
Remarks:

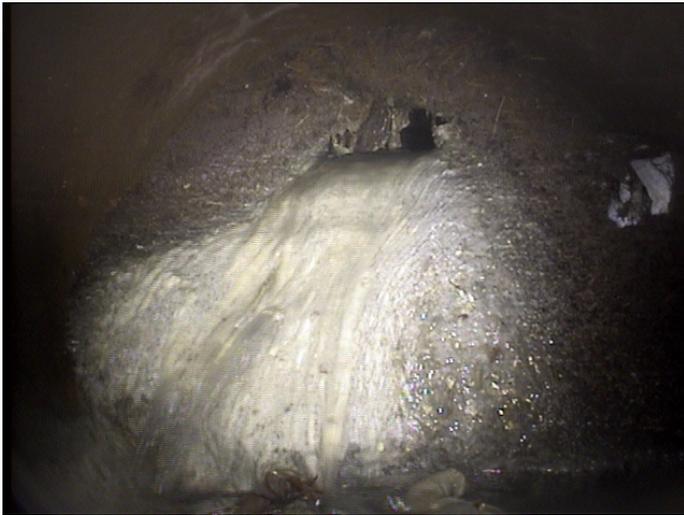
Code: **RBJ**
Description: **Roots Ball Joint**

Distance (ft): **30.9**
Structural Grade: **0**
O&M Grade: **4**
Clock Start/From: **1**
Clock To: **11**
1st Value:
2nd Value:
Value Percent: **90.000**
Continuous Index:
Within 8" of Joint: **YES**
Remarks:

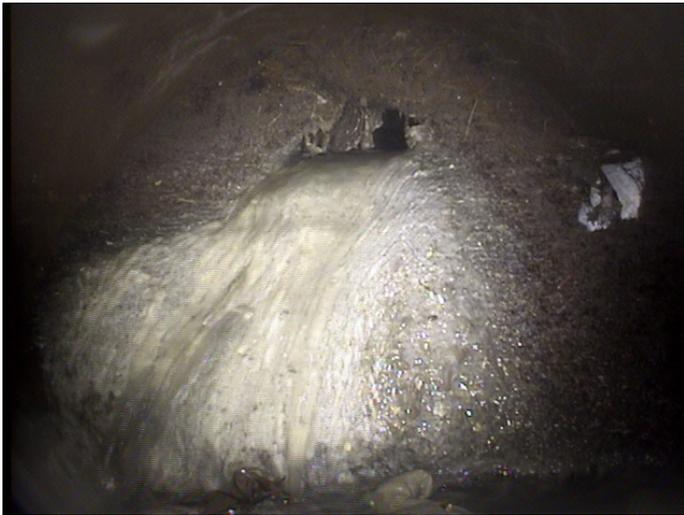
Code: **MSA**
Description: **Abandoned Survey**

Distance (ft): **30.9**
Structural Grade: **0**
O&M Grade: **0**
Clock Start/From:
Clock To:
1st Value:
2nd Value:
Value Percent:
Continuous Index:
Within 8" of Joint: **NO**
Remarks: **Rootball**
