Profile/Photo Observation Report

Date:	03/20/2018	Weather:		Coding:	PACP 6.0
Pipe Length (ft):	127.1	Owner:	NA	Pre Clean:	No Pre-Cleaning
P.O.#:		Surveyor:	John Kuglmaier	PSR:	P-209-004-005
Customer:		Clean Date:	01/01/1900	Shape:	C

Street:	E 62ND PL	Flow Control:	Not Controlled
City:	Hobart, IN	Year Renewed:	
Location:	Light Highway	Tape/Media #:	
Purpose:	Routine Assessment	Dia/Height:	10"
Use:	Sanitary	Material:	VCP
Drain Area:	NA	Lining:	
Category:	NA		
Comment:	P_C at 23 ft nothing visible . Flow direction wrong		
Location Details:		Direction of Survey:	Downstream
US MH:	M-209-005	DS MH:	M-209-004
		Total Length Surveyed (ft):	24.4

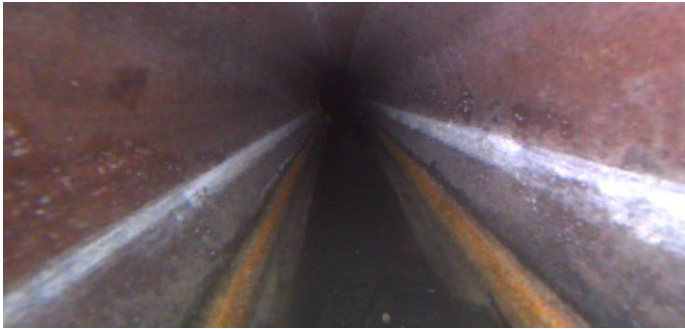
Code:	MWL
Description:	Water Level

Distance (ft):	.0
Structural Grade:	0
O&M Grade:	0
Clock Start/From:	
Clock To:	
1st Value:	
2nd Value:	
Value Percent:	10.000
Continuous Index:	
Within 8" of Joint:	NO
Remarks:

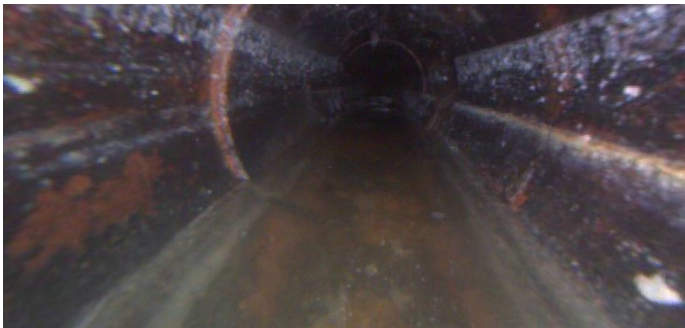
Code:	MWL
Description:	Water Level

Distance (ft):	10.1
Structural Grade:	0
O&M Grade:	0
Clock Start/From:	
Clock To:	
1st Value:	
2nd Value:	
Value Percent:	20.000
Continuous Index:	
Within 8" of Joint:	NO
Remarks:

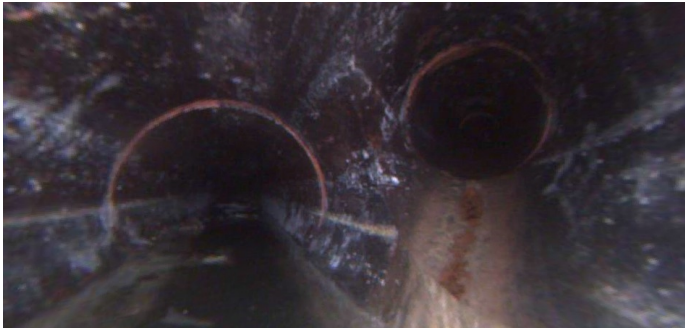
Code: **TF**
Description: **Tap Factory**

Distance (ft): **11.7**
Structural Grade: **0**
O&M Grade: **0**
Clock Start/From: **2**
Clock To:
1st Value: **4.000**
2nd Value:
Value Percent:
Continuous Index:
Within 8" of Joint:
Remarks:

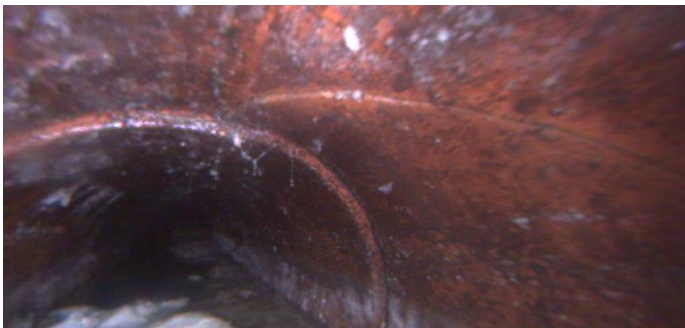
Code: **FS**
Description: **Fracture Spiral**

Distance (ft): **17.5**
Structural Grade: **3**
O&M Grade: **0**
Clock Start/From: **1**
Clock To: **2**
1st Value:
2nd Value:
Value Percent:
Continuous Index:
Within 8" of Joint: **YES**
Remarks:

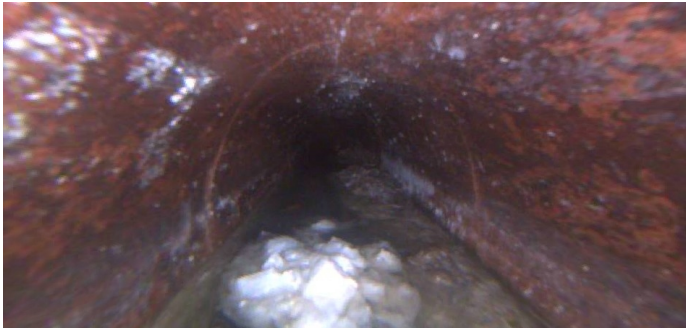
Code: **FM**
Description: **Fracture Multiple**

Distance (ft): **18.8**
Structural Grade: **4**
O&M Grade: **0**
Clock Start/From: **8**
Clock To: **4**
1st Value:
2nd Value:
Value Percent:
Continuous Index:
Within 8" of Joint:
Remarks:

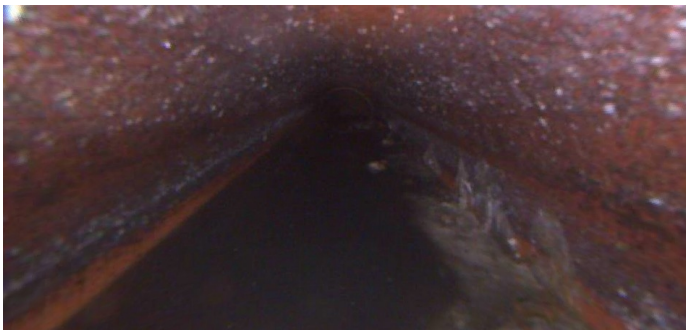
Code: **MSA**
Description: **Abandoned Survey**

Distance (ft): **24.4**
Structural Grade: **0**
O&M Grade: **0**
Clock Start/From:
Clock To:
1st Value:
2nd Value:
Value Percent:
Continuous Index:
Within 8" of Joint: **NO**
Remarks: **Unknown**
