Profile/Photo Observation Report

Date:	03/20/2018	Weather:		Coding:	PACP 6.0
Pipe Length (ft):	127.1	Owner:	NA	Pre Clean:	No Pre-Cleaning
P.O.#:		Surveyor:	John Kuglmaier	PSR:	P-209-004-005
Customer:		Clean Date:	01/01/1900	Shape:	C

Street:	FOXCROFT STREET	Flow Control:	Not Controlled
City:	Hobart, IN	Year Renewed:	
Location:	Light Highway	Tape/Media #:	
Purpose:	Routine Assessment	Dia/Height:	10"
Use:	Sanitary	Material:	VCP
Drain Area:	NA	Lining:	
Category:	NA		
Comment:	P_C at 23 ft nothing visible . Flow direction wrong		
Location Details:		Direction of Survey:	Downstream
US MH:	M-209-005	DS MH:	M-209-004
		Total Length Surveyed (ft):	24.4

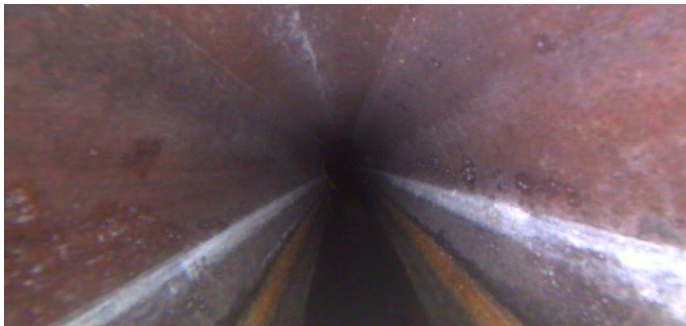
Code: **AMH**
Description: **Manhole**

Distance (ft): **.0**
Structural Grade: **0**
O&M Grade: **0**
Clock Start/From:
Clock To:
1st Value:
2nd Value:
Value Percent:
Continuous Index:
Within 8" of Joint: **NO**
Remarks: **M-209-005**

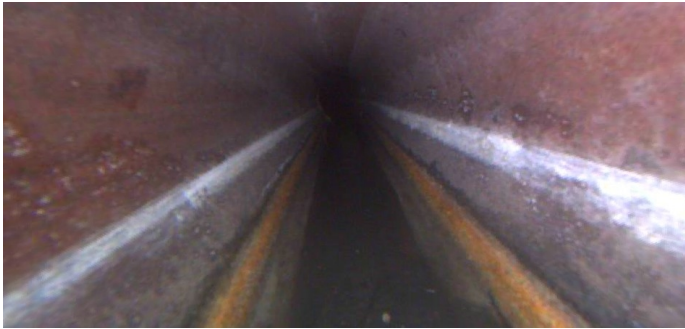
Code:	MWL
Description:	Water Level

Distance (ft):	.0
Structural Grade:	0
O&M Grade:	0
Clock Start/From:	
Clock To:	
1st Value:	
2nd Value:	
Value Percent:	10.000
Continuous Index:	
Within 8" of Joint:	NO
Remarks:

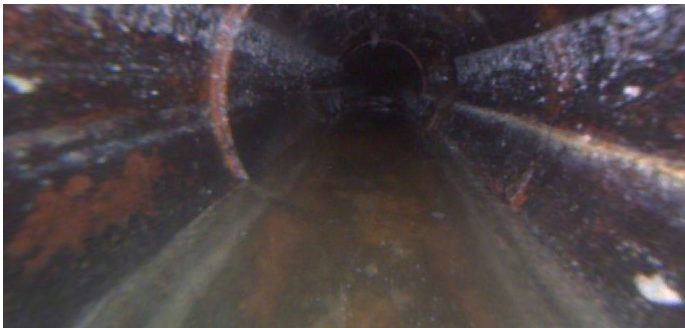
Code:	MWL
Description:	Water Level

Distance (ft):	10.1
Structural Grade:	0
O&M Grade:	0
Clock Start/From:	
Clock To:	
1st Value:	
2nd Value:	
Value Percent:	20.000
Continuous Index:	
Within 8" of Joint:	NO
Remarks:

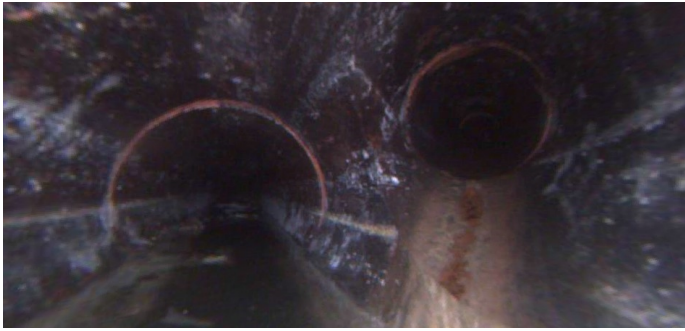
Code: **TF**
Description: **Tap Factory**

Distance (ft): **11.7**
Structural Grade: **0**
O&M Grade: **0**
Clock Start/From: **2**
Clock To:
1st Value: **4.000**
2nd Value:
Value Percent:
Continuous Index:
Within 8" of Joint:
Remarks:

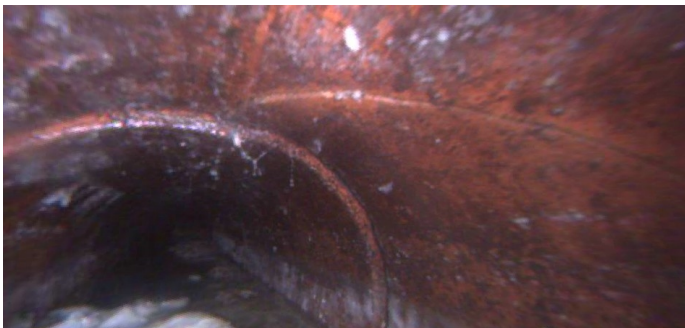
Code: **FS**
Description: **Fracture Spiral**

Distance (ft): **17.5**
Structural Grade: **3**
O&M Grade: **0**
Clock Start/From: **1**
Clock To: **2**
1st Value:
2nd Value:
Value Percent:
Continuous Index:
Within 8" of Joint: **YES**
Remarks:

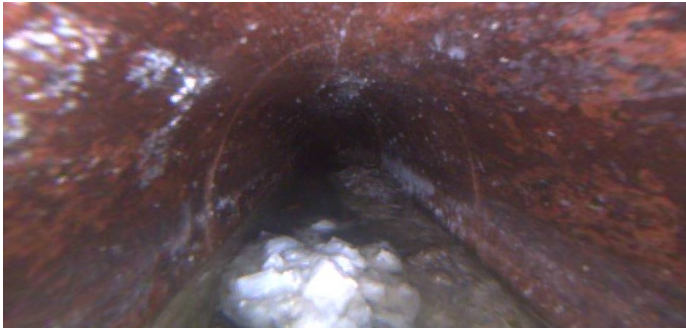
Code: **FM**
Description: **Fracture Multiple**

Distance (ft): **18.8**
Structural Grade: **4**
O&M Grade: **0**
Clock Start/From: **8**
Clock To: **4**
1st Value:
2nd Value:
Value Percent:
Continuous Index:
Within 8" of Joint:
Remarks:

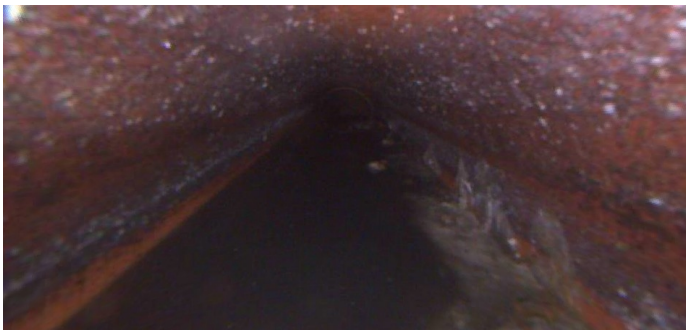
Code: **MSA**
Description: **Abandoned Survey**

Distance (ft): **24.4**
Structural Grade: **0**
O&M Grade: **0**
Clock Start/From:
Clock To:
1st Value:
2nd Value:
Value Percent:
Continuous Index:
Within 8" of Joint: **NO**
Remarks: **Unknown**
