## Profile/Photo Observation Report

Street:	<b>E 62ND PL &amp; MINNESOTA ST</b>	Flow Control:	<b>Not Controlled</b>
City:	<b>Hobart, IN</b>	Year Renewed:	
Location:	<b>Light Highway</b>	Tape/Media #:	
Purpose:	<b>Routine Assessment</b>	Dia/Height:	<b>10"</b>
Use:	<b>Sanitary</b>	Material:	<b>VCP</b>
Drain Area:	<b>NA</b>	Lining:	
Category:	<b>NA</b>		
Comment:	<b>False MH at 3 ft debris all over solo .Flow wrong</b>		
Location Details:		Direction of Survey:	<b>Downstream</b>
US MH:	<b>M-209-005</b>	DS MH:	<b>M-209-010</b>
		Total Length Surveyed (ft):	<b>4.1</b>

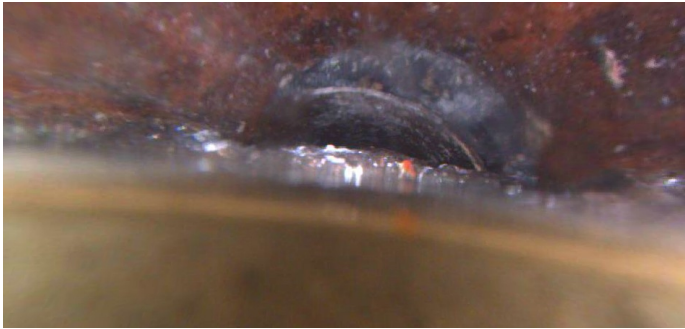
Code:	<b>MWL</b>
Description:	<b>Water Level</b>

Distance (ft):	<b>.0</b>
Structural Grade:	<b>0</b>
O&M Grade:	<b>0</b>
Clock Start/From:	
Clock To:	
1st Value:	
2nd Value:	
Value Percent:	<b>55.000</b>
Continuous Index:	
Within 8" of Joint:	<b>NO</b>
Remarks:
