Profile/Photo Observation Report

Street:	FOXCROFT STREET	Flow Control:	Not Controlled
City:	Hobart, IN	Year Renewed:	
Location:	Light Highway	Tape/Media #:	
Purpose:	Routine Assessment	Dia/Height:	10"
Use:	Sanitary	Material:	VCP
Drain Area:	NA	Lining:	
Category:	NA		
Comment:	False MH at 3 ft debris all over solo .Flow wrong		
Location Details:		Direction of Survey:	Downstream
US MH:	M-209-005	DS MH:	M-209-010
		Total Length Surveyed (ft):	4.1

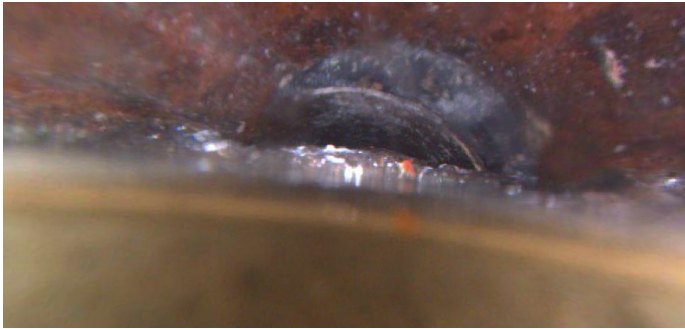
Code:	MWL
Description:	Water Level

Distance (ft):	.0
Structural Grade:	0
O&M Grade:	0
Clock Start/From:	
Clock To:	
1st Value:	
2nd Value:	
Value Percent:	55.000
Continuous Index:	
Within 8" of Joint:	NO
Remarks:
