## Profile/Photo Observation Report

| Street: | <b>E 62ND PL</b> | Flow Control: | <b>Not Controlled</b> |
| City: | <b>Hobart, IN</b> | Year Renewed: | |
| US MH: | <b>M-209-006</b> | DS MH: | <b>M-209-005</b> |

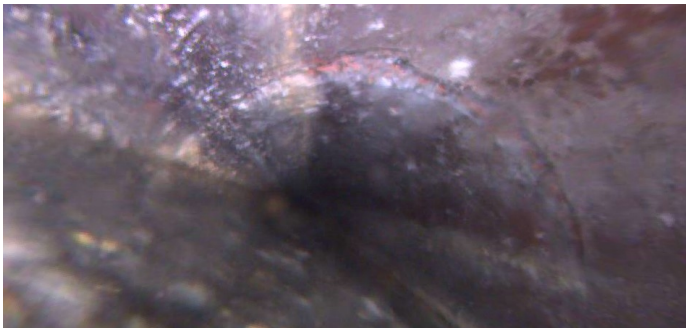
| Code: | <b>MSA</b> |

| Comment: | <b>F_S_R_M at 1 ft sludge and debris. Flow direction wrong</b> | | |

| Description: | <b>Abandoned Survey</b> |

| Distance (ft): | <b>3.0</b> |
