## Profile/Photo Observation Report

Date:	<b>03/20/2018</b>	Weather:		Coding:	<b>PACP 6.0</b>
Pipe Length (ft):	<b>307.9</b>	Owner:	<b>NA</b>	Pre Clean:	<b>No Pre-Cleaning</b>
P.O.#:		Surveyor:	<b>John Kuglmaier</b>	PSR:	<b>P-209-005-006</b>
Customer:		Clean Date:	<b>01/01/1900</b>	Shape:	<b>C</b>

Street:	<b>FOXCROFT STREET</b>	Flow Control:	<b>Not Controlled</b>
City:	<b>Hobart, IN</b>	Year Renewed:	
Location:	<b>Light Highway</b>	Tape/Media #:	
Purpose:	<b>Routine Assessment</b>	Dia/Height:	<b>10"</b>
Use:	<b>Sanitary</b>	Material:	<b>VCP</b>
Drain Area:	<b>NA</b>	Lining:	
Category:	<b>NA</b>		
Comment:	<b>F_S_R_M at 1 ft sludge and debris. Flow direction wrong</b>		
Location Details:		Direction of Survey:	<b>Upstream</b>
US MH:	<b>M-209-006</b>	DS MH:	<b>M-209-005</b>
		Total Length Surveyed (ft):	<b>3.0</b>

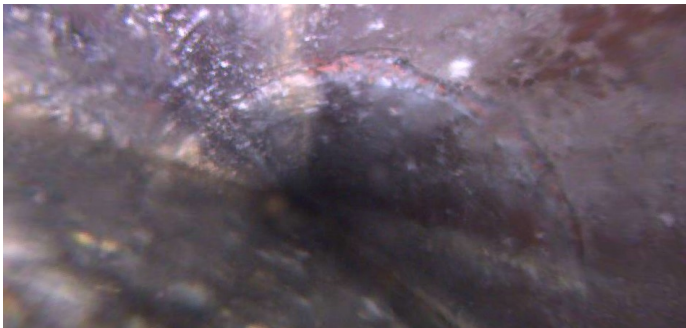
Code:	<b>MSA</b>
Description:	<b>Abandoned Survey</b>

Distance (ft):	<b>3.0</b>
Structural Grade:	<b>0</b>
O&M Grade:	<b>0</b>
Clock Start/From:	
Clock To:	
1st Value:	
2nd Value:	
Value Percent:	
Continuous Index:	
Within 8" of Joint:	<b>NO</b>
Remarks:	<b>Unknown</b>
