Profile/Photo Observation Report

Date:	03/20/2018	Weather:		Coding:	PACP 6.0
Pipe Length (ft):	269.8	Owner:	NA	Pre Clean:	No Pre-Cleaning
P.O.#:		Surveyor:	John Kuglmaier	PSR:	P-209-003-007
Customer:		Clean Date:	01/01/1900	Shape:	C

Street:	OFF E 61ST LN	Flow Control:	Not Controlled
City:	Hobart, IN	Year Renewed:	
Location:	Light Highway	Tape/Media #:	
Purpose:	Routine Assessment	Dia/Height:	10"
Use:	Sanitary	Material:	VCP
Drain Area:	NA	Lining:	
Category:	NA		
Comment:	P_C at 152 ft nothing visible. Flow direction wrong		
Location Details:		Direction of Survey:	Downstream
US MH:	M-209-007	DS MH:	M-209-003
		Total Length Surveyed (ft):	153.6

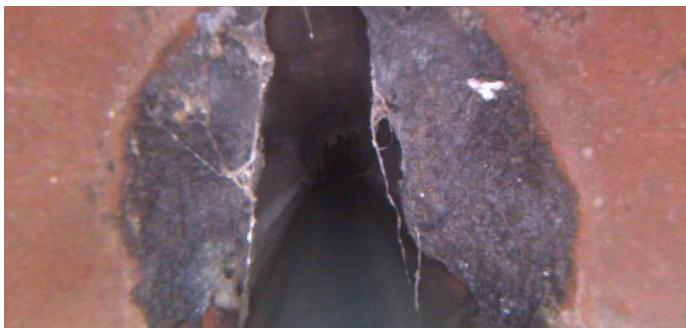
Code: **AMH**
Description: **Manhole**

Distance (ft): **.0**
Structural Grade: **0**
O&M Grade: **0**
Clock Start/From:
Clock To:
1st Value:
2nd Value:
Value Percent:
Continuous Index:
Within 8" of Joint: **NO**
Remarks: **M-209-007**

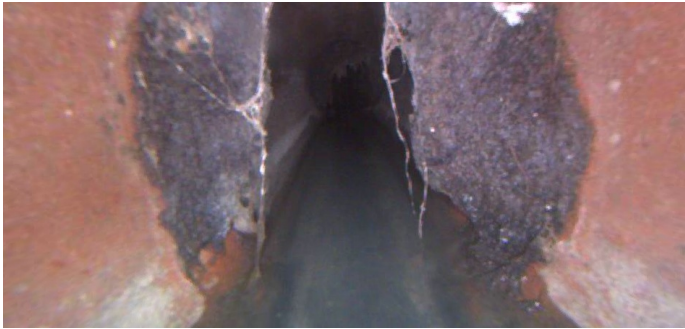
Code:	MWL
Description:	Water Level

Distance (ft):	.0
Structural Grade:	0
O&M Grade:	0
Clock Start/From:	
Clock To:	
1st Value:	
2nd Value:	
Value Percent:	15.000
Continuous Index:	
Within 8" of Joint:	NO
Remarks:

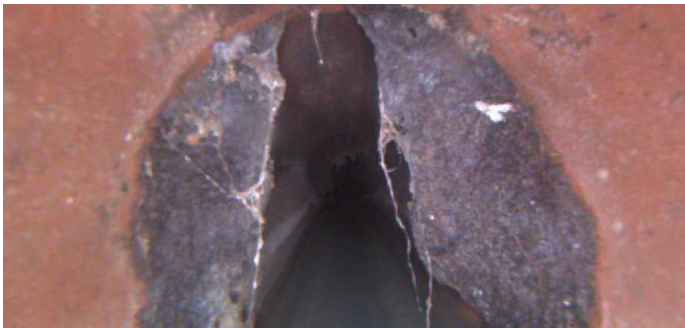
Code:	RMJ
Description:	Roots Medium Joint

Distance (ft):	.0
Structural Grade:	0
O&M Grade:	3
Clock Start/From:	8
Clock To:	4
1st Value:	
2nd Value:	
Value Percent:	40.000
Continuous Index:	S01
Within 8" of Joint:	YES
Remarks:

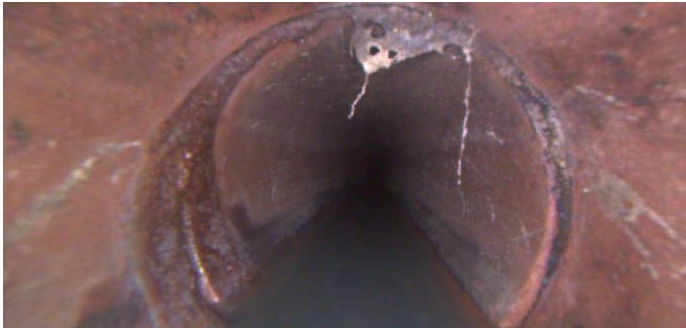
Code: **DAE**
Description: **Deposits Attached Encrustation**

Distance (ft): **8.9**
Structural Grade: **0**
O&M Grade: **2**
Clock Start/From: **8**
Clock To: **11**
1st Value:
2nd Value:
Value Percent: **5.000**
Continuous Index:
Within 8" of Joint: **YES**
Remarks:

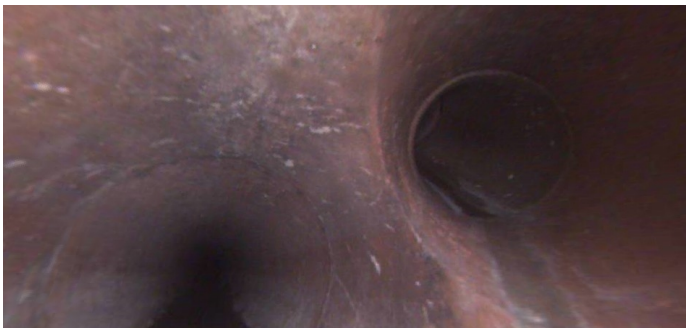
Code: **TF**
Description: **Tap Factory**

Distance (ft): **15.9**
Structural Grade: **0**
O&M Grade: **0**
Clock Start/From: **2**
Clock To:
1st Value: **4.000**
2nd Value:
Value Percent:
Continuous Index:
Within 8" of Joint:
Remarks:

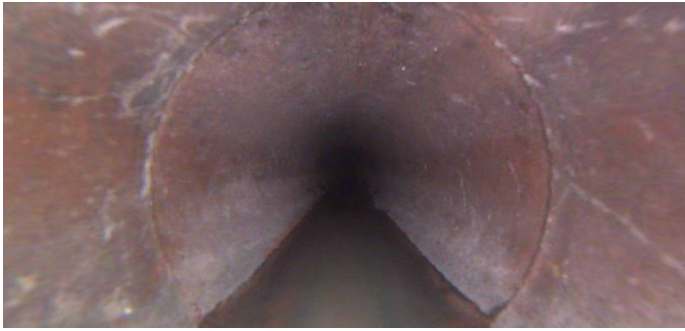
Code: **RMJ**
Description: **Roots Medium Joint**

Distance (ft): **16.4**
Structural Grade: **0**
O&M Grade: **3**
Clock Start/From: **8**
Clock To: **4**
1st Value:
2nd Value:
Value Percent: **40.000**
Continuous Index: **F01**
Within 8" of Joint: **YES**
Remarks: **Clock positions vary**

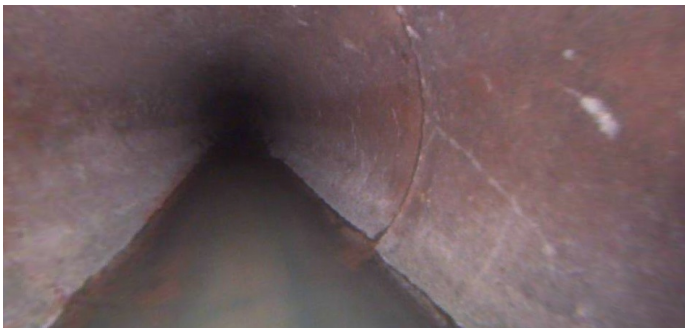
Code: **CS**
Description: **Crack Spiral**

Distance (ft): **16.4**
Structural Grade: **2**
O&M Grade: **0**
Clock Start/From: **3**
Clock To: **4**
1st Value:
2nd Value:
Value Percent:
Continuous Index:
Within 8" of Joint: **YES**
Remarks:

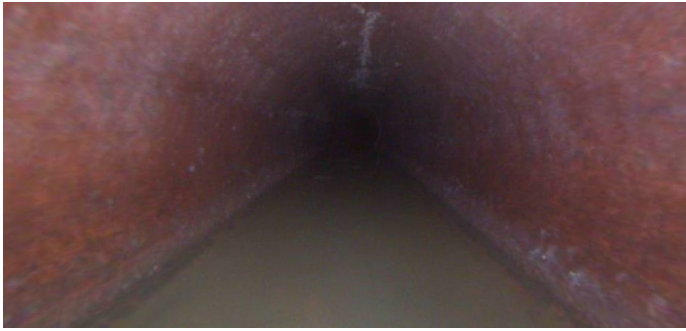
Code: **MWL**
Description: **Water Level**

Distance (ft): **54.8**
Structural Grade: **0**
O&M Grade: **0**
Clock Start/From:
Clock To:
1st Value:
2nd Value:
Value Percent: **25.000**
Continuous Index:
Within 8" of Joint: **NO**
Remarks:

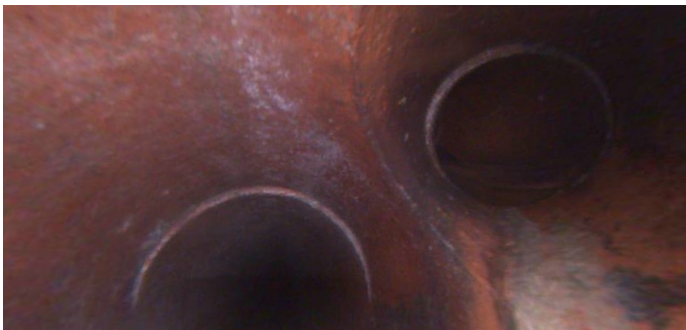
Code: **TF**
Description: **Tap Factory**

Distance (ft): **71.6**
Structural Grade: **0**
O&M Grade: **0**
Clock Start/From: **2**
Clock To:
1st Value: **4.000**
2nd Value:
Value Percent:
Continuous Index:
Within 8" of Joint:
Remarks:

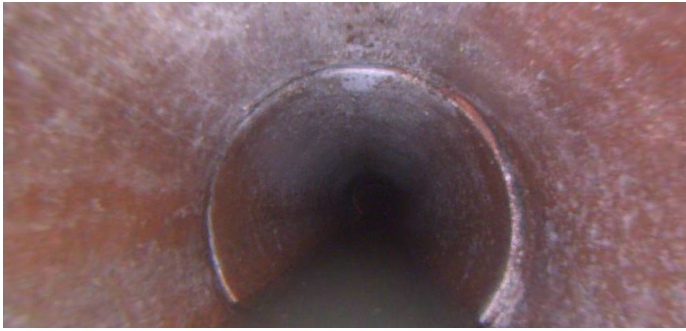
Code: **CL**
Description: **Crack Longitudinal**

Distance (ft): **125.1**
Structural Grade: **2**
O&M Grade: **0**
Clock Start/From: **10**
Clock To:
1st Value:
2nd Value:
Value Percent:
Continuous Index:
Within 8" of Joint: **YES**
Remarks:

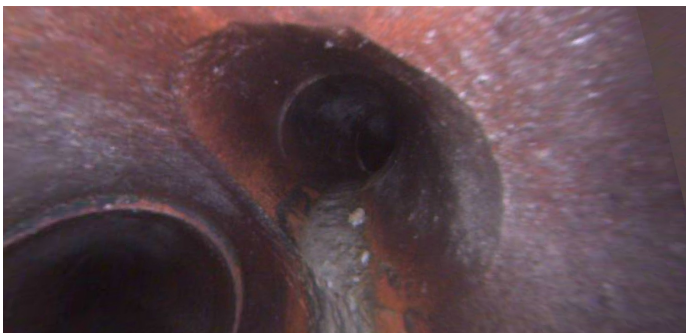
Code: **TF**
Description: **Tap Factory**

Distance (ft): **132.0**
Structural Grade: **0**
O&M Grade: **0**
Clock Start/From: **2**
Clock To:
1st Value: **4.000**
2nd Value:
Value Percent:
Continuous Index:
Within 8" of Joint:
Remarks:

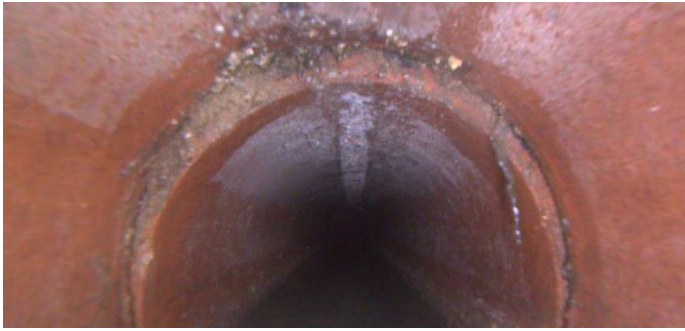
Code: **RFJ**
Description: **Roots Fine Joint**

Distance (ft): **138.1**
Structural Grade: **0**
O&M Grade: **1**
Clock Start/From: **11**
Clock To: **2**
1st Value:
2nd Value:
Value Percent:
Continuous Index: **S02**
Within 8" of Joint: **YES**
Remarks:

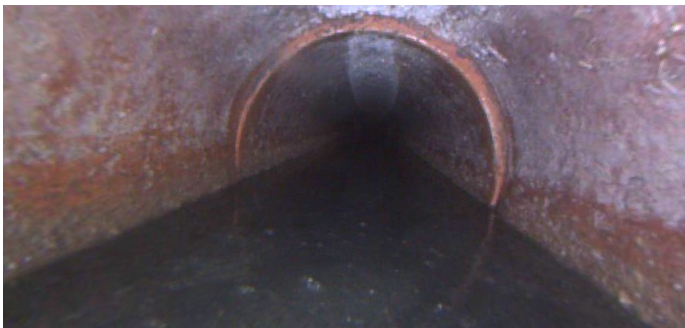
Code: **RFJ**
Description: **Roots Fine Joint**

Distance (ft): **153.6**
Structural Grade: **0**
O&M Grade: **1**
Clock Start/From: **11**
Clock To: **2**
1st Value:
2nd Value:
Value Percent:
Continuous Index: **F02**
Within 8" of Joint: **YES**
Remarks: **Clock positions vary**

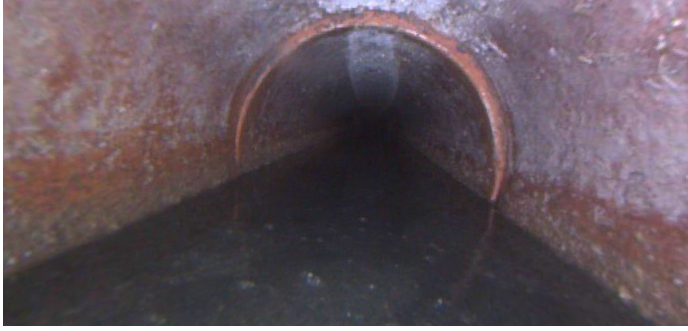
Code:	MSA
Description:	Abandoned Survey
Distance (ft):	153.6
Structural Grade:	0
O&M Grade:	0
Clock Start/From:	
Clock To:	
1st Value:	
2nd Value:	
Value Percent:	
Continuous Index:	
Within 8" of Joint:	NO
Remarks:	Unknown
