Profile/Photo Observation Report

Date:	03/20/2018	Weather:		Coding:	PACP 6.0
Pipe Length (ft):	269.8	Owner:	NA	Pre Clean:	No Pre-Cleaning
P.O.#:		Surveyor:	John Kuglmaier	PSR:	P-209-003-007
Customer:		Clean Date:	01/01/1900	Shape:	C

Street:	FOXCROFT STREET	Flow Control:	Not Controlled
City:	Hobart, IN	Year Renewed:	
Location:	Light Highway	Tape/Media #:	
Purpose:	Routine Assessment	Dia/Height:	10"
Use:	Sanitary	Material:	VCP
Drain Area:	NA	Lining:	
Category:	NA		
Comment:	P_C at 152 ft nothing visible. Flow direction wrong		
Location Details:		Direction of Survey:	Downstream
US MH:	M-209-007	DS MH:	M-209-003
		Total Length Surveyed (ft):	153.6

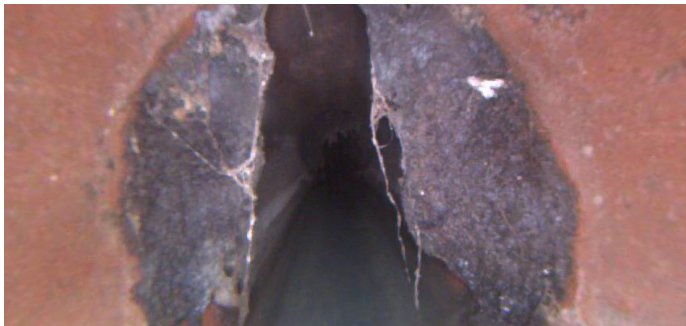
Code: **AMH**
Description: **Manhole**

Distance (ft): **.0**
Structural Grade: **0**
O&M Grade: **0**
Clock Start/From:
Clock To:
1st Value:
2nd Value:
Value Percent:
Continuous Index:
Within 8" of Joint: **NO**
Remarks: **M-209-007**

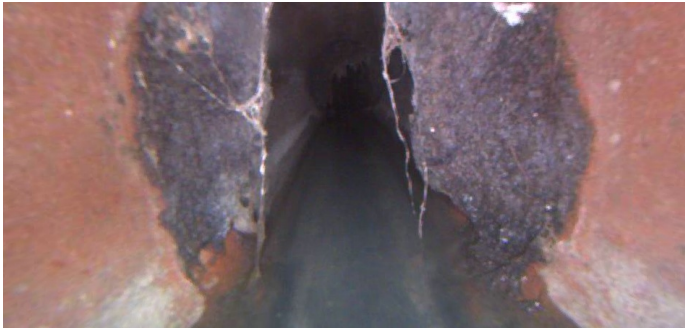
Code:	MWL
Description:	Water Level

Distance (ft):	.0
Structural Grade:	0
O&M Grade:	0
Clock Start/From:	
Clock To:	
1st Value:	
2nd Value:	
Value Percent:	15.000
Continuous Index:	
Within 8" of Joint:	NO
Remarks:

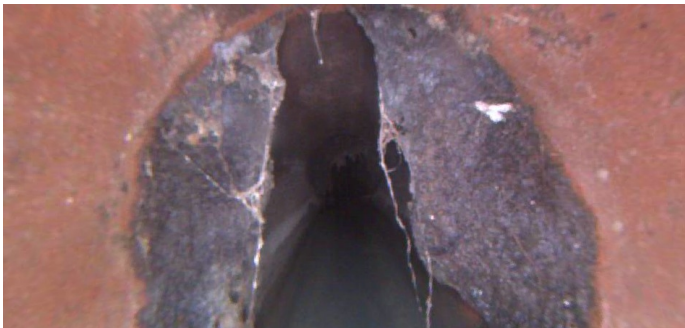
Code:	RMJ
Description:	Roots Medium Joint

Distance (ft):	.0
Structural Grade:	0
O&M Grade:	3
Clock Start/From:	8
Clock To:	4
1st Value:	
2nd Value:	
Value Percent:	40.000
Continuous Index:	S01
Within 8" of Joint:	YES
Remarks:

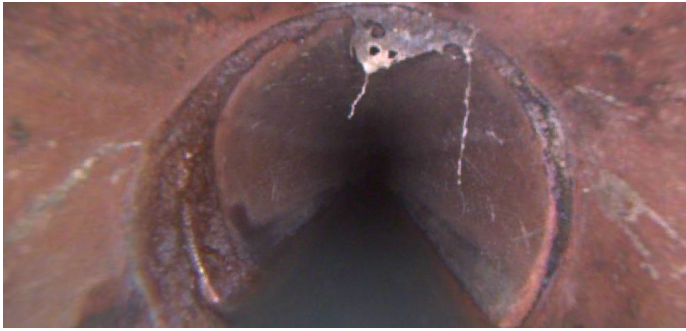
Code: **DAE**
Description: **Deposits Attached Encrustation**

Distance (ft): **8.9**
Structural Grade: **0**
O&M Grade: **2**
Clock Start/From: **8**
Clock To: **11**
1st Value:
2nd Value:
Value Percent: **5.000**
Continuous Index:
Within 8" of Joint: **YES**
Remarks:

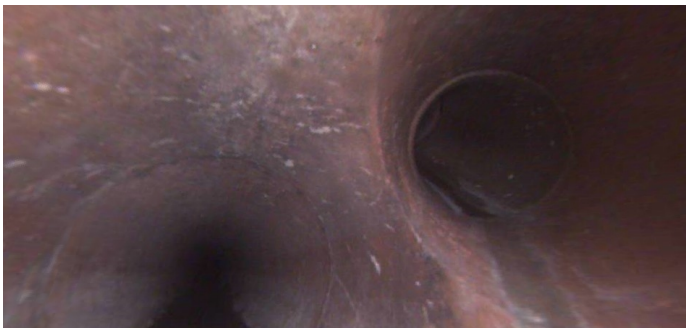
Code: **TF**
Description: **Tap Factory**

Distance (ft): **15.9**
Structural Grade: **0**
O&M Grade: **0**
Clock Start/From: **2**
Clock To:
1st Value: **4.000**
2nd Value:
Value Percent:
Continuous Index:
Within 8" of Joint:
Remarks:

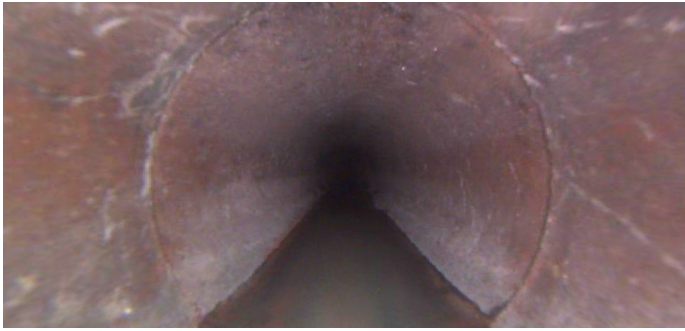
Code: **RMJ**
Description: **Roots Medium Joint**

Distance (ft): **16.4**
Structural Grade: **0**
O&M Grade: **3**
Clock Start/From: **8**
Clock To: **4**
1st Value:
2nd Value:
Value Percent: **40.000**
Continuous Index: **F01**
Within 8" of Joint: **YES**
Remarks: **Clock positions vary**

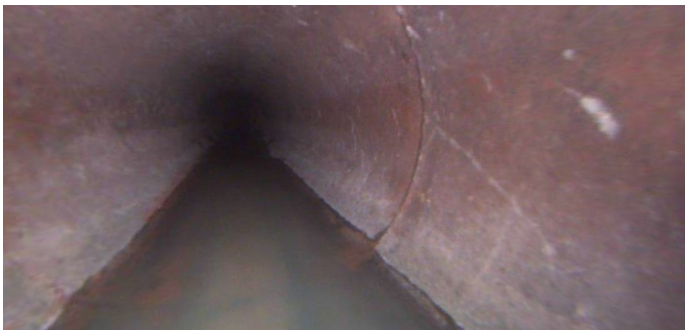
Code: **CS**
Description: **Crack Spiral**

Distance (ft): **16.4**
Structural Grade: **2**
O&M Grade: **0**
Clock Start/From: **3**
Clock To: **4**
1st Value:
2nd Value:
Value Percent:
Continuous Index:
Within 8" of Joint: **YES**
Remarks:

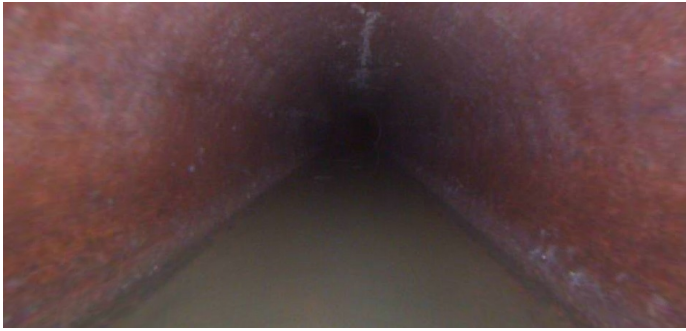
Code: **MWL**
Description: **Water Level**

Distance (ft): **54.8**
Structural Grade: **0**
O&M Grade: **0**
Clock Start/From:
Clock To:
1st Value:
2nd Value:
Value Percent: **25.000**
Continuous Index:
Within 8" of Joint: **NO**
Remarks:

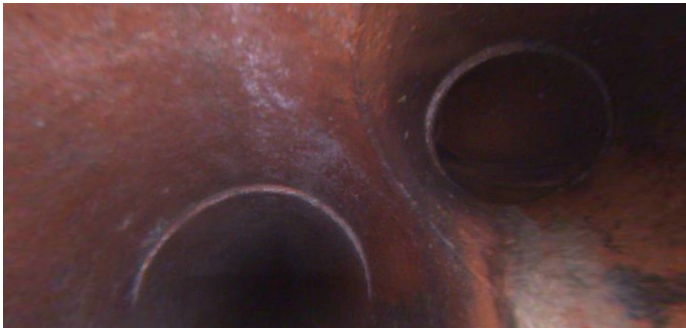
Code: **TF**
Description: **Tap Factory**

Distance (ft): **71.6**
Structural Grade: **0**
O&M Grade: **0**
Clock Start/From: **2**
Clock To:
1st Value: **4.000**
2nd Value:
Value Percent:
Continuous Index:
Within 8" of Joint:
Remarks:

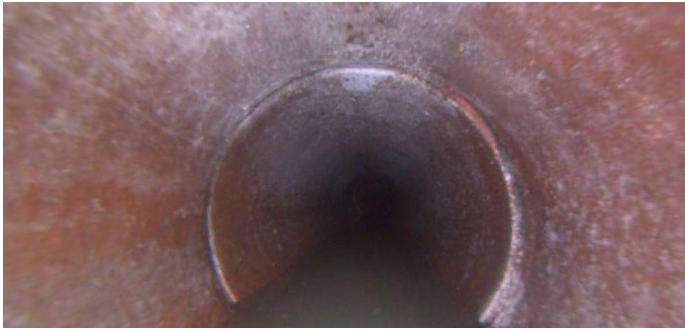
Code: **CL**
Description: **Crack Longitudinal**

Distance (ft): **125.1**
Structural Grade: **2**
O&M Grade: **0**
Clock Start/From: **10**
Clock To:
1st Value:
2nd Value:
Value Percent:
Continuous Index:
Within 8" of Joint: **YES**
Remarks:

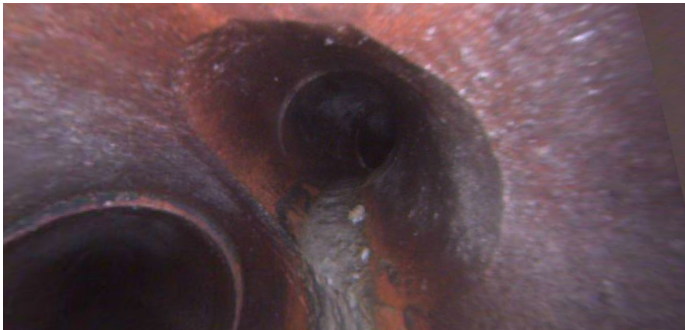
Code: **TF**
Description: **Tap Factory**

Distance (ft): **132.0**
Structural Grade: **0**
O&M Grade: **0**
Clock Start/From: **2**
Clock To:
1st Value: **4.000**
2nd Value:
Value Percent:
Continuous Index:
Within 8" of Joint:
Remarks:

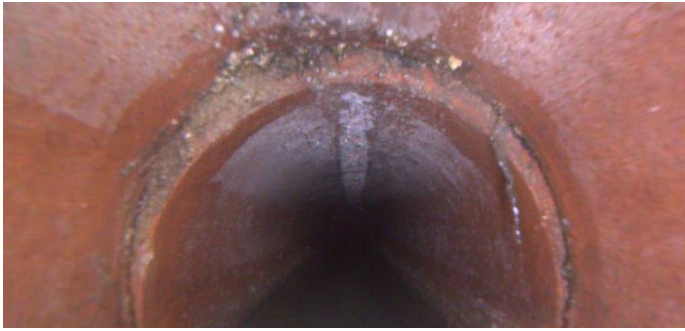
Code: **RFJ**
Description: **Roots Fine Joint**

Distance (ft): **138.1**
Structural Grade: **0**
O&M Grade: **1**
Clock Start/From: **11**
Clock To: **2**
1st Value:
2nd Value:
Value Percent:
Continuous Index: **S02**
Within 8" of Joint: **YES**
Remarks:

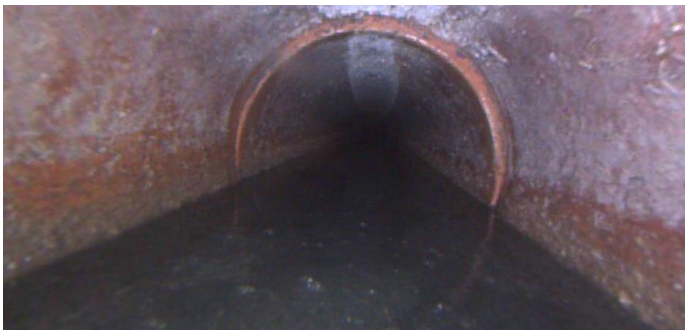
Code: **RFJ**
Description: **Roots Fine Joint**

Distance (ft): **153.6**
Structural Grade: **0**
O&M Grade: **1**
Clock Start/From: **11**
Clock To: **2**
1st Value:
2nd Value:
Value Percent:
Continuous Index: **F02**
Within 8" of Joint: **YES**
Remarks: **Clock positions vary**

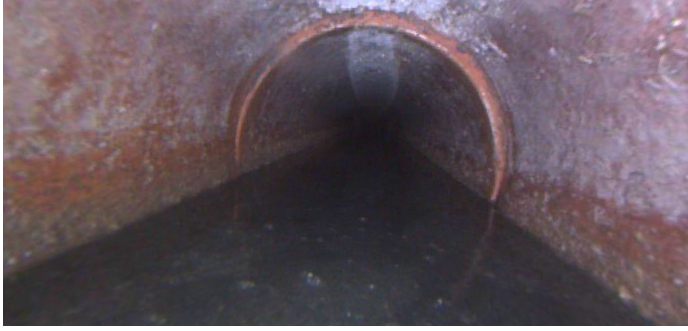
Code:	MSA
Description:	Abandoned Survey
Distance (ft):	153.6
Structural Grade:	0
O&M Grade:	0
Clock Start/From:	
Clock To:	
1st Value:	
2nd Value:	
Value Percent:	
Continuous Index:	
Within 8" of Joint:	NO
Remarks:	Unknown
