Profile/Photo Observation Report

Date:	03/20/2018	Weather:		Coding:	PACP 6.0
Pipe Length (ft):	322.9	Owner:	NA	Pre Clean:	No Pre-Cleaning
P.O.#:		Surveyor:	John Kuglmaier	PSR:	P-209-006-007
Customer:		Clean Date:	01/01/1900	Shape:	C

Street:	FOXCROFT STREET	Flow Control:	Not Controlled
City:	Hobart, IN	Year Renewed:	
Location:	Light Highway	Tape/Media #:	
Purpose:	Routine Assessment	Dia/Height:	10"
Use:	Sanitary	Material:	VCP
Drain Area:	NA	Lining:	
Category:	NA		
Comment:	P_C at 71 ft roots . Flow direction wrong		
Location Details:		Direction of Survey:	Downstream
US MH:	M-209-007	DS MH:	M-209-006
		Total Length Surveyed (ft):	72.3

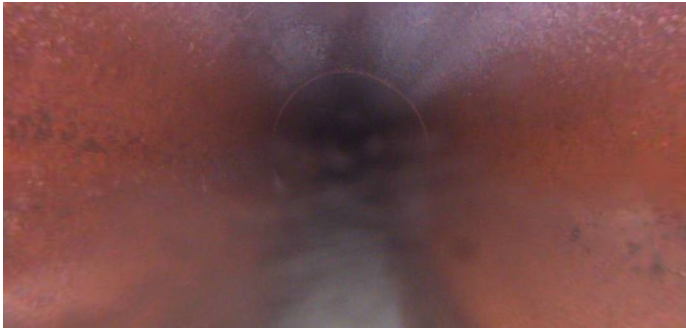
Code: **AMH**
Description: **Manhole**

Distance (ft): **.0**
Structural Grade: **0**
O&M Grade: **0**
Clock Start/From:
Clock To:
1st Value:
2nd Value:
Value Percent:
Continuous Index:
Within 8" of Joint: **NO**
Remarks: **M-209-007**

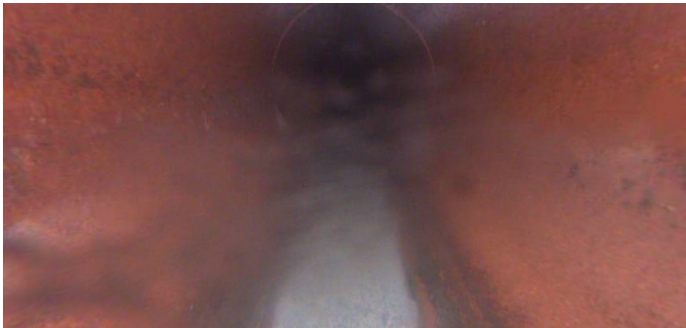
Code: **MWL**
Description: **Water Level**

Distance (ft): **.0**
Structural Grade: **0**
O&M Grade: **0**
Clock Start/From:
Clock To:
1st Value:
2nd Value:
Value Percent: **10.000**
Continuous Index:
Within 8" of Joint: **NO**
Remarks:

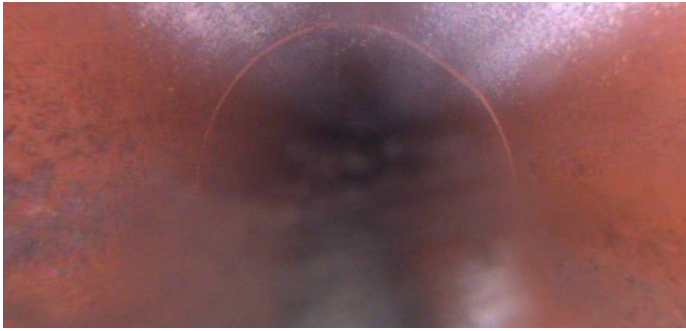
Code: **FC**
Description: **Fracture Circumferential**

Distance (ft): **1.9**
Structural Grade: **2**
O&M Grade: **0**
Clock Start/From: **7**
Clock To: **5**
1st Value:
2nd Value:
Value Percent:
Continuous Index:
Within 8" of Joint:
Remarks:

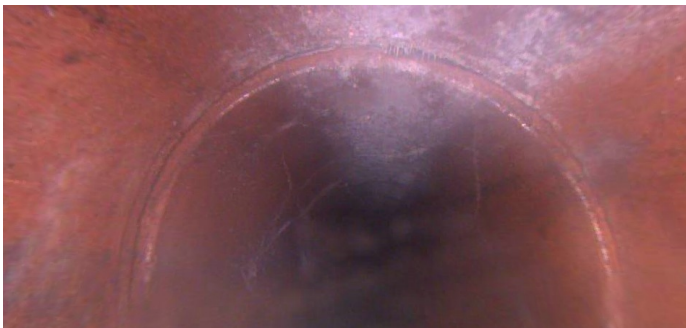
Code: **CM**
Description: **Crack Multiple**

Distance (ft): **4.4**
Structural Grade: **3**
O&M Grade: **0**
Clock Start/From: **9**
Clock To: **2**
1st Value:
2nd Value:
Value Percent:
Continuous Index:
Within 8" of Joint: **YES**
Remarks:

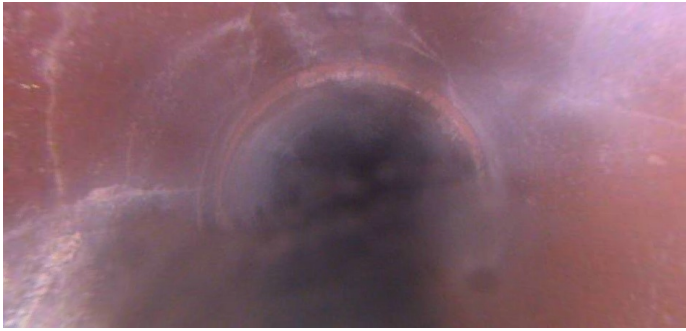
Code: **FM**
Description: **Fracture Multiple**

Distance (ft): **8.9**
Structural Grade: **4**
O&M Grade: **0**
Clock Start/From: **8**
Clock To: **3**
1st Value:
2nd Value:
Value Percent:
Continuous Index:
Within 8" of Joint: **YES**
Remarks:

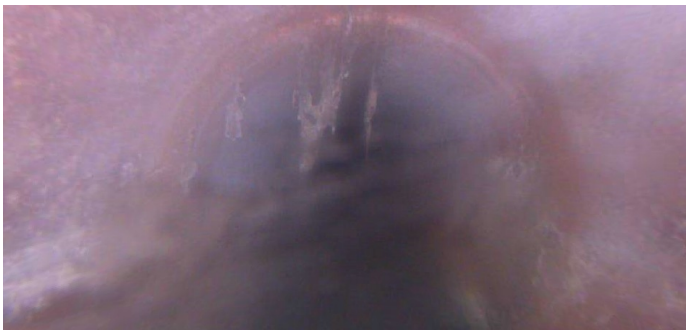
Code: **CM**
Description: **Crack Multiple**

Distance (ft): **14.2**
Structural Grade: **3**
O&M Grade: **0**
Clock Start/From: **8**
Clock To: **4**
1st Value:
2nd Value:
Value Percent:
Continuous Index:
Within 8" of Joint: **YES**
Remarks:

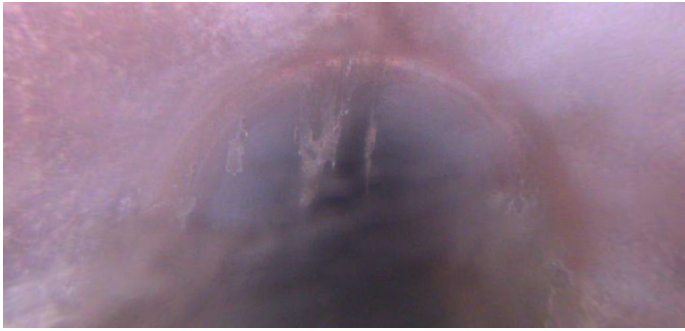
Code: **RFJ**
Description: **Roots Fine Joint**

Distance (ft): **14.2**
Structural Grade: **0**
O&M Grade: **1**
Clock Start/From: **11**
Clock To: **12**
1st Value:
2nd Value:
Value Percent:
Continuous Index:
Within 8" of Joint: **YES**
Remarks:

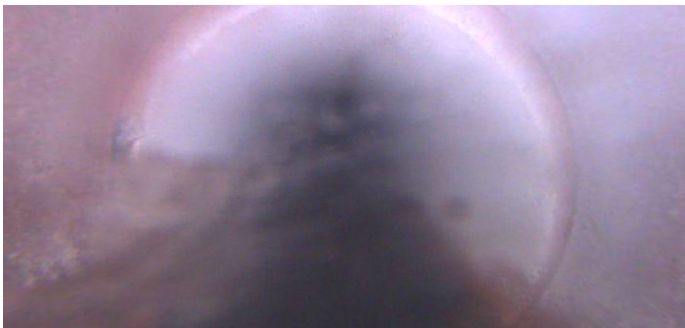
Code: **CM**
Description: **Crack Multiple**

Distance (ft): **19.4**
Structural Grade: **3**
O&M Grade: **0**
Clock Start/From: **9**
Clock To: **4**
1st Value:
2nd Value:
Value Percent:
Continuous Index:
Within 8" of Joint: **YES**
Remarks:

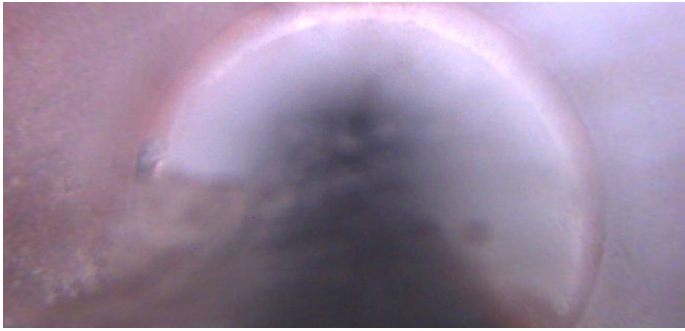
Code: **DAGS**
Description: **Deposits Attached Grease**

Distance (ft): **19.4**
Structural Grade: **0**
O&M Grade: **2**
Clock Start/From: **9**
Clock To: **4**
1st Value:
2nd Value:
Value Percent: **5.000**
Continuous Index: **S01**
Within 8" of Joint: **NO**
Remarks:

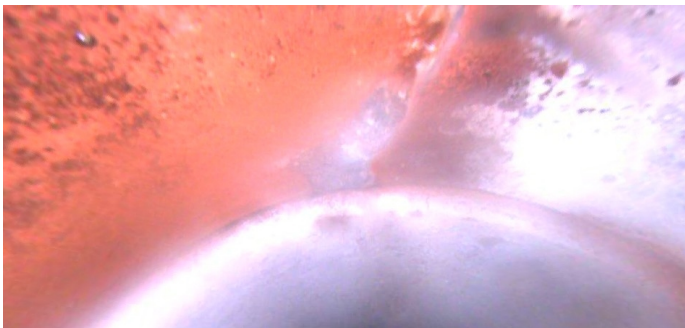
Code: **FL**
Description: **Fracture Longitudinal**

Distance (ft): **24.6**
Structural Grade: **3**
O&M Grade: **0**
Clock Start/From: **12**
Clock To:
1st Value:
2nd Value:
Value Percent:
Continuous Index:
Within 8" of Joint: **YES**
Remarks:

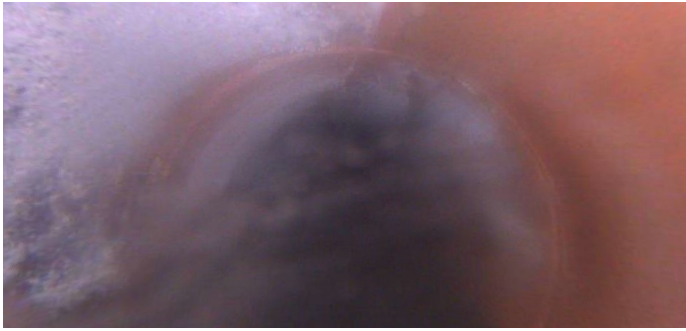
Code: **FM**
Description: **Fracture Multiple**

Distance (ft): **29.4**
Structural Grade: **4**
O&M Grade: **0**
Clock Start/From: **9**
Clock To: **1**
1st Value:
2nd Value:
Value Percent:
Continuous Index:
Within 8" of Joint: **YES**
Remarks:

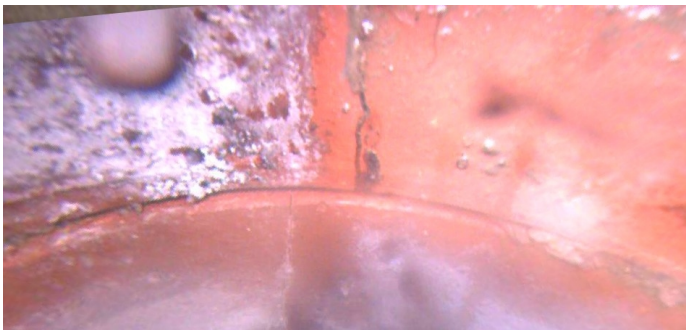
Code: **FL**
Description: **Fracture Longitudinal**

Distance (ft): **29.8**
Structural Grade: **3**
O&M Grade: **0**
Clock Start/From: **12**
Clock To:
1st Value:
2nd Value:
Value Percent:
Continuous Index:
Within 8" of Joint: **YES**
Remarks:

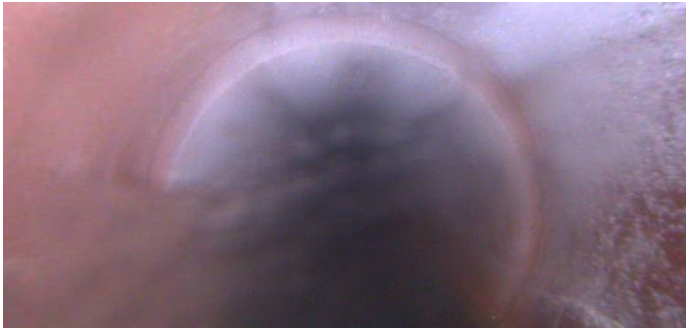
Code: **FM**
Description: **Fracture Multiple**

Distance (ft): **34.4**
Structural Grade: **4**
O&M Grade: **0**
Clock Start/From: **9**
Clock To: **4**
1st Value:
2nd Value:
Value Percent:
Continuous Index: **S02**
Within 8" of Joint: **YES**
Remarks:

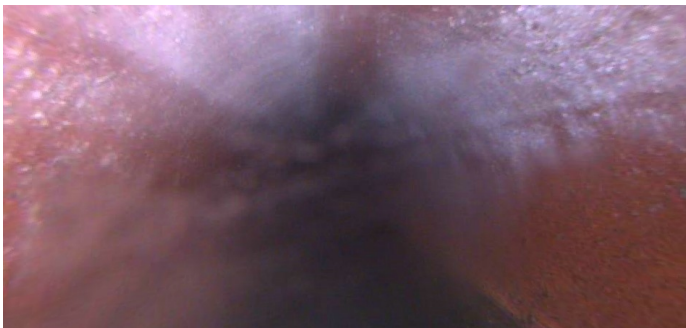
Code: **DAGS**
Description: **Deposits Attached Grease**

Distance (ft): **45.3**
Structural Grade: **0**
O&M Grade: **2**
Clock Start/From: **9**
Clock To: **4**
1st Value:
2nd Value:
Value Percent: **5.000**
Continuous Index: **F01**
Within 8" of Joint: **NO**
Remarks: **Clock positions vary**

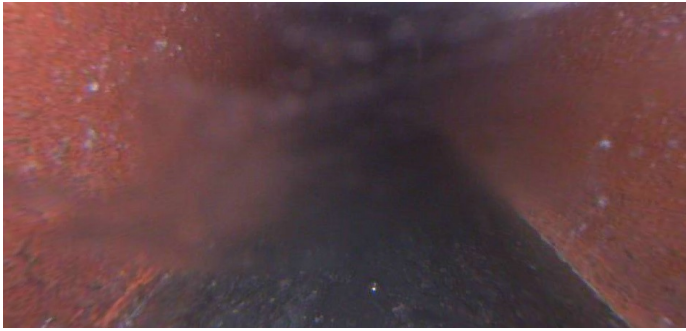
Code: **MWL**
Description: **Water Level**

Distance (ft): **47.3**
Structural Grade: **0**
O&M Grade: **0**
Clock Start/From:
Clock To:
1st Value:
2nd Value:
Value Percent: **20.000**
Continuous Index:
Within 8" of Joint: **NO**
Remarks:

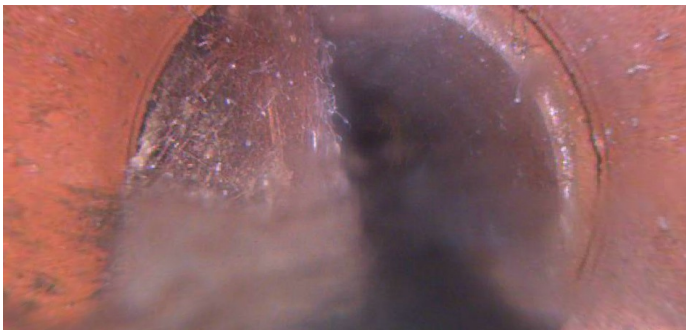
Code: **RMJ**
Description: **Roots Medium Joint**

Distance (ft): **49.5**
Structural Grade: **0**
O&M Grade: **3**
Clock Start/From: **6**
Clock To: **11**
1st Value:
2nd Value:
Value Percent: **50.000**
Continuous Index:
Within 8" of Joint: **YES**
Remarks:

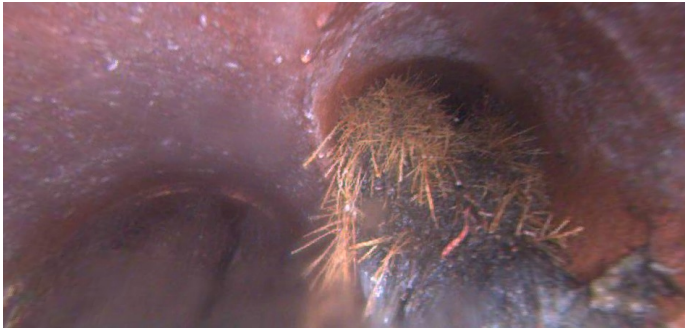
Code: **TFD**
Description: **Tap Factory Defective**

Distance (ft): **50.9**
Structural Grade: **0**
O&M Grade: **2**
Clock Start/From: **2**
Clock To:
1st Value: **4.000**
2nd Value:
Value Percent:
Continuous Index:
Within 8" of Joint:
Remarks: **Roots**

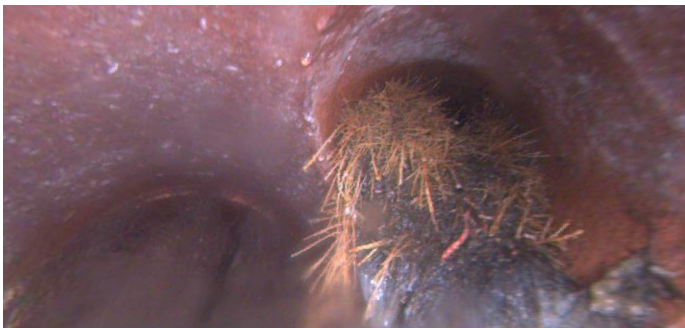
Code: **RML**
Description: **Roots Medium Lateral**

Distance (ft): **50.9**
Structural Grade: **0**
O&M Grade: **3**
Clock Start/From: **2**
Clock To:
1st Value:
2nd Value:
Value Percent: **50.000**
Continuous Index:
Within 8" of Joint: **NO**
Remarks:

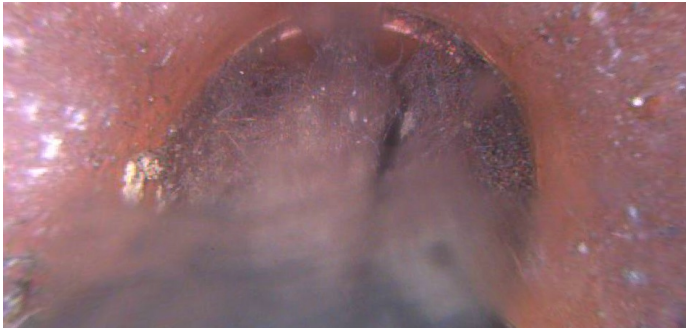
Code: **RBJ**
Description: **Roots Ball Joint**

Distance (ft): **51.4**
Structural Grade: **0**
O&M Grade: **4**
Clock Start/From: **8**
Clock To: **4**
1st Value:
2nd Value:
Value Percent: **80.000**
Continuous Index:
Within 8" of Joint: **YES**
Remarks:

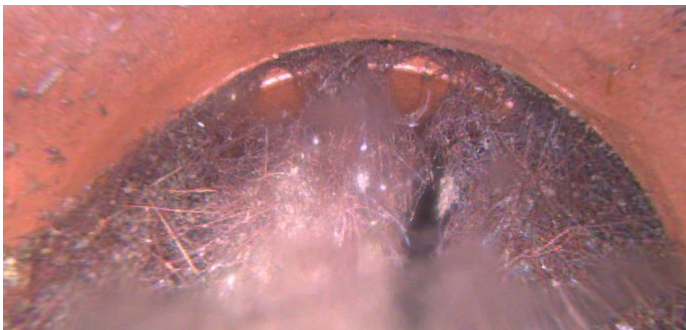
Code: **CM**
Description: **Crack Multiple**

Distance (ft): **51.6**
Structural Grade: **3**
O&M Grade: **0**
Clock Start/From: **9**
Clock To: **4**
1st Value:
2nd Value:
Value Percent:
Continuous Index: **F02**
Within 8" of Joint: **YES**
Remarks: **Clock positions vary**

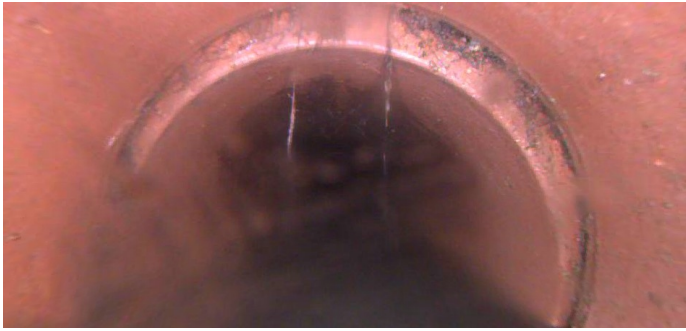
Code: **RFJ**
Description: **Roots Fine Joint**

Distance (ft): **61.6**
Structural Grade: **0**
O&M Grade: **1**
Clock Start/From: **8**
Clock To: **2**
1st Value:
2nd Value:
Value Percent:
Continuous Index:
Within 8" of Joint: **YES**
Remarks:

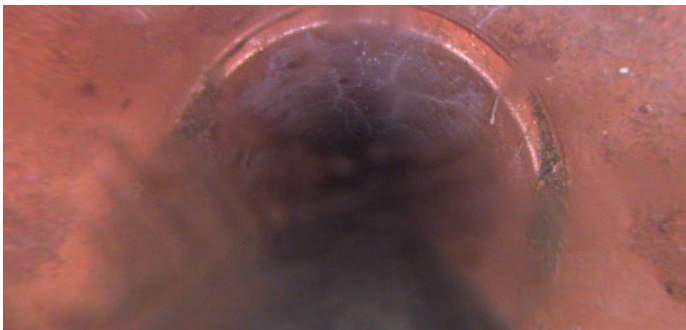
Code: **RFJ**
Description: **Roots Fine Joint**

Distance (ft): **66.5**
Structural Grade: **0**
O&M Grade: **1**
Clock Start/From: **3**
Clock To: **10**
1st Value:
2nd Value:
Value Percent:
Continuous Index:
Within 8" of Joint: **YES**
Remarks:

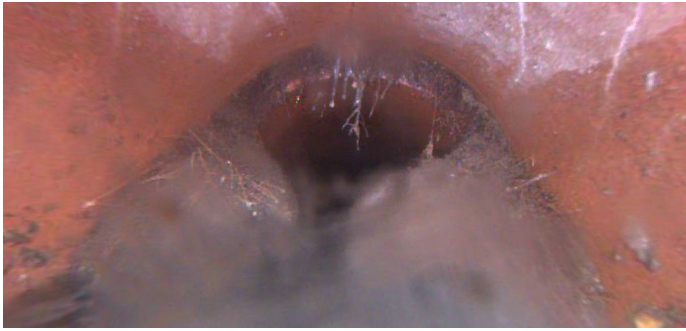
Code: **RMJ**
Description: **Roots Medium Joint**

Distance (ft): **71.4**
Structural Grade: **0**
O&M Grade: **3**
Clock Start/From: **9**
Clock To: **3**
1st Value:
2nd Value:
Value Percent: **40.000**
Continuous Index:
Within 8" of Joint: **YES**
Remarks:

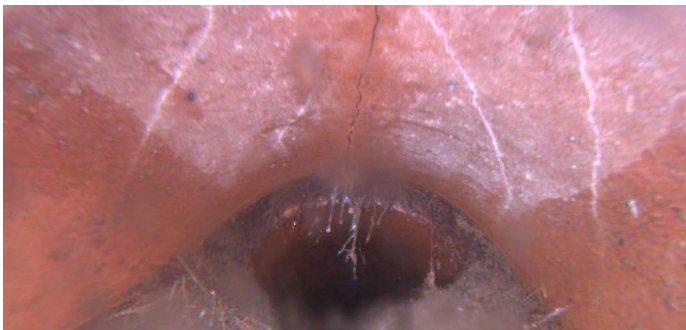
Code: **FM**
Description: **Fracture Multiple**

Distance (ft): **71.4**
Structural Grade: **4**
O&M Grade: **0**
Clock Start/From: **10**
Clock To: **2**
1st Value:
2nd Value:
Value Percent:
Continuous Index:
Within 8" of Joint: **YES**
Remarks:

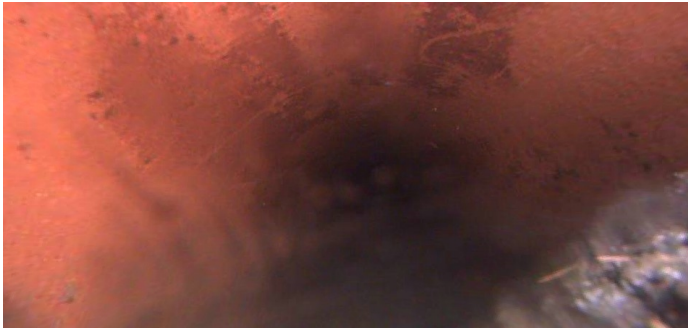
Code:	MSA
Description:	Abandoned Survey
Distance (ft):	72.3
Structural Grade:	0
O&M Grade:	0
Clock Start/From:	
Clock To:	
1st Value:	
2nd Value:	
Value Percent:	
Continuous Index:	
Within 8" of Joint:	NO
Remarks:	RMJ
