Profile/Photo Observation Report

Date:	03/19/2018	Weather:		Coding:	PACP 6.0
Pipe Length (ft):	151.7	Owner:	NA	Pre Clean:	No Pre-Cleaning
P.O.#:		Surveyor:	Byrd Fitzgerald	PSR:	P-209-007-008
Customer:		Clean Date:	01/01/1900	Shape:	C

Street:	OFF MINNESOTA ST	Flow Control:	Not Controlled
City:	Hobart, IN	Year Renewed:	
Location:	Light Highway	Tape/Media #:	
Purpose:	Routine Assessment	Dia/Height:	12"
Use:	Sanitary	Material:	VCP
Drain Area:	NA	Lining:	
Category:	NA		
Comment:	P_C at 229l ft past MH at 153 ft . flow direction wrong .		
Location Details:		Direction of Survey:	Upstream
US MH:	M-209-008	DS MH:	M-209-007
		Total Length Surveyed (ft):	230.8

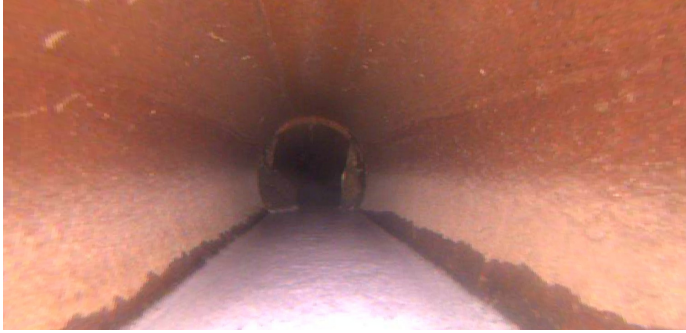
Code: **CM**
Description: **Crack Multiple**

Distance (ft): **.0**
Structural Grade: **3**
O&M Grade: **0**
Clock Start/From: **10**
Clock To: **2**
1st Value:
2nd Value:
Value Percent:
Continuous Index: **S01**
Within 8" of Joint: **YES**
Remarks: **wandering/into barrel**

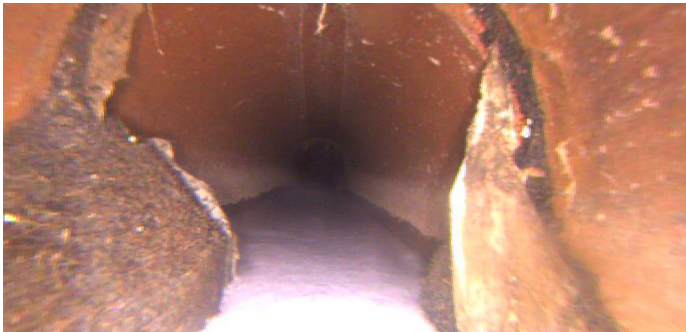
Code: **RMJ**
Description: **Roots Medium Joint**

Distance (ft): **3.3**
Structural Grade: **0**
O&M Grade: **3**
Clock Start/From: **7**
Clock To: **5**
1st Value:
2nd Value:
Value Percent: **15.000**
Continuous Index:
Within 8" of Joint: **YES**
Remarks:

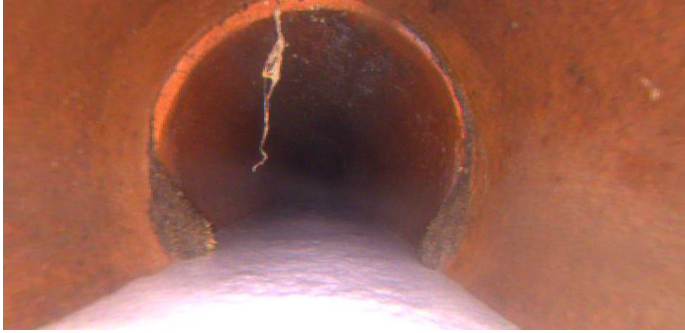
Code: **RFJ**
Description: **Roots Fine Joint**

Distance (ft): **11.4**
Structural Grade: **0**
O&M Grade: **1**
Clock Start/From: **7**
Clock To: **5**
1st Value:
2nd Value:
Value Percent:
Continuous Index: **S02**
Within 8" of Joint: **YES**
Remarks: **wandering**

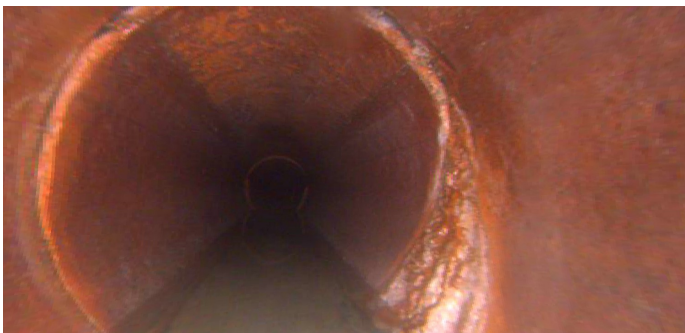
Code: **DAE**
Description: **Deposits Attached Encrustation**

Distance (ft): **110.7**
Structural Grade: **0**
O&M Grade: **2**
Clock Start/From: **3**
Clock To:
1st Value:
2nd Value:
Value Percent: **5.000**
Continuous Index: **S03**
Within 8" of Joint: **YES**
Remarks: **wandering**

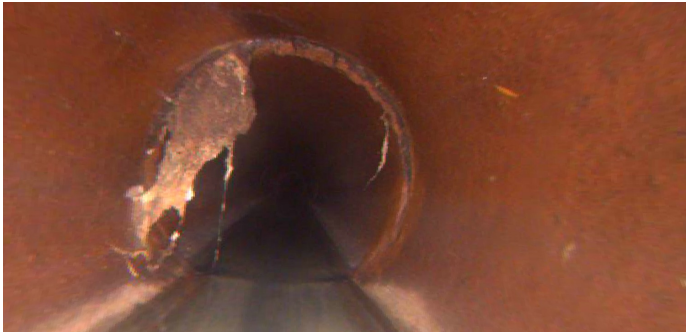
Code: **RMJ**
Description: **Roots Medium Joint**

Distance (ft): **135.8**
Structural Grade: **0**
O&M Grade: **3**
Clock Start/From: **11**
Clock To:
1st Value:
2nd Value:
Value Percent: **15.000**
Continuous Index:
Within 8" of Joint: **YES**
Remarks:

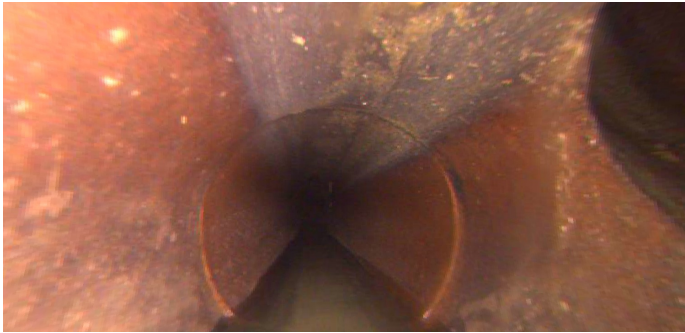
Code: **DAE**
Description: **Deposits Attached Encrustation**

Distance (ft): **146.5**
Structural Grade: **0**
O&M Grade: **2**
Clock Start/From: **3**
Clock To:
1st Value:
2nd Value:
Value Percent: **5.000**
Continuous Index: **F03**
Within 8" of Joint: **YES**
Remarks: **wandering**

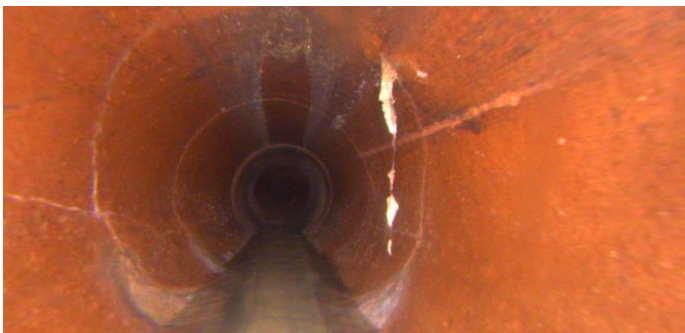
Code: **FM**
Description: **Fracture Multiple**

Distance (ft): **150.2**
Structural Grade: **4**
O&M Grade: **0**
Clock Start/From: **12**
Clock To: **12**
1st Value:
2nd Value:
Value Percent:
Continuous Index:
Within 8" of Joint:
Remarks:

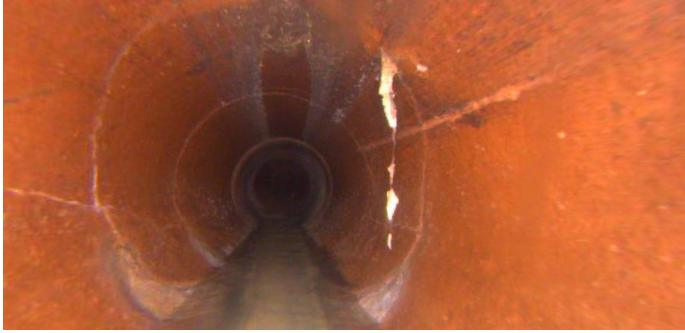
Code: **RFB**
Description: **Roots Fine Barrel**

Distance (ft): **150.2**
Structural Grade: **0**
O&M Grade: **2**
Clock Start/From: **2**
Clock To:
1st Value:
2nd Value:
Value Percent:
Continuous Index:
Within 8" of Joint: **NO**
Remarks:

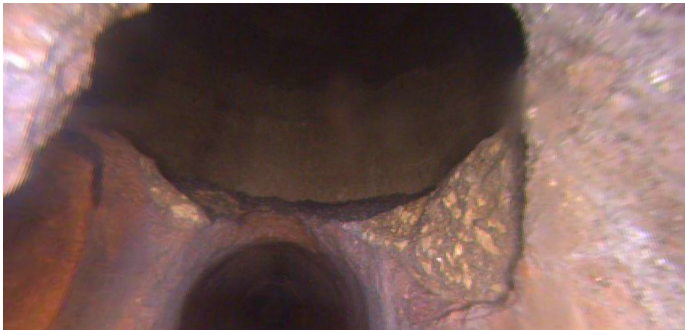
Code: **MGO**
Description: **General Observation**

Distance (ft): **153.2**
Structural Grade: **0**
O&M Grade: **0**
Clock Start/From:
Clock To:
1st Value:
2nd Value:
Value Percent:
Continuous Index:
Within 8" of Joint: **NO**
Remarks: **unidentified access point**

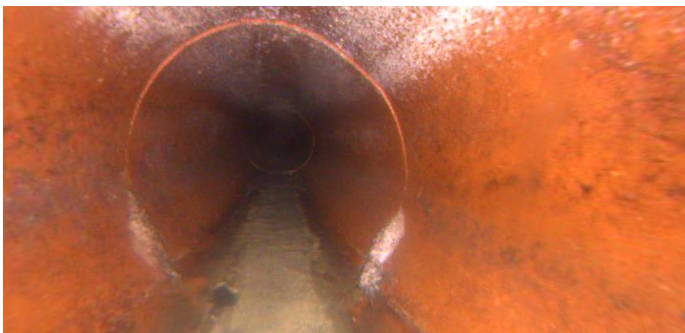
Code: **FC**
Description: **Fracture Circumferential**

Distance (ft): **156.6**
Structural Grade: **2**
O&M Grade: **0**
Clock Start/From: **12**
Clock To: **12**
1st Value:
2nd Value:
Value Percent:
Continuous Index:
Within 8" of Joint:
Remarks:

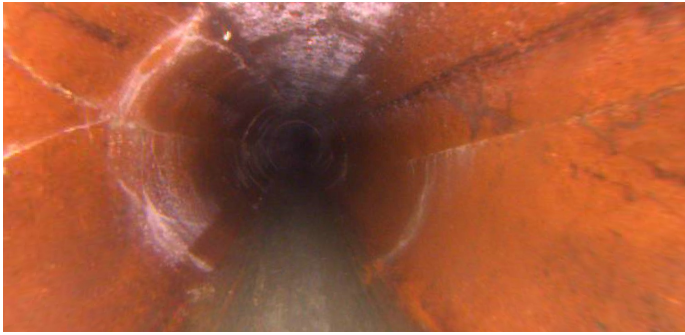
Code: **FM**
Description: **Fracture Multiple**

Distance (ft): **160.8**
Structural Grade: **4**
O&M Grade: **0**
Clock Start/From: **8**
Clock To: **4**
1st Value:
2nd Value:
Value Percent:
Continuous Index: **S05**
Within 8" of Joint: **YES**
Remarks:

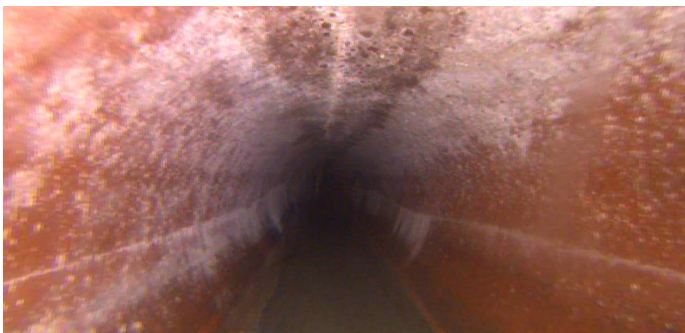
Code: **CH3**
Description: **Crack Longitudinal Hinge, 3**

Distance (ft): **167.2**
Structural Grade: **5**
O&M Grade: **0**
Clock Start/From: **9**
Clock To: **3**
1st Value:
2nd Value:
Value Percent:
Continuous Index: **S04**
Within 8" of Joint:
Remarks:

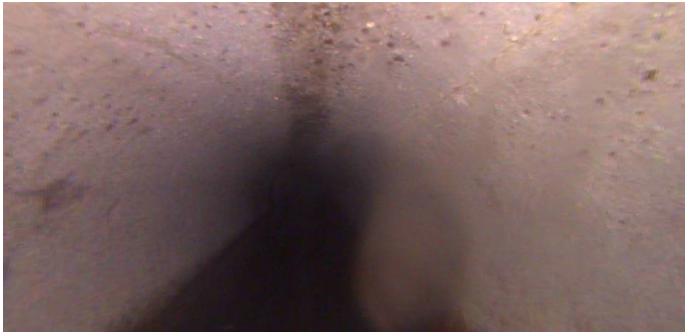
Code: **CH3**
Description: **Crack Longitudinal Hinge, 3**

Distance (ft): **177.1**
Structural Grade: **5**
O&M Grade: **0**
Clock Start/From: **9**
Clock To: **3**
1st Value:
2nd Value:
Value Percent:
Continuous Index: **F04**
Within 8" of Joint:
Remarks:

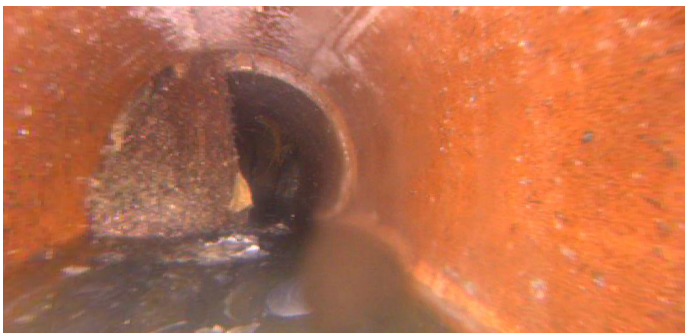
Code: **RBJ**
Description: **Roots Ball Joint**

Distance (ft): **206.3**
Structural Grade: **0**
O&M Grade: **4**
Clock Start/From: **6**
Clock To: **12**
1st Value:
2nd Value:
Value Percent: **55.000**
Continuous Index:
Within 8" of Joint: **YES**
Remarks:

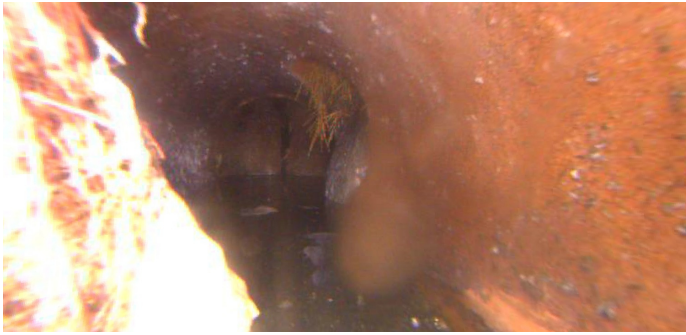
Code: **FM**
Description: **Fracture Multiple**

Distance (ft): **207.5**
Structural Grade: **4**
O&M Grade: **0**
Clock Start/From: **8**
Clock To: **4**
1st Value:
2nd Value:
Value Percent:
Continuous Index: **F05**
Within 8" of Joint: **YES**
Remarks:

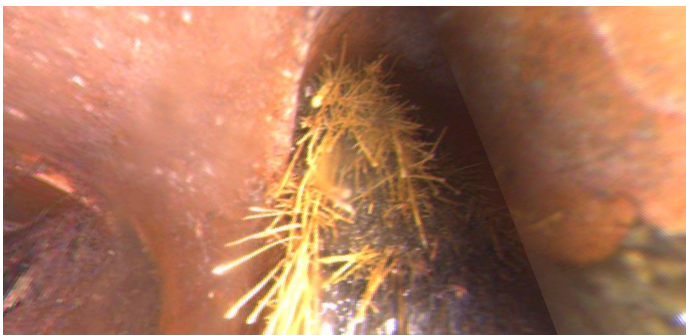
Code: **TFD**
Description: **Tap Factory Defective**

Distance (ft): **208.8**
Structural Grade: **0**
O&M Grade: **2**
Clock Start/From: **2**
Clock To:
1st Value: **4.000**
2nd Value:
Value Percent:
Continuous Index:
Within 8" of Joint:
Remarks: **blocked by roots**

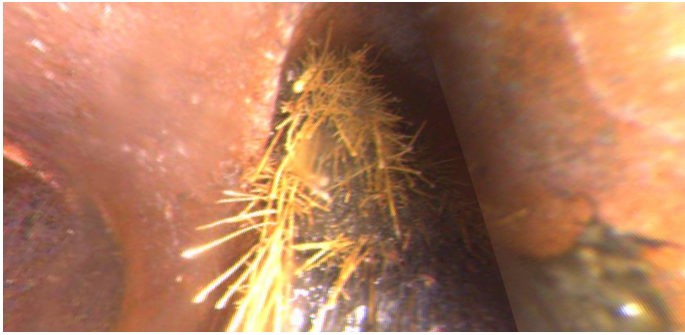
Code: **RML**
Description: **Roots Medium Lateral**

Distance (ft): **208.8**
Structural Grade: **0**
O&M Grade: **3**
Clock Start/From: **2**
Clock To:
1st Value:
2nd Value:
Value Percent: **25.000**
Continuous Index:
Within 8" of Joint: **NO**
Remarks:

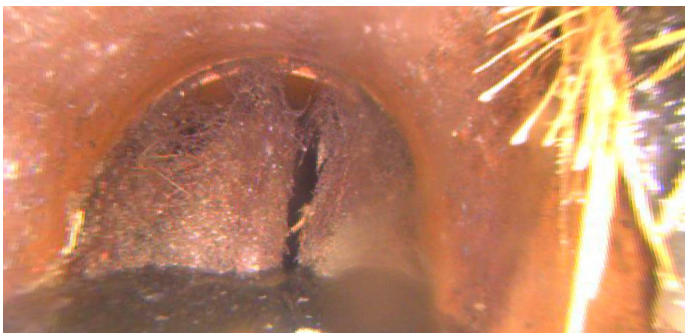
Code: **RBJ**
Description: **Roots Ball Joint**

Distance (ft): **208.8**
Structural Grade: **0**
O&M Grade: **4**
Clock Start/From: **7**
Clock To: **5**
1st Value:
2nd Value:
Value Percent: **90.000**
Continuous Index:
Within 8" of Joint: **YES**
Remarks:

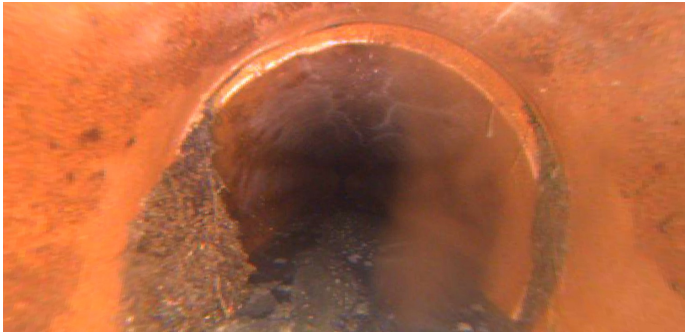
Code: **RMJ**
Description: **Roots Medium Joint**

Distance (ft): **224.8**
Structural Grade: **0**
O&M Grade: **3**
Clock Start/From: **8**
Clock To:
1st Value:
2nd Value:
Value Percent: **5.000**
Continuous Index:
Within 8" of Joint: **YES**
Remarks:

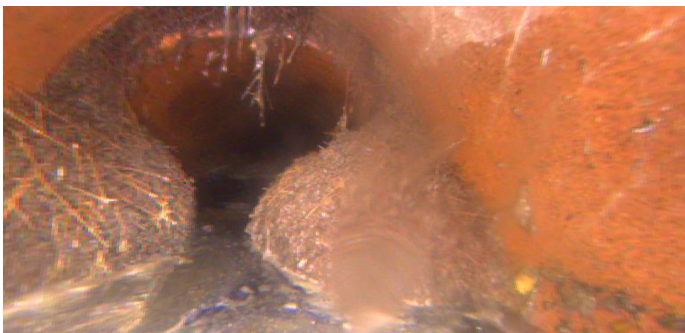
Code: **RBJ**
Description: **Roots Ball Joint**

Distance (ft): **229.9**
Structural Grade: **0**
O&M Grade: **4**
Clock Start/From: **7**
Clock To: **5**
1st Value:
2nd Value:
Value Percent: **75.000**
Continuous Index:
Within 8" of Joint: **YES**
Remarks:

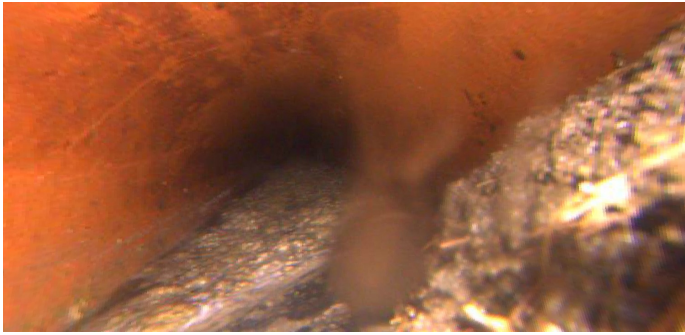
Code: **MSA**
Description: **Abandoned Survey**

Distance (ft): **230.8**
Structural Grade: **0**
O&M Grade: **0**
Clock Start/From:
Clock To:
1st Value:
2nd Value:
Value Percent:
Continuous Index:
Within 8" of Joint: **NO**
Remarks: **rbj**

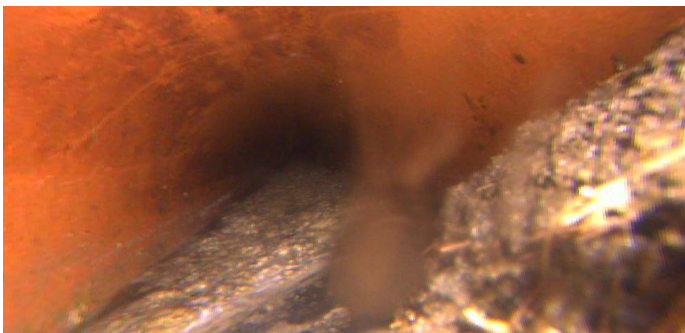
Code: **CM**
Description: **Crack Multiple**

Distance (ft): **230.8**
Structural Grade: **3**
O&M Grade: **0**
Clock Start/From: **10**
Clock To: **2**
1st Value:
2nd Value:
Value Percent:
Continuous Index: **F01**
Within 8" of Joint: **YES**
Remarks: **wandering/into barrel**

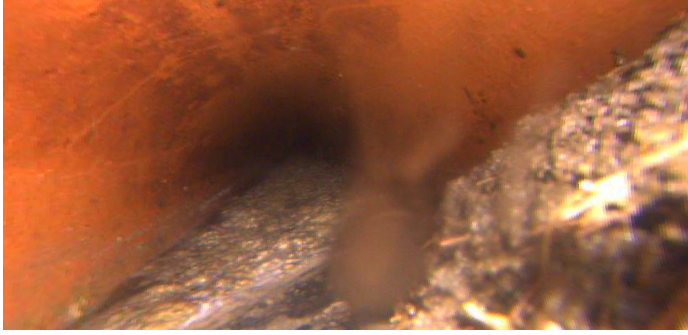
Code:	RFJ
Description:	Roots Fine Joint
Distance (ft):	230.8
Structural Grade:	0
O&M Grade:	1
Clock Start/From:	7
Clock To:	5
1st Value:	
2nd Value:	
Value Percent:	
Continuous Index:	F02
Within 8" of Joint:	YES
Remarks:	wandering
