Profile/Photo Observation Report

Street:	FOXCROFT STREET	Flow Control:	Not Controlled
City:	Hobart, IN	Year Renewed:	
Location:	Light Highway	Tape/Media #:	
Purpose:	Routine Assessment	Dia/Height:	12"
Use:	Sanitary	Material:	VCP
Drain Area:	NA	Lining:	
Category:	NA		
Comment:	P_C at 229l ft past MH at 153 ft . flow direction wrong .		
Location Details:		Direction of Survey:	Upstream
US MH:	M-209-008	DS MH:	M-209-007
		Total Length Surveyed (ft):	230.8

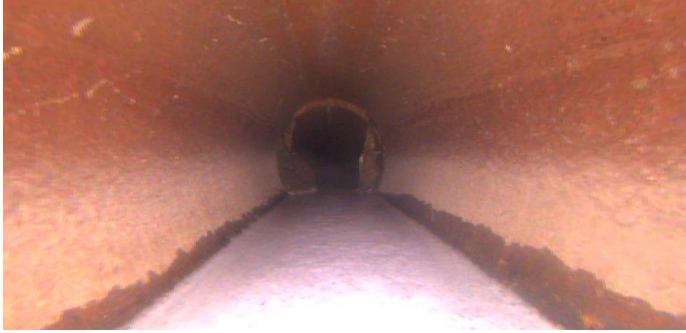
Code: **AMH**
Description: **Manhole**

Distance (ft): **.0**
Structural Grade: **0**
O&M Grade: **0**
Clock Start/From:
Clock To:
1st Value:
2nd Value:
Value Percent:
Continuous Index:
Within 8" of Joint: **NO**
Remarks: **M-209-008**

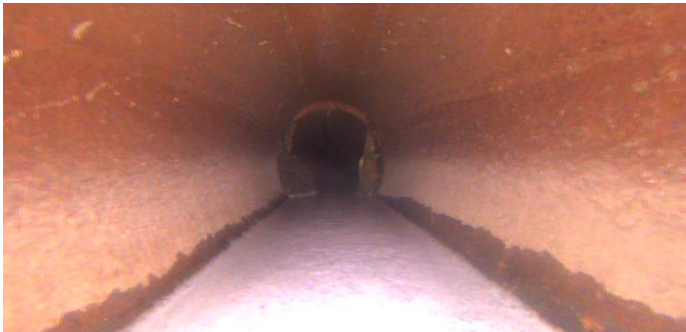
Code: **MWL**
Description: **Water Level**

Distance (ft): **.0**
Structural Grade: **0**
O&M Grade: **0**
Clock Start/From:
Clock To:
1st Value:
2nd Value:
Value Percent: **5.000**
Continuous Index:
Within 8" of Joint: **NO**
Remarks:

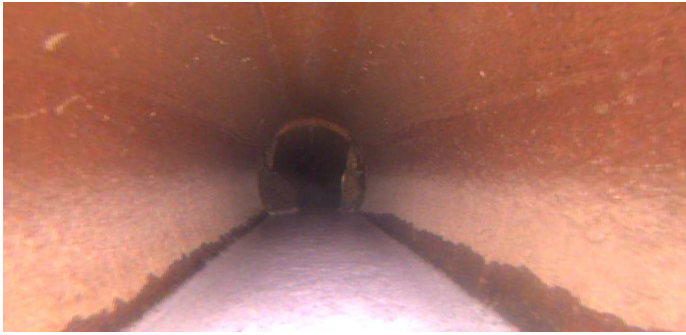
Code: **CM**
Description: **Crack Multiple**

Distance (ft): **.0**
Structural Grade: **3**
O&M Grade: **0**
Clock Start/From: **10**
Clock To: **2**
1st Value:
2nd Value:
Value Percent:
Continuous Index: **S01**
Within 8" of Joint: **YES**
Remarks: **wandering/into barrel**

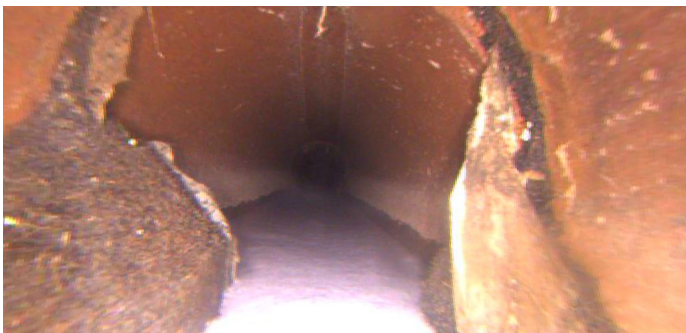
Code: **RMJ**
Description: **Roots Medium Joint**

Distance (ft): **3.3**
Structural Grade: **0**
O&M Grade: **3**
Clock Start/From: **7**
Clock To: **5**
1st Value:
2nd Value:
Value Percent: **15.000**
Continuous Index:
Within 8" of Joint: **YES**
Remarks:

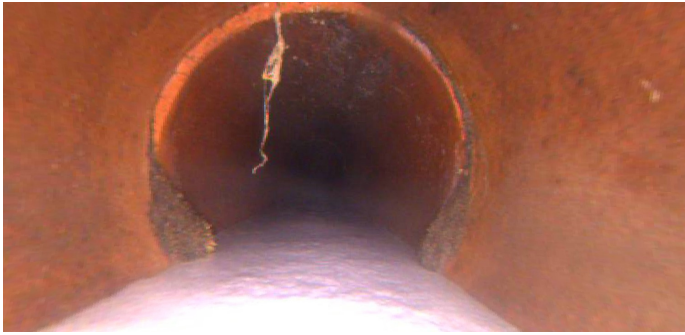
Code: **RFJ**
Description: **Roots Fine Joint**

Distance (ft): **11.4**
Structural Grade: **0**
O&M Grade: **1**
Clock Start/From: **7**
Clock To: **5**
1st Value:
2nd Value:
Value Percent:
Continuous Index: **S02**
Within 8" of Joint: **YES**
Remarks: **wandering**

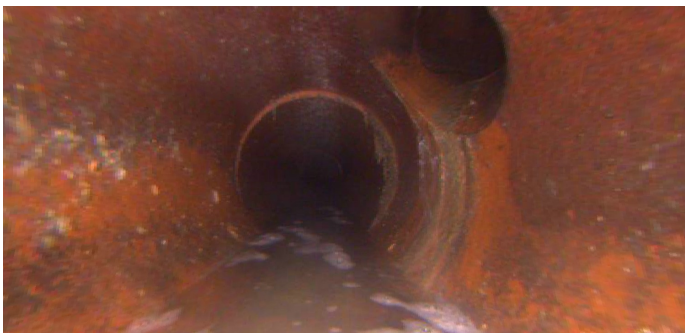
Code: **TFA**
Description: **Tap Factory Active**

Distance (ft): **25.6**
Structural Grade: **0**
O&M Grade: **0**
Clock Start/From: **2**
Clock To:
1st Value: **4.000**
2nd Value:
Value Percent:
Continuous Index:
Within 8" of Joint: **YES**
Remarks:

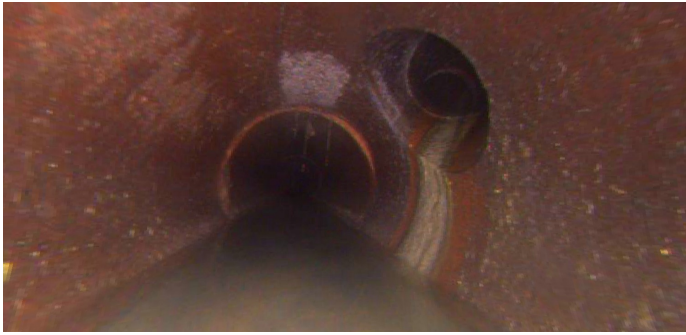
Code: **TF**
Description: **Tap Factory**

Distance (ft): **92.2**
Structural Grade: **0**
O&M Grade: **0**
Clock Start/From: **2**
Clock To:
1st Value: **4.000**
2nd Value:
Value Percent:
Continuous Index:
Within 8" of Joint: **YES**
Remarks:

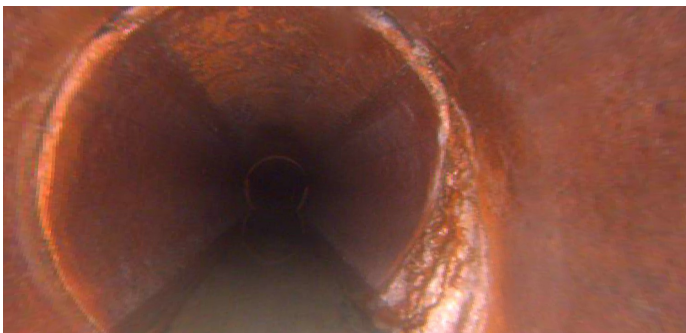
Code: **DAE**
Description: **Deposits Attached Encrustation**

Distance (ft): **110.7**
Structural Grade: **0**
O&M Grade: **2**
Clock Start/From: **3**
Clock To:
1st Value:
2nd Value:
Value Percent: **5.000**
Continuous Index: **S03**
Within 8" of Joint: **YES**
Remarks: **wandering**

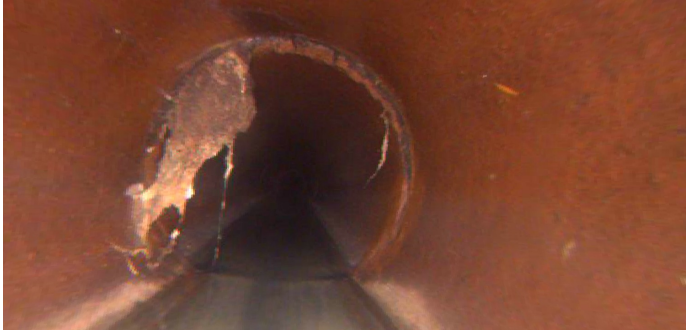
Code: **RMJ**
Description: **Roots Medium Joint**

Distance (ft): **135.8**
Structural Grade: **0**
O&M Grade: **3**
Clock Start/From: **11**
Clock To:
1st Value:
2nd Value:
Value Percent: **15.000**
Continuous Index:
Within 8" of Joint: **YES**
Remarks:

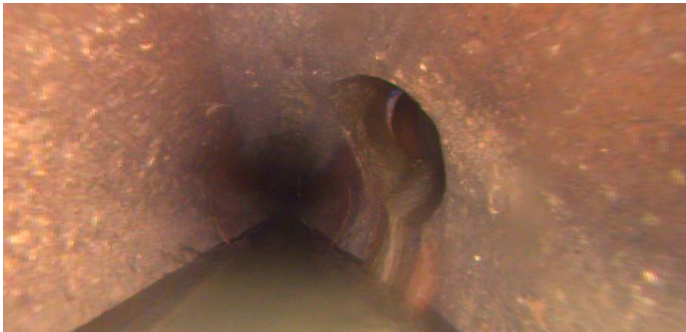
Code: **TF**
Description: **Tap Factory**

Distance (ft): **145.6**
Structural Grade: **0**
O&M Grade: **0**
Clock Start/From: **2**
Clock To:
1st Value: **4.000**
2nd Value:
Value Percent:
Continuous Index:
Within 8" of Joint: **YES**
Remarks:

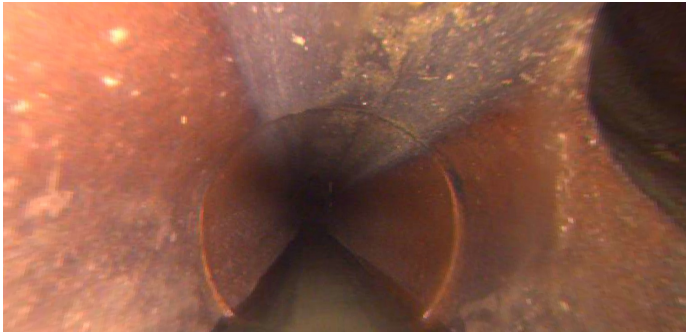
Code: **DAE**
Description: **Deposits Attached Encrustation**

Distance (ft): **146.5**
Structural Grade: **0**
O&M Grade: **2**
Clock Start/From: **3**
Clock To:
1st Value:
2nd Value:
Value Percent: **5.000**
Continuous Index: **F03**
Within 8" of Joint: **YES**
Remarks: **wandering**

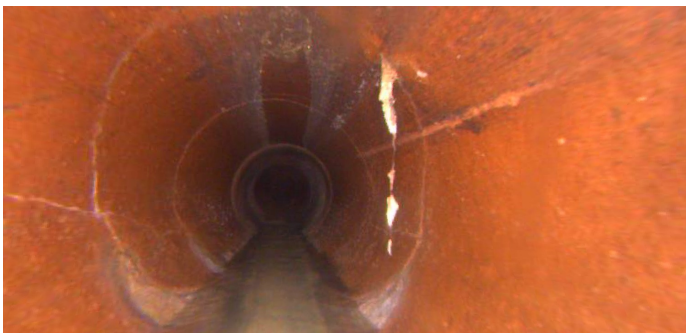
Code: **FM**
Description: **Fracture Multiple**

Distance (ft): **150.2**
Structural Grade: **4**
O&M Grade: **0**
Clock Start/From: **12**
Clock To: **12**
1st Value:
2nd Value:
Value Percent:
Continuous Index:
Within 8" of Joint:
Remarks:

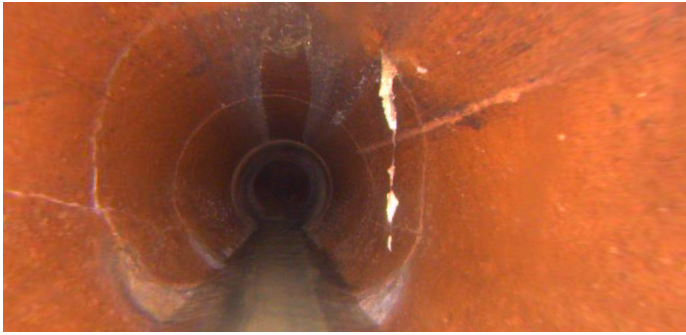
Code: **RFB**
Description: **Roots Fine Barrel**

Distance (ft): **150.2**
Structural Grade: **0**
O&M Grade: **2**
Clock Start/From: **2**
Clock To:
1st Value:
2nd Value:
Value Percent:
Continuous Index:
Within 8" of Joint: **NO**
Remarks:

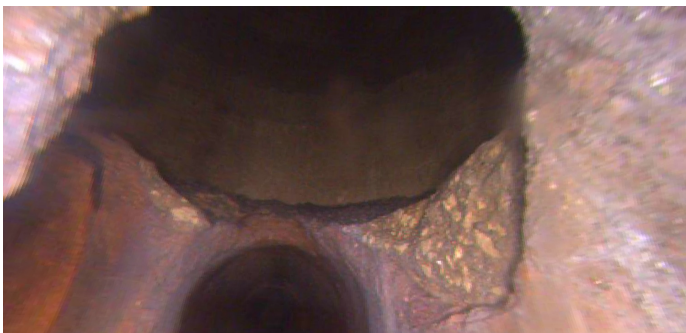
Code: **MGO**
Description: **General Observation**

Distance (ft): **153.2**
Structural Grade: **0**
O&M Grade: **0**
Clock Start/From:
Clock To:
1st Value:
2nd Value:
Value Percent:
Continuous Index:
Within 8" of Joint: **NO**
Remarks: **unidentified access point**

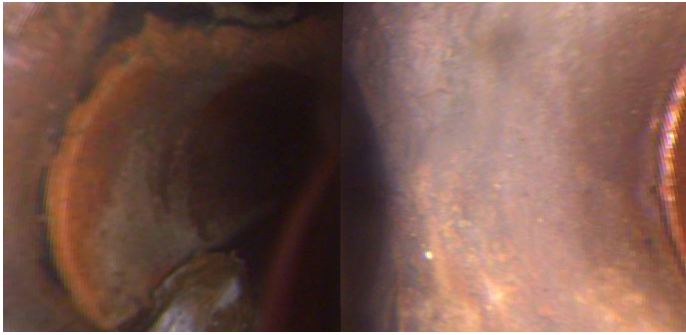
Code: **TB**
Description: **Tap Break-in**

Distance (ft): **154.3**
Structural Grade: **0**
O&M Grade: **0**
Clock Start/From: **9**
Clock To:
1st Value: **6.000**
2nd Value:
Value Percent:
Continuous Index:
Within 8" of Joint:
Remarks:

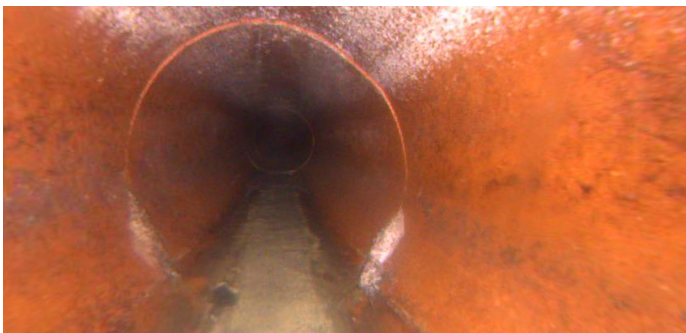
Code: **FC**
Description: **Fracture Circumferential**

Distance (ft): **156.6**
Structural Grade: **2**
O&M Grade: **0**
Clock Start/From: **12**
Clock To: **12**
1st Value:
2nd Value:
Value Percent:
Continuous Index:
Within 8" of Joint:
Remarks:

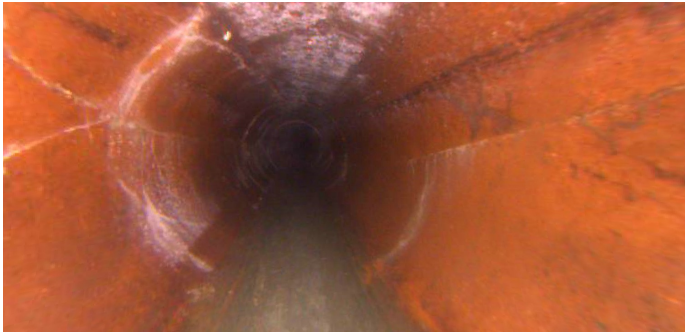
Code: **FM**
Description: **Fracture Multiple**

Distance (ft): **160.8**
Structural Grade: **4**
O&M Grade: **0**
Clock Start/From: **8**
Clock To: **4**
1st Value:
2nd Value:
Value Percent:
Continuous Index: **S05**
Within 8" of Joint: **YES**
Remarks:

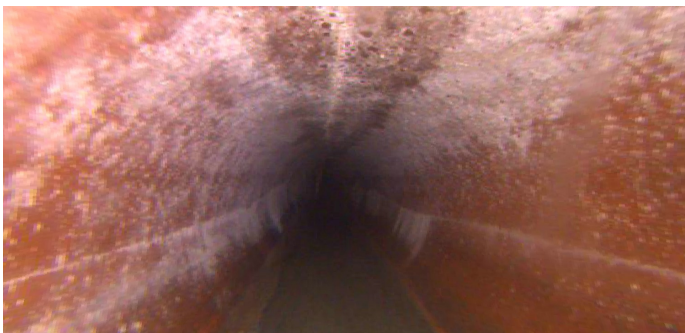
Code: **CH3**
Description: **Crack Longitudinal Hinge, 3**

Distance (ft): **167.2**
Structural Grade: **5**
O&M Grade: **0**
Clock Start/From: **9**
Clock To: **3**
1st Value:
2nd Value:
Value Percent:
Continuous Index: **S04**
Within 8" of Joint:
Remarks:

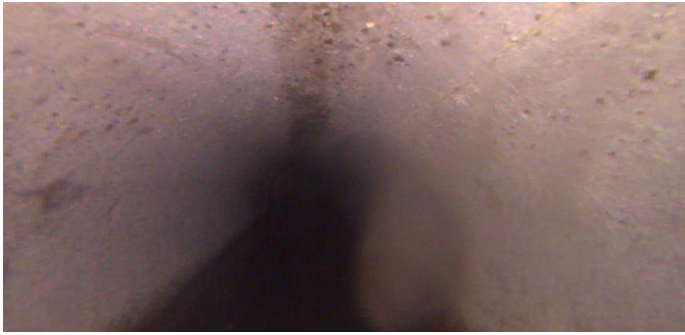
Code: **CH3**
Description: **Crack Longitudinal Hinge, 3**

Distance (ft): **177.1**
Structural Grade: **5**
O&M Grade: **0**
Clock Start/From: **9**
Clock To: **3**
1st Value:
2nd Value:
Value Percent:
Continuous Index: **F04**
Within 8" of Joint:
Remarks:

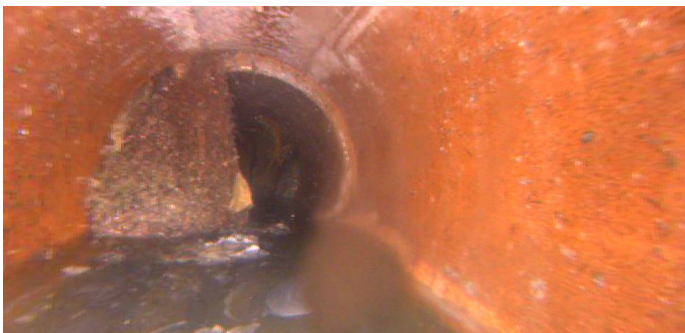
Code: **RBJ**
Description: **Roots Ball Joint**

Distance (ft): **206.3**
Structural Grade: **0**
O&M Grade: **4**
Clock Start/From: **6**
Clock To: **12**
1st Value:
2nd Value:
Value Percent: **55.000**
Continuous Index:
Within 8" of Joint: **YES**
Remarks:

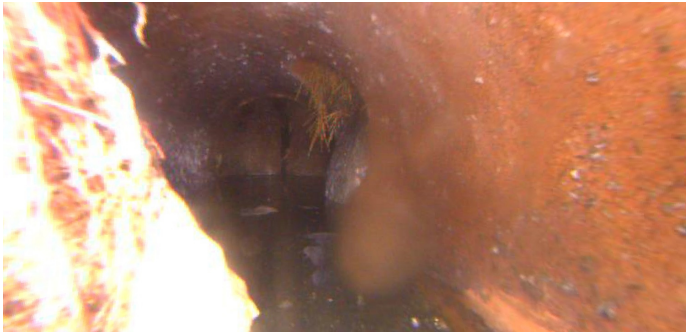
Code: **FM**
Description: **Fracture Multiple**

Distance (ft): **207.5**
Structural Grade: **4**
O&M Grade: **0**
Clock Start/From: **8**
Clock To: **4**
1st Value:
2nd Value:
Value Percent:
Continuous Index: **F05**
Within 8" of Joint: **YES**
Remarks:

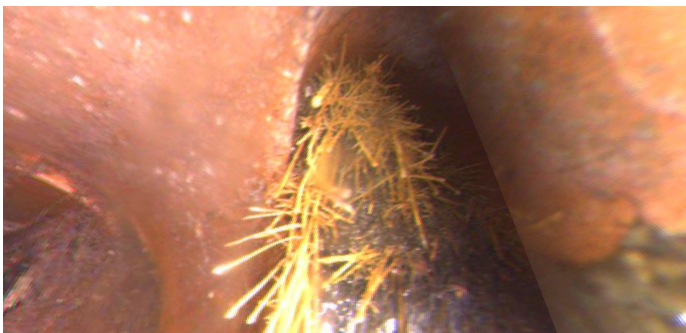
Code: **TFD**
Description: **Tap Factory Defective**

Distance (ft): **208.8**
Structural Grade: **0**
O&M Grade: **2**
Clock Start/From: **2**
Clock To:
1st Value: **4.000**
2nd Value:
Value Percent:
Continuous Index:
Within 8" of Joint:
Remarks: **blocked by roots**

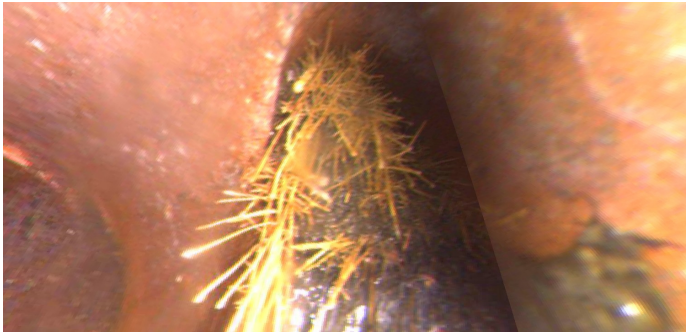
Code: **RML**
Description: **Roots Medium Lateral**

Distance (ft): **208.8**
Structural Grade: **0**
O&M Grade: **3**
Clock Start/From: **2**
Clock To:
1st Value:
2nd Value:
Value Percent: **25.000**
Continuous Index:
Within 8" of Joint: **NO**
Remarks:

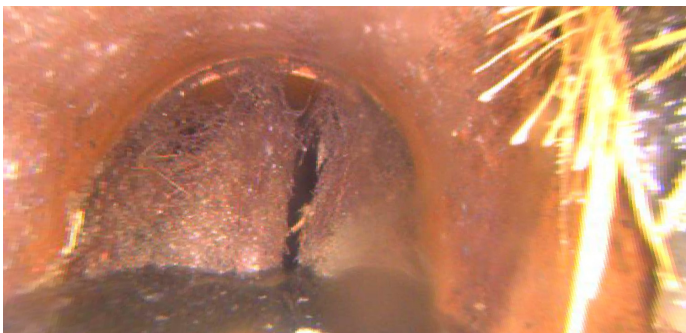
Code: **RBJ**
Description: **Roots Ball Joint**

Distance (ft): **208.8**
Structural Grade: **0**
O&M Grade: **4**
Clock Start/From: **7**
Clock To: **5**
1st Value:
2nd Value:
Value Percent: **90.000**
Continuous Index:
Within 8" of Joint: **YES**
Remarks:

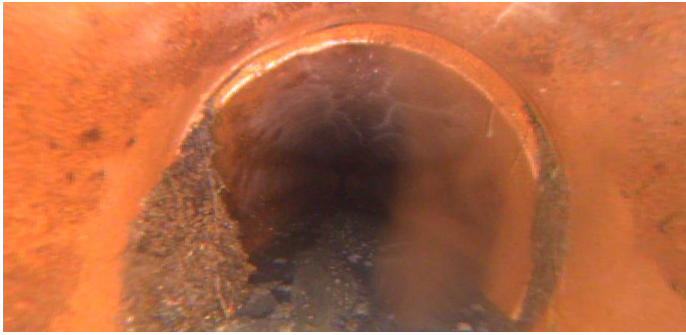
Code: **RMJ**
Description: **Roots Medium Joint**

Distance (ft): **224.8**
Structural Grade: **0**
O&M Grade: **3**
Clock Start/From: **8**
Clock To:
1st Value:
2nd Value:
Value Percent: **5.000**
Continuous Index:
Within 8" of Joint: **YES**
Remarks:

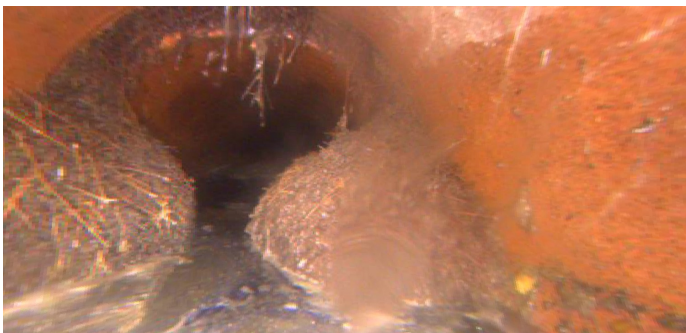
Code: **RBJ**
Description: **Roots Ball Joint**

Distance (ft): **229.9**
Structural Grade: **0**
O&M Grade: **4**
Clock Start/From: **7**
Clock To: **5**
1st Value:
2nd Value:
Value Percent: **75.000**
Continuous Index:
Within 8" of Joint: **YES**
Remarks:

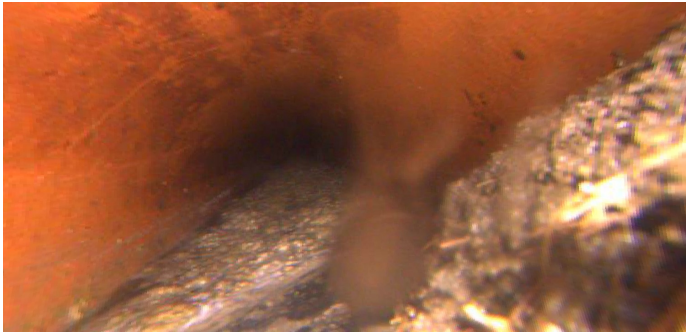
Code: **MSA**
Description: **Abandoned Survey**

Distance (ft): **230.8**
Structural Grade: **0**
O&M Grade: **0**
Clock Start/From:
Clock To:
1st Value:
2nd Value:
Value Percent:
Continuous Index:
Within 8" of Joint: **NO**
Remarks: **rbj**

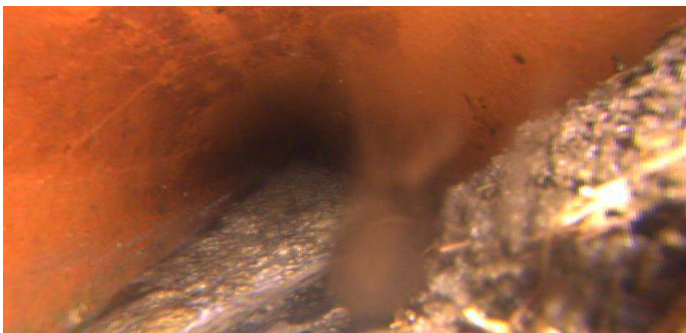
Code: **CM**
Description: **Crack Multiple**

Distance (ft): **230.8**
Structural Grade: **3**
O&M Grade: **0**
Clock Start/From: **10**
Clock To: **2**
1st Value:
2nd Value:
Value Percent:
Continuous Index: **F01**
Within 8" of Joint: **YES**
Remarks: **wandering/into barrel**

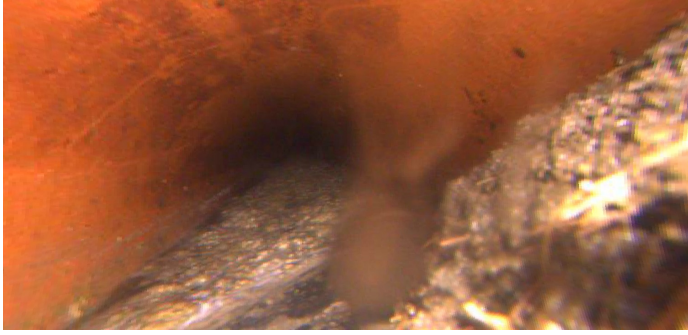
Code:	RFJ
Description:	Roots Fine Joint
Distance (ft):	230.8
Structural Grade:	0
O&M Grade:	1
Clock Start/From:	7
Clock To:	5
1st Value:	
2nd Value:	
Value Percent:	
Continuous Index:	F02
Within 8" of Joint:	YES
Remarks:	wandering
