## Profile/Photo Observation Report

Street:	<b>OFF E 37TH AVE</b>	Flow Control:	<b>Not Controlled</b>
City:	<b>Hobart, IN</b>	Year Renewed:	
Location:	<b>Other</b>	Tape/Media #:	
Purpose:	<b>Not Known</b>	Dia/Height:	<b>10"</b>
Use:	<b>Sanitary</b>	Material:	<b>PVC</b>
Drain Area:	<b>NA</b>	Lining:	
Category:	<b>NA</b>		
Comment:

Location Details:		Direction of Survey:	<b>Upstream</b>
US MH:	<b>M-903-063</b>	DS MH:	<b>M-903-062</b>
		Total Length Surveyed (ft):	<b>144.3</b>

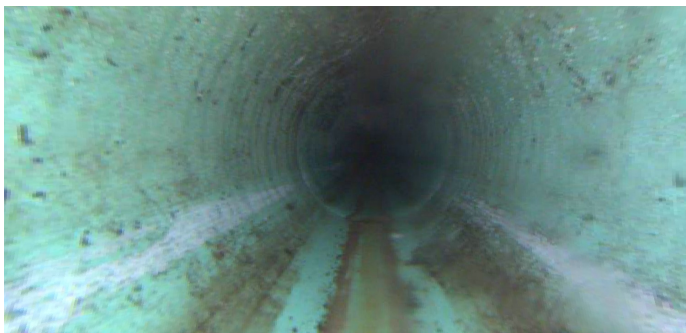
Code: **AMH**  
Description: **Manhole**

Distance (ft): **.0**  
Structural Grade: **0**  
O&M Grade: **0**  
Clock Start/From:  
Clock To:  
1st Value:  
2nd Value:  
Value Percent:  
Continuous Index:  
Within 8" of Joint: **NO**  
Remarks: **M-903-062**

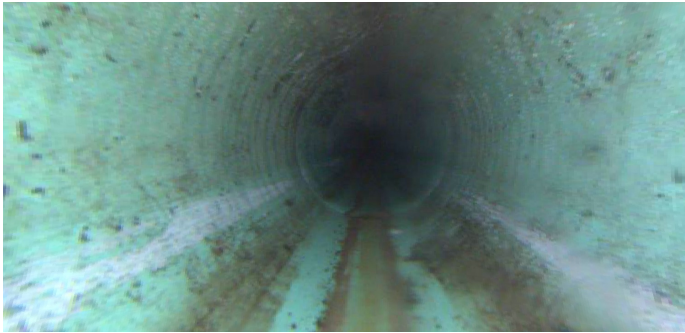
Code:	<b>MWL</b>
Description:	<b>Water Level</b>

Distance (ft):	<b>.0</b>
Structural Grade:	<b>0</b>
O&M Grade:	<b>0</b>
Clock Start/From:	
Clock To:	
1st Value:	
2nd Value:	
Value Percent:	<b>5.000</b>
Continuous Index:	
Within 8" of Joint:	<b>NO</b>
Remarks:

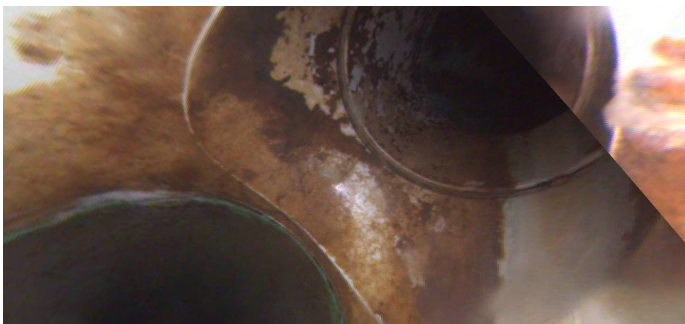
Code:	<b>TF</b>
Description:	<b>Tap Factory</b>

Distance (ft):	<b>68.8</b>
Structural Grade:	<b>0</b>
O&M Grade:	<b>0</b>
Clock Start/From:	<b>2</b>
Clock To:	
1st Value:	<b>4.000</b>
2nd Value:	
Value Percent:	
Continuous Index:	
Within 8" of Joint:	
Remarks:

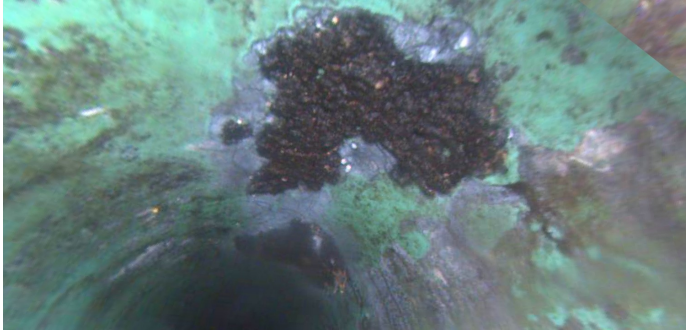
Code: **DAZ**  
Description: **Deposits Attached Other**

Distance (ft): **87.0**  
Structural Grade: **0**  
O&M Grade: **2**  
Clock Start/From: **12**  
Clock To: **1**  
1st Value:  
2nd Value:  
Value Percent: **5.000**  
Continuous Index:  
Within 8" of Joint: **NO**  
Remarks:

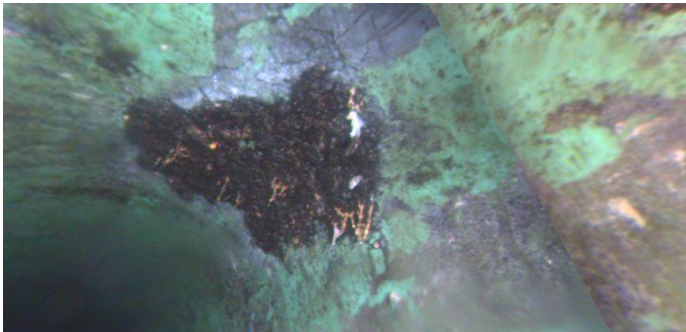
Code: **RFB**  
Description: **Roots Fine Barrel**

Distance (ft): **87.5**  
Structural Grade: **0**  
O&M Grade: **2**  
Clock Start/From: **1**  
Clock To: **2**  
1st Value:  
2nd Value:  
Value Percent:  
Continuous Index:  
Within 8" of Joint: **NO**  
Remarks:

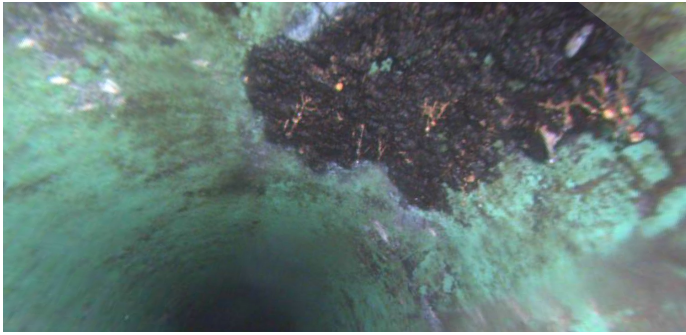
Code: **DAZ**  
Description: **Deposits Attached Other**

Distance (ft): **87.7**  
Structural Grade: **0**  
O&M Grade: **2**  
Clock Start/From: **12**  
Clock To: **1**  
1st Value:  
2nd Value:  
Value Percent: **5.000**  
Continuous Index:  
Within 8" of Joint: **NO**  
Remarks:

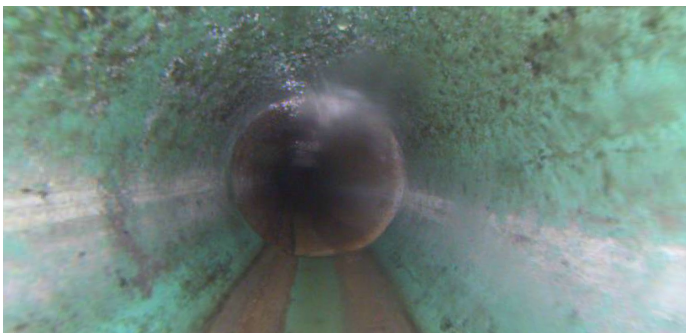
Code: **LL**  
Description: **Alignment Left**

Distance (ft): **134.4**  
Structural Grade: **0**  
O&M Grade: **1**  
Clock Start/From:  
Clock To:  
1st Value:  
2nd Value:  
Value Percent: **5.000**  
Continuous Index:  
Within 8" of Joint: **NO**  
Remarks:

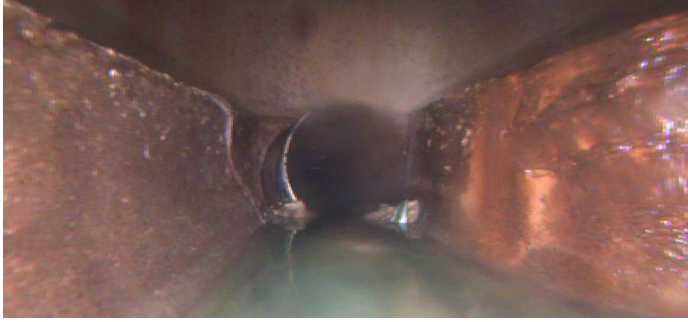
Code:	<b>AMH</b>
Description:	<b>Manhole</b>
Distance (ft):	<b>144.3</b>
Structural Grade:	<b>0</b>
O&M Grade:	<b>0</b>
Clock Start/From:	
Clock To:	
1st Value:	
2nd Value:	
Value Percent:	
Continuous Index:	
Within 8" of Joint:	<b>NO</b>
Remarks:	<b>M-903-063</b>
