Profile/Photo Observation Report

Date:	03/19/2018	Weather:		Coding:	PACP 6.0
Pipe Length (ft):	89.3	Owner:	NA	Pre Clean:	No Pre-Cleaning
P.O.#:		Surveyor:	John Kuglmaier	PSR:	P-209-009-008
Customer:		Clean Date:	01/01/1900	Shape:	C

Street:	OFF MINNESOTA ST	Flow Control:	Not Controlled
City:	Hobart, IN	Year Renewed:	
Location:	Light Highway	Tape/Media #:	
Purpose:	Routine Assessment	Dia/Height:	12"
Use:	Sanitary	Material:	VCP
Drain Area:	NA	Lining:	
Category:	NA		
Comment:	F_S_P_C at 2 ft debris . Flow direction		
Location Details:		Direction of Survey:	Downstream
US MH:	M-209-008	DS MH:	M-209-009
		Total Length Surveyed (ft):	3.1

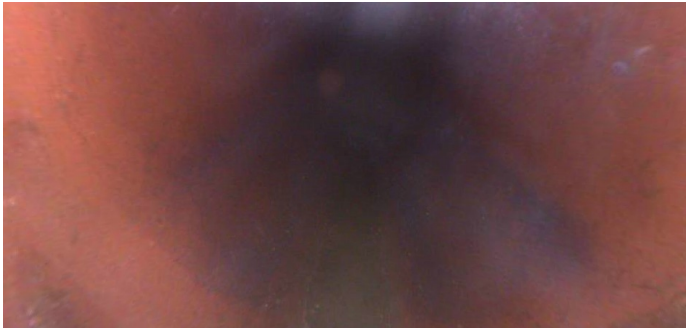
Code:	MWL
Description:	Water Level

Distance (ft):	.0
Structural Grade:	0
O&M Grade:	0
Clock Start/From:	
Clock To:	
1st Value:	
2nd Value:	
Value Percent:	5.000
Continuous Index:	
Within 8" of Joint:	NO
Remarks:

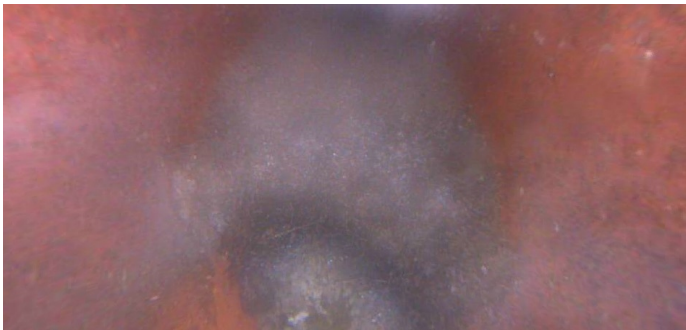
Code:	RBJ
Description:	Roots Ball Joint

Distance (ft):	2.7
Structural Grade:	0
O&M Grade:	4
Clock Start/From:	12
Clock To:	12
1st Value:	
2nd Value:	
Value Percent:	100.000
Continuous Index:	
Within 8" of Joint:	YES
Remarks:

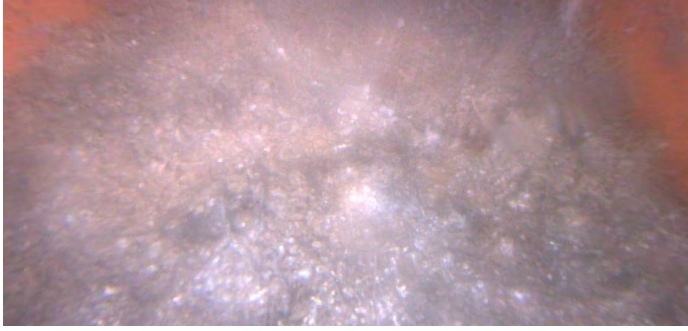
Code:	MSA
Description:	Abandoned Survey
Distance (ft):	3.1
Structural Grade:	0
O&M Grade:	0
Clock Start/From:	
Clock To:	
1st Value:	
2nd Value:	
Value Percent:	
Continuous Index:	
Within 8" of Joint:	NO
Remarks:	RBJ
