## Profile/Photo Observation Report

Date:	<b>03/19/2018</b>	Weather:		Coding:	<b>PACP 6.0</b>
Pipe Length (ft):	<b>89.3</b>	Owner:	<b>NA</b>	Pre Clean:	<b>No Pre-Cleaning</b>
P.O.#:		Surveyor:	<b>John Kuglmaier</b>	PSR:	<b>P-209-009-008</b>
Customer:		Clean Date:	<b>01/01/1900</b>	Shape:	<b>C</b>

Street:	<b>FOXCROFT STREET</b>	Flow Control:	<b>Not Controlled</b>
City:	<b>Hobart, IN</b>	Year Renewed:	
Location:	<b>Light Highway</b>	Tape/Media #:	
Purpose:	<b>Routine Assessment</b>	Dia/Height:	<b>12"</b>
Use:	<b>Sanitary</b>	Material:	<b>VCP</b>
Drain Area:	<b>NA</b>	Lining:	
Category:	<b>NA</b>		
Comment:	<b>F_S_P_C at 2 ft debris . Flow direction</b>		
Location Details:		Direction of Survey:	<b>Downstream</b>
US MH:	<b>M-209-008</b>	DS MH:	<b>M-209-009</b>
		Total Length Surveyed (ft):	<b>3.1</b>

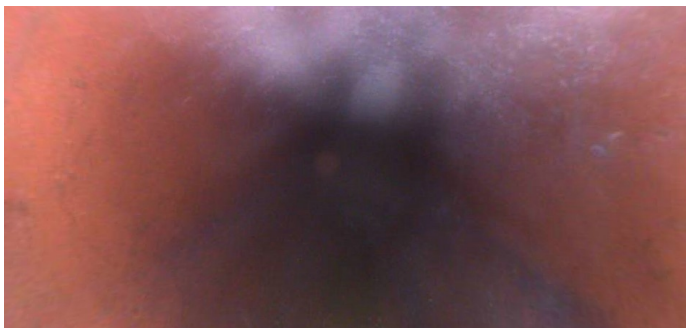
Code: **AMH**  
Description: **Manhole**

Distance (ft): **.0**  
Structural Grade: **0**  
O&M Grade: **0**  
Clock Start/From:  
Clock To:  
1st Value:  
2nd Value:  
Value Percent:  
Continuous Index:  
Within 8" of Joint: **NO**  
Remarks: **M-209-008**

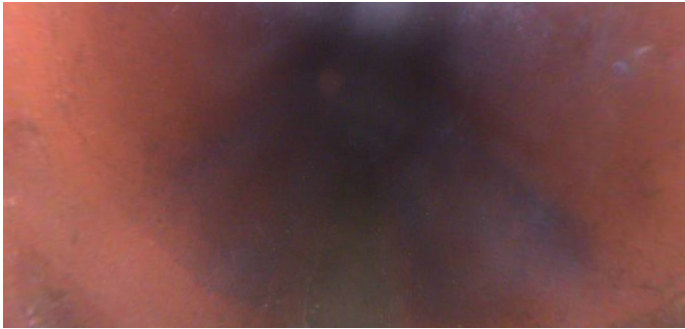
Code:	<b>MWL</b>
Description:	<b>Water Level</b>

Distance (ft):	<b>.0</b>
Structural Grade:	<b>0</b>
O&M Grade:	<b>0</b>
Clock Start/From:	
Clock To:	
1st Value:	
2nd Value:	
Value Percent:	<b>5.000</b>
Continuous Index:	
Within 8" of Joint:	<b>NO</b>
Remarks:

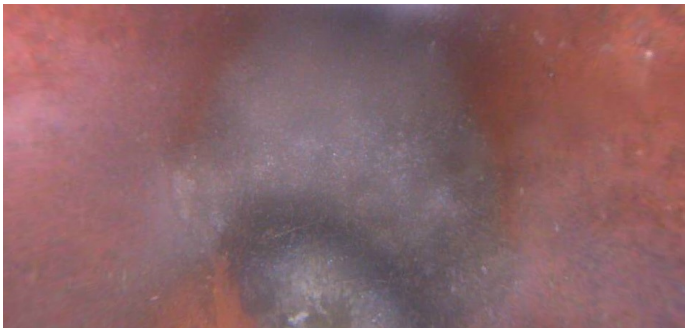
Code:	<b>RBJ</b>
Description:	<b>Roots Ball Joint</b>

Distance (ft):	<b>2.7</b>
Structural Grade:	<b>0</b>
O&M Grade:	<b>4</b>
Clock Start/From:	<b>12</b>
Clock To:	<b>12</b>
1st Value:	
2nd Value:	
Value Percent:	<b>100.000</b>
Continuous Index:	
Within 8" of Joint:	<b>YES</b>
Remarks:

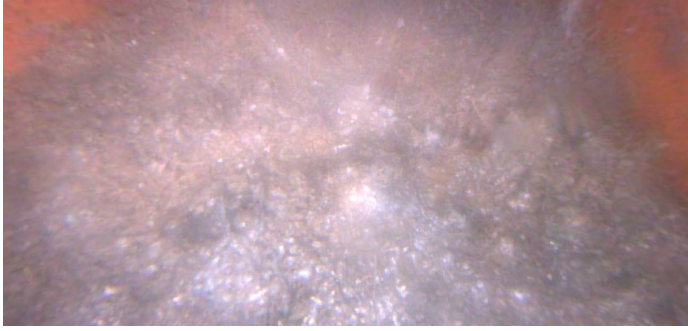
Code:	<b>MSA</b>
Description:	<b>Abandoned Survey</b>
Distance (ft):	<b>3.1</b>
Structural Grade:	<b>0</b>
O&M Grade:	<b>0</b>
Clock Start/From:	
Clock To:	
1st Value:	
2nd Value:	
Value Percent:	
Continuous Index:	
Within 8" of Joint:	<b>NO</b>
Remarks:	<b>RBJ</b>
