## Profile/Photo Observation Report

Date:	<b>03/20/2018</b>	Weather:		Coding:	<b>PACP 6.0</b>
Pipe Length (ft):	<b>393.1</b>	Owner:	<b>NA</b>	Pre Clean:	<b>No Pre-Cleaning</b>
P.O.#:		Surveyor:	<b>John Kuglmaier</b>	PSR:	<b>P-209-011-012</b>
Customer:		Clean Date:	<b>01/01/1900</b>	Shape:	<b>C</b>

Street:	<b>ALLEY BETWEEN MINNESOTA ST &amp; C</b>	Flow Control:	<b>Not Controlled</b>
City:	<b>Hobart, IN</b>	Year Renewed:	
Location:	<b>Light Highway</b>	Tape/Media #:	
Purpose:	<b>Routine Assessment</b>	Dia/Height:	<b>8"</b>
Use:	<b>Sanitary</b>	Material:	<b>VCP</b>
Drain Area:	<b>NA</b>	Lining:	
Category:	<b>NA</b>		
Comment:	<b>P_C at 76 ft roots . Flow wrong</b>		
Location Details:		Direction of Survey:	<b>Downstream</b>
US MH:	<b>M-209-012</b>	DS MH:	<b>M-209-011</b>
		Total Length Surveyed (ft):	<b>77.1</b>

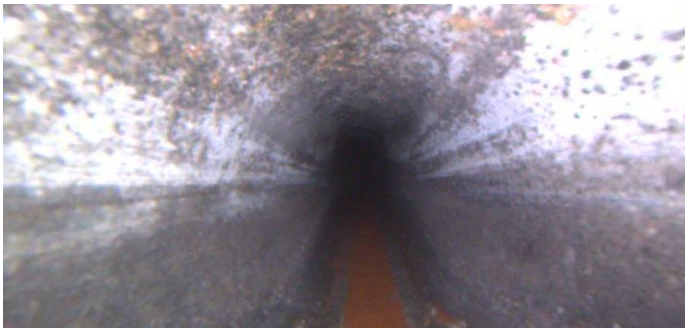
Code:	<b>DAZ</b>
Description:	<b>Deposits Attached Other</b>

Distance (ft):	<b>.0</b>
Structural Grade:	<b>0</b>
O&M Grade:	<b>2</b>
Clock Start/From:	<b>7</b>
Clock To:	<b>5</b>
1st Value:	
2nd Value:	
Value Percent:	<b>5.000</b>
Continuous Index:	<b>S01</b>
Within 8" of Joint:	<b>NO</b>
Remarks:	<b>Mixed materials</b>

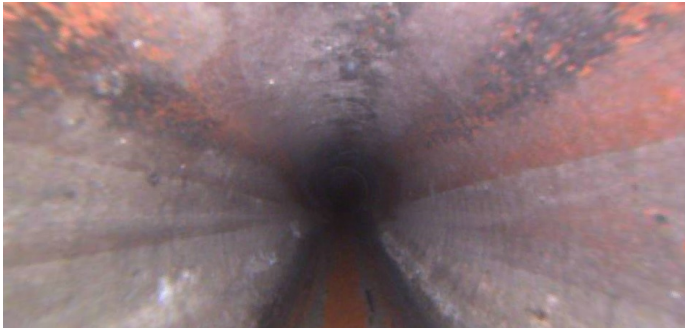
Code: **DAZ**  
Description: **Deposits Attached Other**

Distance (ft): **5.9**  
Structural Grade: **0**  
O&M Grade: **2**  
Clock Start/From: **7**  
Clock To: **5**  
1st Value:  
2nd Value:  
Value Percent: **5.000**  
Continuous Index: **F01**  
Within 8" of Joint: **NO**  
Remarks: **Mixed materials / Clock positions vary**

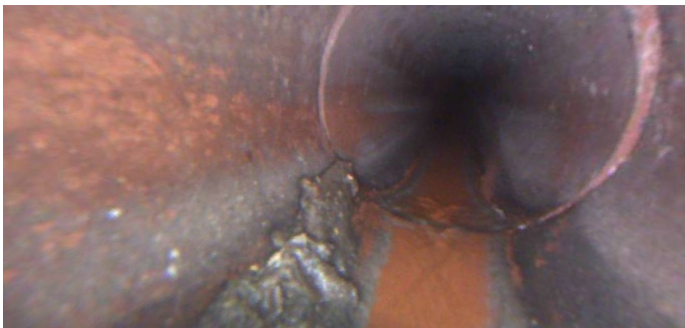
Code: **DAZ**  
Description: **Deposits Attached Other**

Distance (ft): **9.0**  
Structural Grade: **0**  
O&M Grade: **2**  
Clock Start/From: **7**  
Clock To: **8**  
1st Value:  
2nd Value:  
Value Percent: **5.000**  
Continuous Index:  
Within 8" of Joint: **YES**  
Remarks: **Mixed materials**

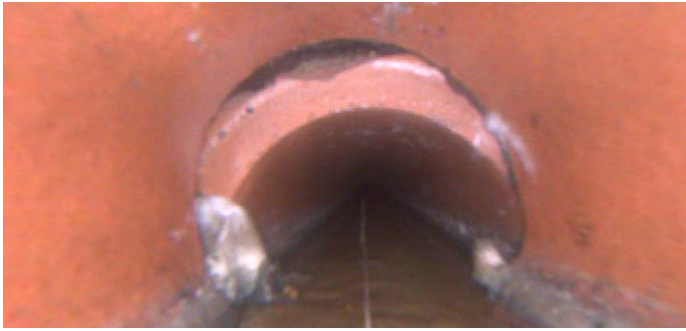
Code: **JOM**  
Description: **Joint Offset Medium**

Distance (ft): **35.7**  
Structural Grade: **1**  
O&M Grade: **0**  
Clock Start/From:  
Clock To:  
1st Value:  
2nd Value:  
Value Percent:  
Continuous Index:  
Within 8" of Joint: **NO**  
Remarks:

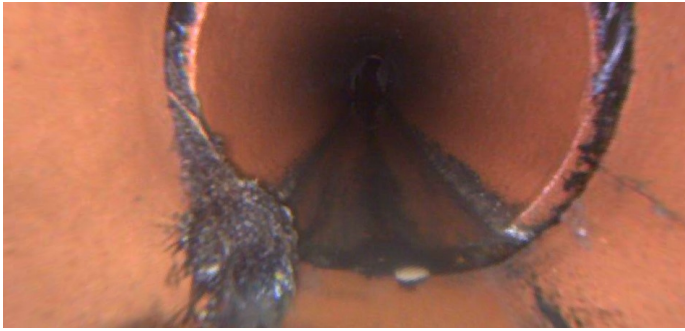
Code: **RMJ**  
Description: **Roots Medium Joint**

Distance (ft): **55.9**  
Structural Grade: **0**  
O&M Grade: **3**  
Clock Start/From: **7**  
Clock To: **8**  
1st Value:  
2nd Value:  
Value Percent: **5.000**  
Continuous Index:  
Within 8" of Joint: **YES**  
Remarks:

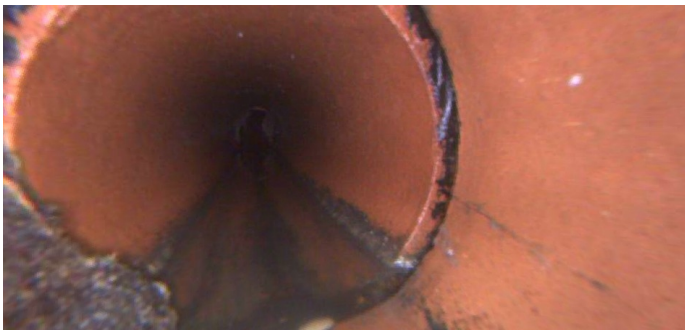
Code: **CL**  
Description: **Crack Longitudinal**

Distance (ft): **55.9**  
Structural Grade: **2**  
O&M Grade: **0**  
Clock Start/From: **4**  
Clock To:  
1st Value:  
2nd Value:  
Value Percent:  
Continuous Index:  
Within 8" of Joint: **YES**  
Remarks:

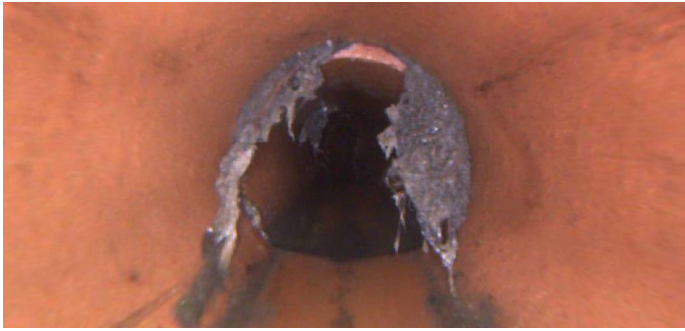
Code: **RMJ**  
Description: **Roots Medium Joint**

Distance (ft): **59.7**  
Structural Grade: **0**  
O&M Grade: **3**  
Clock Start/From: **7**  
Clock To: **5**  
1st Value:  
2nd Value:  
Value Percent: **30.000**  
Continuous Index: **S02**  
Within 8" of Joint: **YES**  
Remarks:

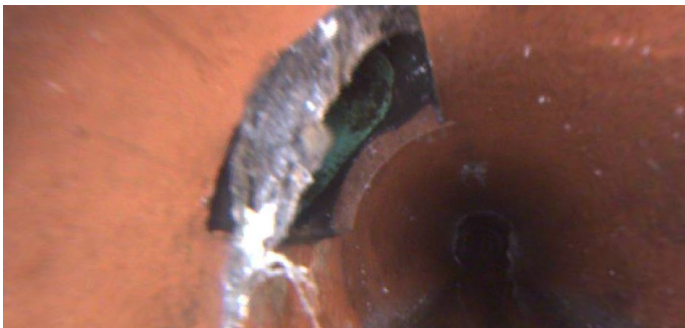
Code: **RFC**  
Description: **Roots Fine Connection**

Distance (ft): **61.4**  
Structural Grade: **0**  
O&M Grade: **1**  
Clock Start/From: **10**  
Clock To:  
1st Value:  
2nd Value:  
Value Percent:  
Continuous Index:  
Within 8" of Joint: **NO**  
Remarks:

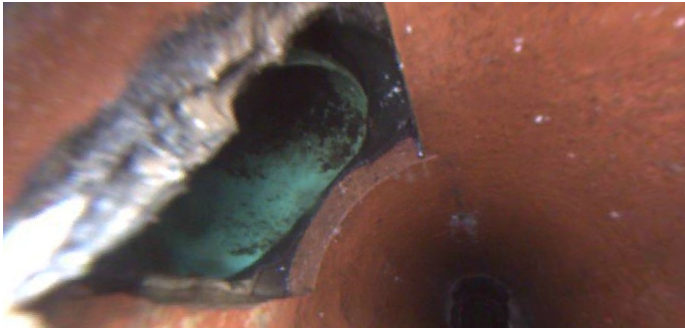
Code: **TBD**  
Description: **Tap Break-in Defective**

Distance (ft): **61.5**  
Structural Grade: **0**  
O&M Grade: **3**  
Clock Start/From: **10**  
Clock To:  
1st Value: **4.000**  
2nd Value:  
Value Percent:  
Continuous Index:  
Within 8" of Joint:  
Remarks: **RFC**

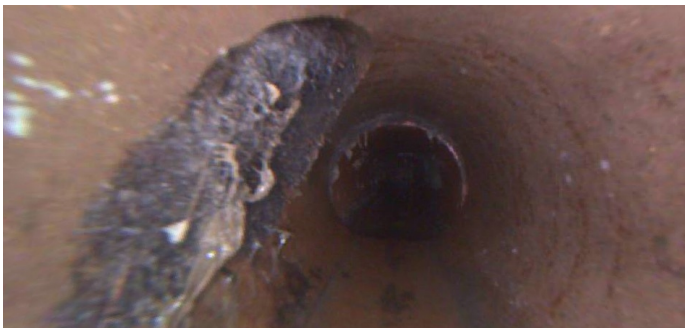
Code: **RBC**  
Description: **Roots Ball Connection**

Distance (ft): **65.6**  
Structural Grade: **0**  
O&M Grade: **4**  
Clock Start/From: **10**  
Clock To:  
1st Value:  
2nd Value:  
Value Percent: **100.000**  
Continuous Index:  
Within 8" of Joint: **NO**  
Remarks:

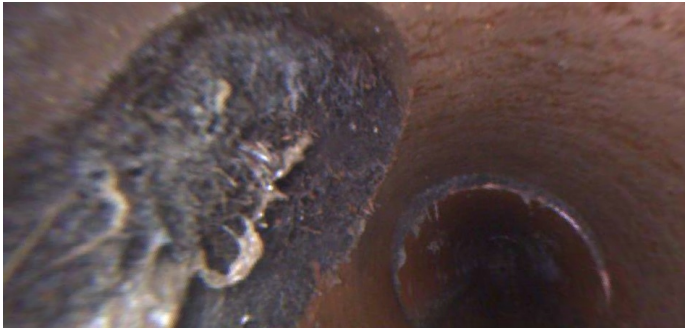
Code: **TFD**  
Description: **Tap Factory Defective**

Distance (ft): **65.8**  
Structural Grade: **0**  
O&M Grade: **2**  
Clock Start/From: **10**  
Clock To:  
1st Value: **4.000**  
2nd Value:  
Value Percent:  
Continuous Index:  
Within 8" of Joint:  
Remarks: **Roots**

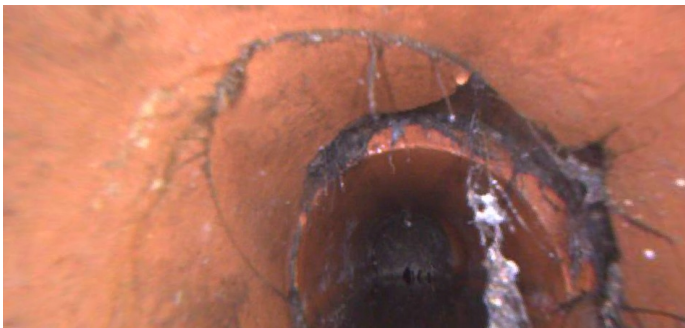
Code: **CM**  
Description: **Crack Multiple**

Distance (ft): **70.5**  
Structural Grade: **3**  
O&M Grade: **0**  
Clock Start/From: **8**  
Clock To: **3**  
1st Value:  
2nd Value:  
Value Percent:  
Continuous Index:  
Within 8" of Joint: **YES**  
Remarks:

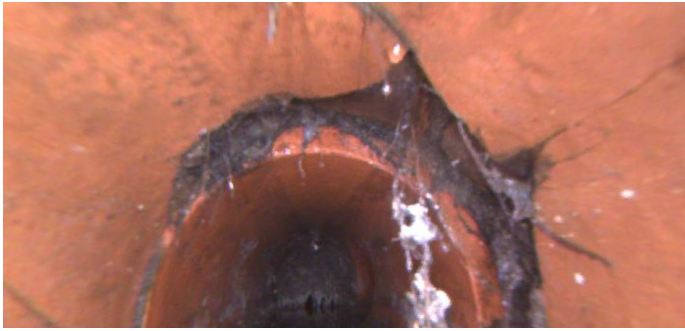
Code: HSV  
Description: Hole Soil Visible

Distance (ft): 70.7  
Structural Grade: 5  
O&M Grade: 0  
Clock Start/From: 11  
Clock To: 3  
1st Value:  
2nd Value:  
Value Percent:  
Continuous Index:  
Within 8" of Joint: YES  
Remarks:

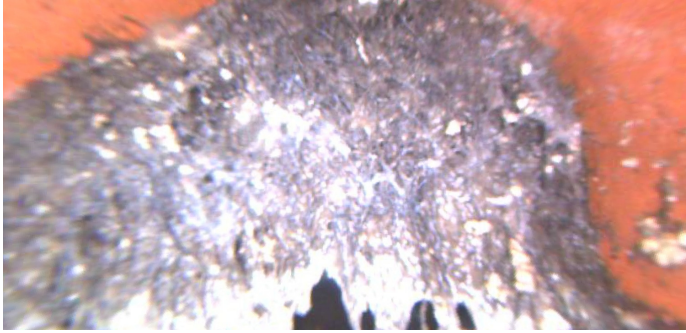
Code: **RBJ**  
Description: **Roots Ball Joint**

Distance (ft): **72.9**  
Structural Grade: **0**  
O&M Grade: **4**  
Clock Start/From: **7**  
Clock To: **5**  
1st Value:  
2nd Value:  
Value Percent: **90.000**  
Continuous Index:  
Within 8" of Joint: **YES**  
Remarks:

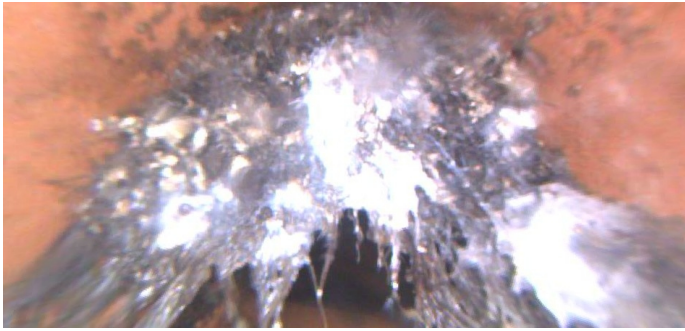
Code: **RMJ**  
Description: **Roots Medium Joint**

Distance (ft): **77.1**  
Structural Grade: **0**  
O&M Grade: **3**  
Clock Start/From: **7**  
Clock To: **5**  
1st Value:  
2nd Value:  
Value Percent: **30.000**  
Continuous Index: **F02**  
Within 8" of Joint: **YES**  
Remarks: **Clock positions vary**

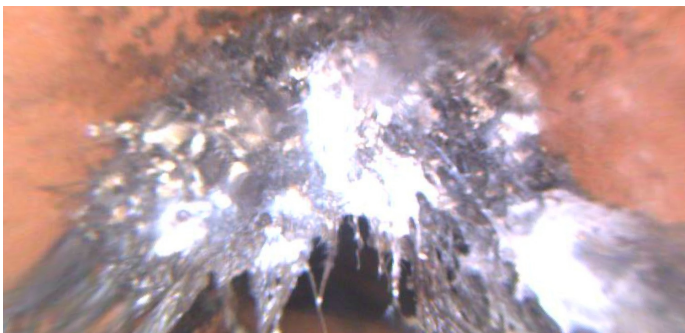
Code: **RBJ**  
Description: **Roots Ball Joint**

Distance (ft): **77.1**  
Structural Grade: **0**  
O&M Grade: **4**  
Clock Start/From: **8**  
Clock To: **4**  
1st Value:  
2nd Value:  
Value Percent: **70.000**  
Continuous Index:  
Within 8" of Joint: **YES**  
Remarks:
