## Profile/Photo Observation Report

Date:	<b>03/20/2018</b>	Weather:		Coding:	<b>PACP 6.0</b>
Pipe Length (ft):	<b>393.1</b>	Owner:	<b>NA</b>	Pre Clean:	<b>No Pre-Cleaning</b>
P.O.#:		Surveyor:	<b>John Kuglmaier</b>	PSR:	<b>P-209-011-012</b>
Customer:		Clean Date:	<b>01/01/1900</b>	Shape:	<b>C</b>

Street:	<b>FOXCROFT STREET</b>	Flow Control:	<b>Not Controlled</b>
City:	<b>Hobart, IN</b>	Year Renewed:	
Location:	<b>Light Highway</b>	Tape/Media #:	
Purpose:	<b>Routine Assessment</b>	Dia/Height:	<b>8"</b>
Use:	<b>Sanitary</b>	Material:	<b>VCP</b>
Drain Area:	<b>NA</b>	Lining:	
Category:	<b>NA</b>		
Comment:	<b>P_C at 76 ft roots . Flow wrong</b>

Location Details:		Direction of Survey:	<b>Downstream</b>
US MH:	<b>M-209-012</b>	DS MH:	<b>M-209-011</b>
		Total Length Surveyed (ft):	<b>77.1</b>

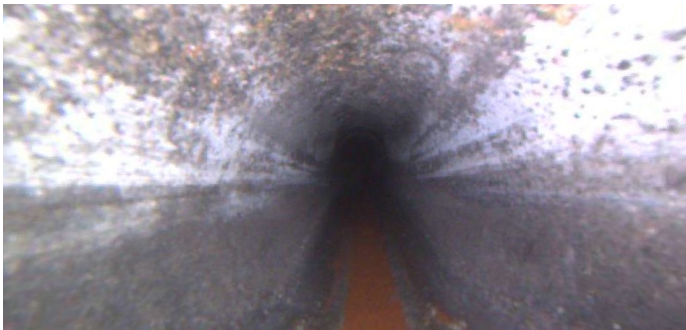
Code:	<b>DAZ</b>
Description:	<b>Deposits Attached Other</b>

Distance (ft):	<b>.0</b>
Structural Grade:	<b>0</b>
O&M Grade:	<b>2</b>
Clock Start/From:	<b>7</b>
Clock To:	<b>5</b>
1st Value:	
2nd Value:	
Value Percent:	<b>5.000</b>
Continuous Index:	<b>S01</b>
Within 8" of Joint:	<b>NO</b>
Remarks:	<b>Mixed materials</b>

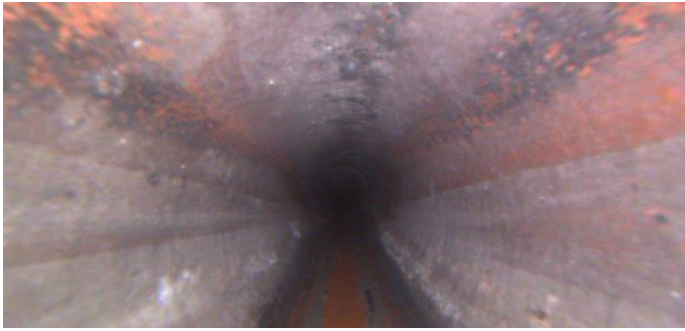
Code: **DAZ**  
Description: **Deposits Attached Other**

Distance (ft): **5.9**  
Structural Grade: **0**  
O&M Grade: **2**  
Clock Start/From: **7**  
Clock To: **5**  
1st Value:  
2nd Value:  
Value Percent: **5.000**  
Continuous Index: **F01**  
Within 8" of Joint: **NO**  
Remarks: **Mixed materials / Clock positions vary**

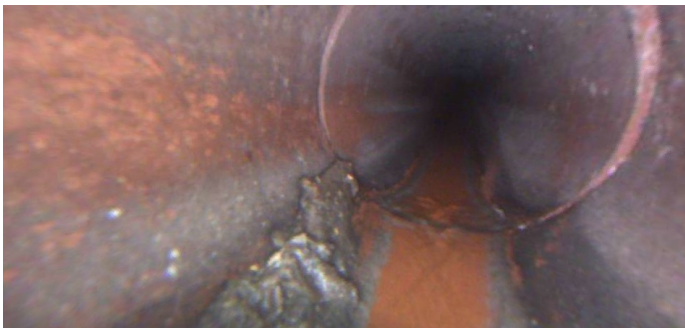
Code: **DAZ**  
Description: **Deposits Attached Other**

Distance (ft): **9.0**  
Structural Grade: **0**  
O&M Grade: **2**  
Clock Start/From: **7**  
Clock To: **8**  
1st Value:  
2nd Value:  
Value Percent: **5.000**  
Continuous Index:  
Within 8" of Joint: **YES**  
Remarks: **Mixed materials**

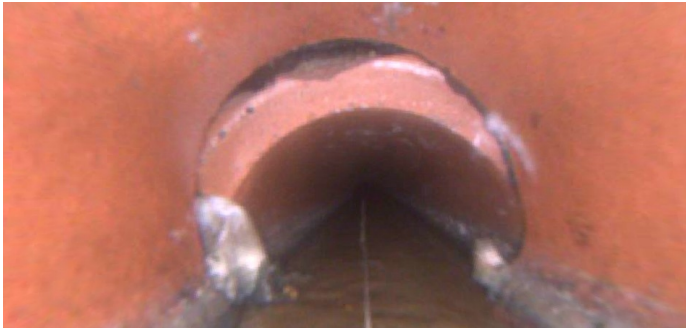
Code: **JOM**  
Description: **Joint Offset Medium**

Distance (ft): **35.7**  
Structural Grade: **1**  
O&M Grade: **0**  
Clock Start/From:  
Clock To:  
1st Value:  
2nd Value:  
Value Percent:  
Continuous Index:  
Within 8" of Joint: **NO**  
Remarks:

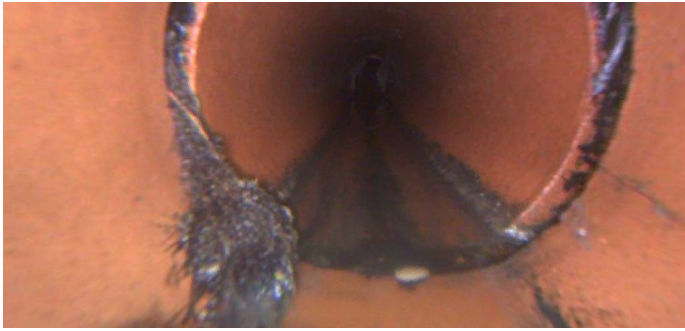
Code: **RMJ**  
Description: **Roots Medium Joint**

Distance (ft): **55.9**  
Structural Grade: **0**  
O&M Grade: **3**  
Clock Start/From: **7**  
Clock To: **8**  
1st Value:  
2nd Value:  
Value Percent: **5.000**  
Continuous Index:  
Within 8" of Joint: **YES**  
Remarks:

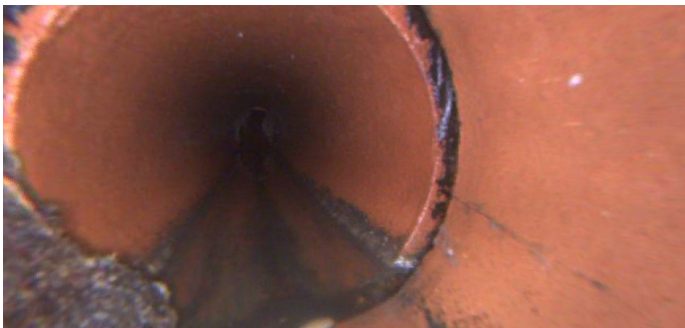
Code: **CL**  
Description: **Crack Longitudinal**

Distance (ft): **55.9**  
Structural Grade: **2**  
O&M Grade: **0**  
Clock Start/From: **4**  
Clock To:  
1st Value:  
2nd Value:  
Value Percent:  
Continuous Index:  
Within 8" of Joint: **YES**  
Remarks:

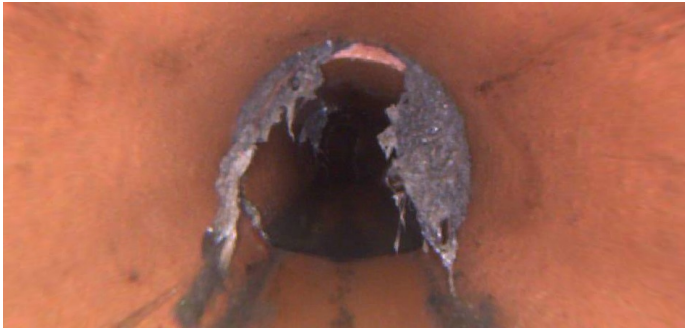
Code: **RMJ**  
Description: **Roots Medium Joint**

Distance (ft): **59.7**  
Structural Grade: **0**  
O&M Grade: **3**  
Clock Start/From: **7**  
Clock To: **5**  
1st Value:  
2nd Value:  
Value Percent: **30.000**  
Continuous Index: **S02**  
Within 8" of Joint: **YES**  
Remarks:

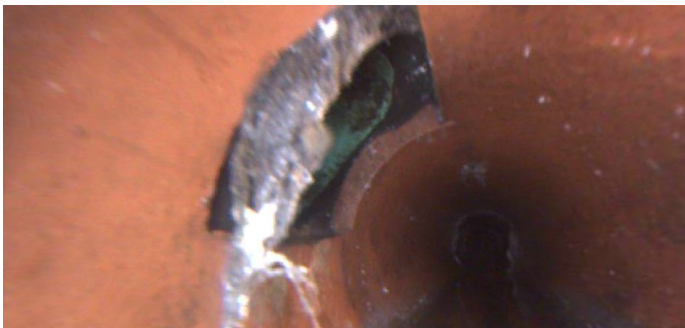
Code: **RFC**  
Description: **Roots Fine Connection**

Distance (ft): **61.4**  
Structural Grade: **0**  
O&M Grade: **1**  
Clock Start/From: **10**  
Clock To:  
1st Value:  
2nd Value:  
Value Percent:  
Continuous Index:  
Within 8" of Joint: **NO**  
Remarks:

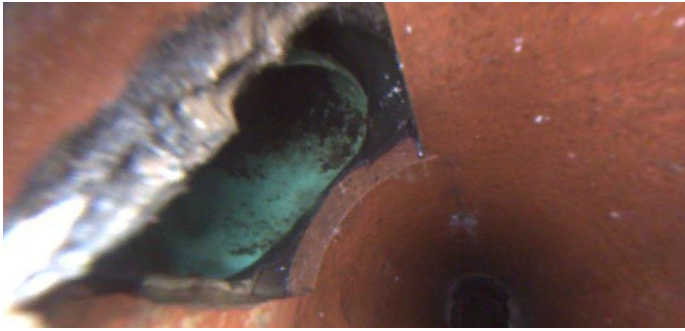
Code: **TBD**  
Description: **Tap Break-in Defective**

Distance (ft): **61.5**  
Structural Grade: **0**  
O&M Grade: **3**  
Clock Start/From: **10**  
Clock To:  
1st Value: **4.000**  
2nd Value:  
Value Percent:  
Continuous Index:  
Within 8" of Joint:  
Remarks: **RFC**

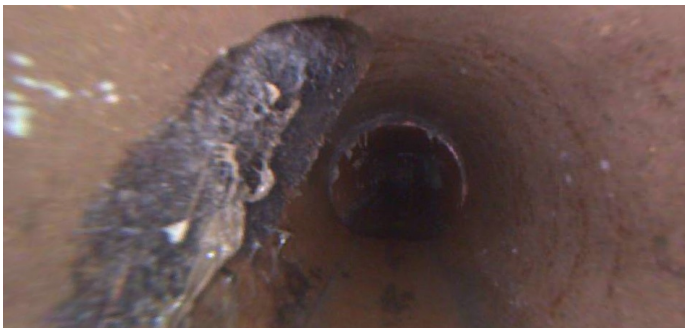
Code: **RBC**  
Description: **Roots Ball Connection**

Distance (ft): **65.6**  
Structural Grade: **0**  
O&M Grade: **4**  
Clock Start/From: **10**  
Clock To:  
1st Value:  
2nd Value:  
Value Percent: **100.000**  
Continuous Index:  
Within 8" of Joint: **NO**  
Remarks:

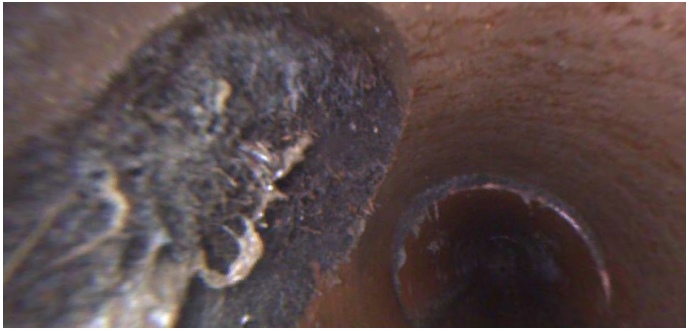
Code: **TFD**  
Description: **Tap Factory Defective**

Distance (ft): **65.8**  
Structural Grade: **0**  
O&M Grade: **2**  
Clock Start/From: **10**  
Clock To:  
1st Value: **4.000**  
2nd Value:  
Value Percent:  
Continuous Index:  
Within 8" of Joint:  
Remarks: **Roots**

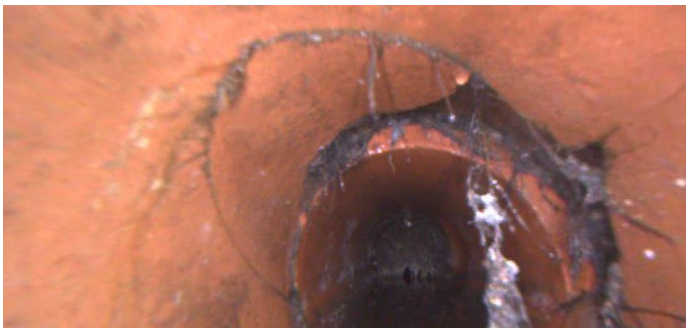
Code: **CM**  
Description: **Crack Multiple**

Distance (ft): **70.5**  
Structural Grade: **3**  
O&M Grade: **0**  
Clock Start/From: **8**  
Clock To: **3**  
1st Value:  
2nd Value:  
Value Percent:  
Continuous Index:  
Within 8" of Joint: **YES**  
Remarks:

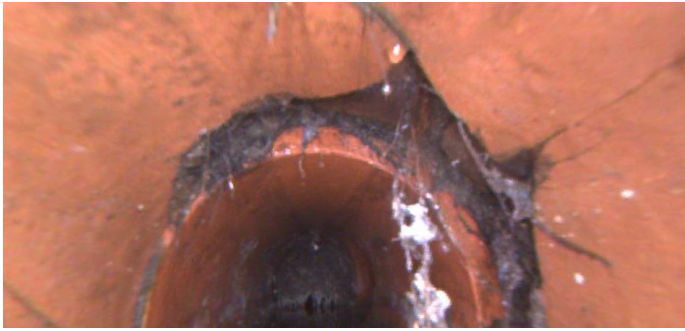
Code: HSV  
Description: Hole Soil Visible

Distance (ft): 70.7  
Structural Grade: 5  
O&M Grade: 0  
Clock Start/From: 11  
Clock To: 3  
1st Value:  
2nd Value:  
Value Percent:  
Continuous Index:  
Within 8" of Joint: YES  
Remarks:

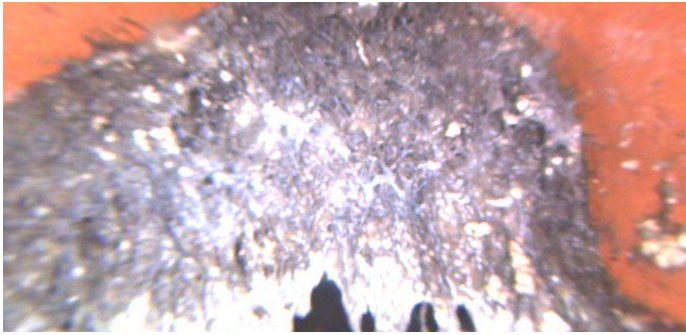
Code: **RBJ**  
Description: **Roots Ball Joint**

Distance (ft): **72.9**  
Structural Grade: **0**  
O&M Grade: **4**  
Clock Start/From: **7**  
Clock To: **5**  
1st Value:  
2nd Value:  
Value Percent: **90.000**  
Continuous Index:  
Within 8" of Joint: **YES**  
Remarks:

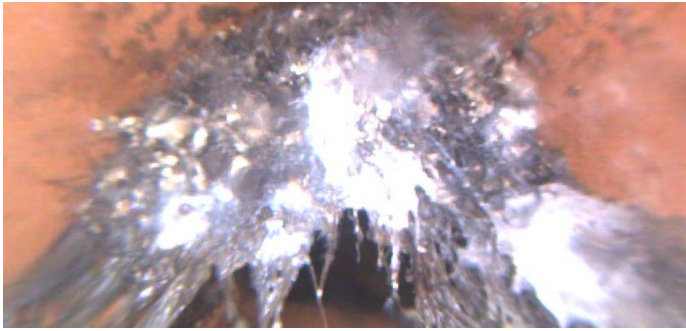
Code: **RMJ**  
Description: **Roots Medium Joint**

Distance (ft): **77.1**  
Structural Grade: **0**  
O&M Grade: **3**  
Clock Start/From: **7**  
Clock To: **5**  
1st Value:  
2nd Value:  
Value Percent: **30.000**  
Continuous Index: **F02**  
Within 8" of Joint: **YES**  
Remarks: **Clock positions vary**

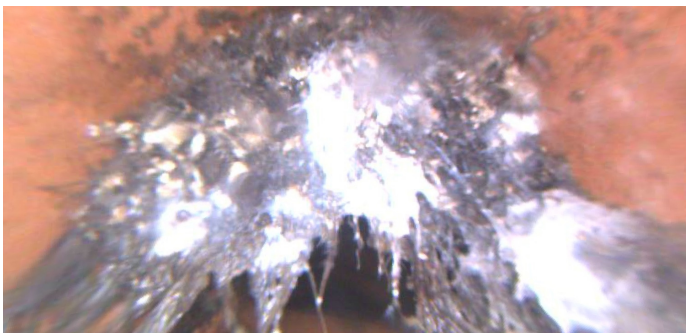
Code: **RBJ**  
Description: **Roots Ball Joint**

Distance (ft): **77.1**  
Structural Grade: **0**  
O&M Grade: **4**  
Clock Start/From: **8**  
Clock To: **4**  
1st Value:  
2nd Value:  
Value Percent: **70.000**  
Continuous Index:  
Within 8" of Joint: **YES**  
Remarks:
