Profile/Photo Observation Report

Date:	03/20/2018	Weather:		Coding:	PACP 6.0
Pipe Length (ft):	237.2	Owner:	NA	Pre Clean:	No Pre-Cleaning
P.O.#:		Surveyor:	John Kuglmaier	PSR:	P-209-012-013
Customer:		Clean Date:	01/01/1900	Shape:	C

Street:	ALLEY BETWEEN MINNESOTA ST & C	Flow Control:	Not Controlled
City:	Hobart, IN	Year Renewed:	
Location:	Light Highway	Tape/Media #:	
Purpose:	Routine Assessment	Dia/Height:	8"
Use:	Sanitary	Material:	VCP
Drain Area:	NA	Lining:	
Category:	NA		
Comment:	P_C at 11 ft unknown obstruction . Flow wrong		
Location Details:		Direction of Survey:	Downstream
US MH:	M-209-013	DS MH:	M-209-012
		Total Length Surveyed (ft):	12.5

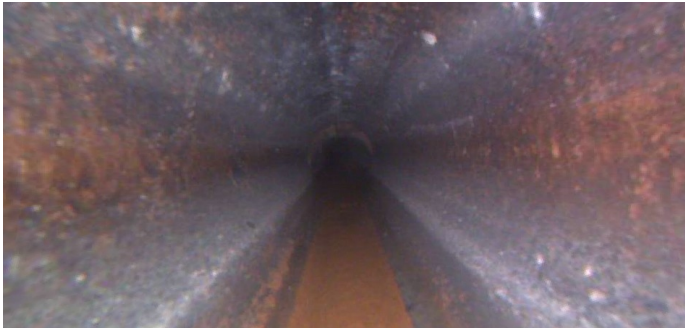
Code:	MWL
Description:	Water Level

Distance (ft):	.0
Structural Grade:	0
O&M Grade:	0
Clock Start/From:	
Clock To:	
1st Value:	
2nd Value:	
Value Percent:	5.000
Continuous Index:	
Within 8" of Joint:	NO
Remarks:

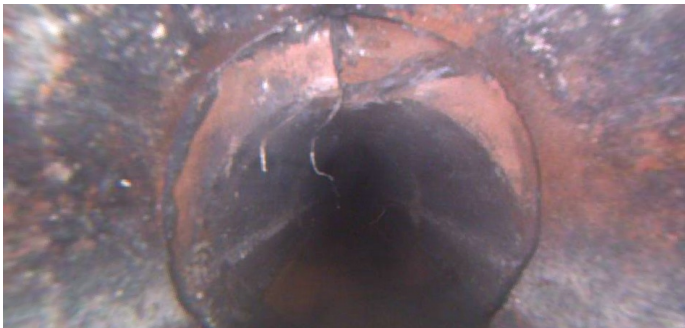
Code:	JOM
Description:	Joint Offset Medium

Distance (ft):	3.6
Structural Grade:	1
O&M Grade:	0
Clock Start/From:	
Clock To:	
1st Value:	
2nd Value:	
Value Percent:	
Continuous Index:	
Within 8" of Joint:	NO
Remarks:

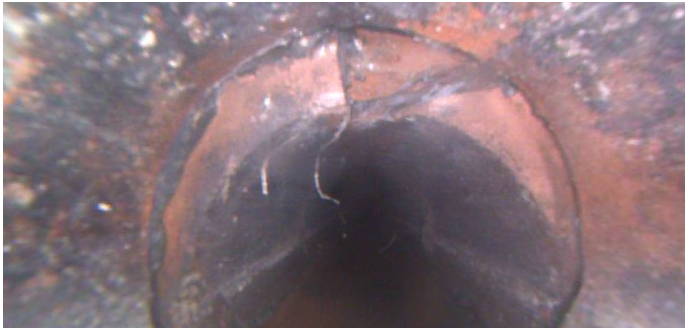
Code: **RFJ**
Description: **Roots Fine Joint**

Distance (ft): **3.7**
Structural Grade: **0**
O&M Grade: **1**
Clock Start/From: **12**
Clock To:
1st Value:
2nd Value:
Value Percent:
Continuous Index:
Within 8" of Joint: **YES**
Remarks:

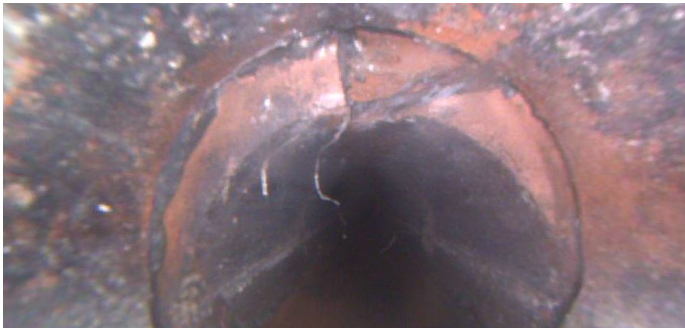
Code: **FM**
Description: **Fracture Multiple**

Distance (ft): **3.7**
Structural Grade: **4**
O&M Grade: **0**
Clock Start/From: **11**
Clock To: **1**
1st Value:
2nd Value:
Value Percent:
Continuous Index:
Within 8" of Joint: **YES**
Remarks:

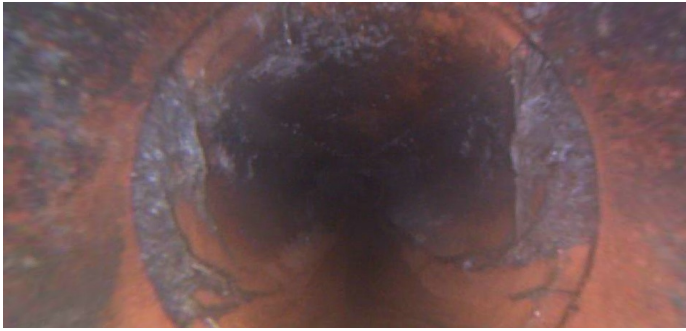
Code: **RFJ**
Description: **Roots Fine Joint**

Distance (ft): **7.7**
Structural Grade: **0**
O&M Grade: **1**
Clock Start/From: **8**
Clock To: **4**
1st Value:
2nd Value:
Value Percent:
Continuous Index:
Within 8" of Joint: **YES**
Remarks:

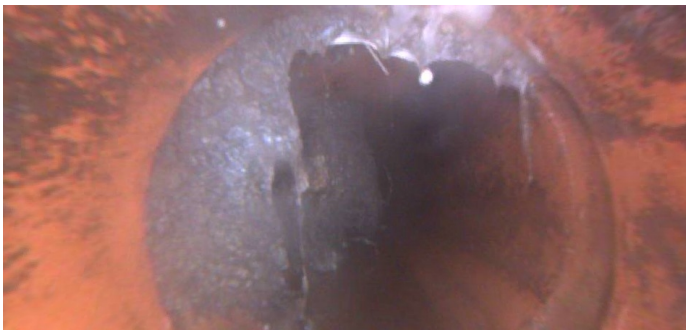
Code: **RMJ**
Description: **Roots Medium Joint**

Distance (ft): **11.6**
Structural Grade: **0**
O&M Grade: **3**
Clock Start/From: **8**
Clock To: **2**
1st Value:
2nd Value:
Value Percent: **30.000**
Continuous Index:
Within 8" of Joint: **YES**
Remarks:

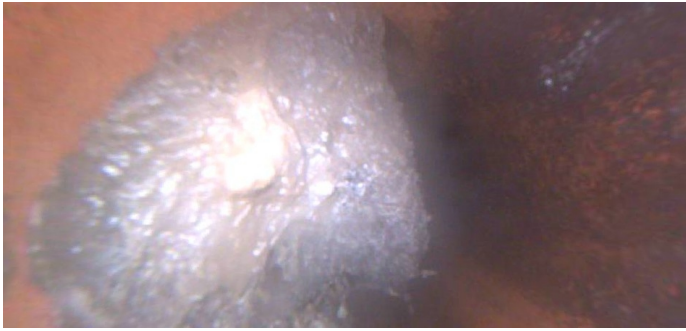
Code: **RMC**
Description: **Roots Medium Connection**

Distance (ft): **12.2**
Structural Grade: **0**
O&M Grade: **3**
Clock Start/From: **7**
Clock To: **12**
1st Value:
2nd Value:
Value Percent: **40.000**
Continuous Index:
Within 8" of Joint: **NO**
Remarks:

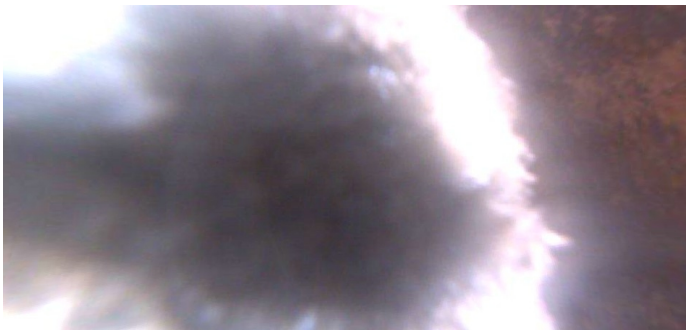
Code: **MSA**
Description: **Abandoned Survey**

Distance (ft): **12.5**
Structural Grade: **0**
O&M Grade: **0**
Clock Start/From:
Clock To:
1st Value:
2nd Value:
Value Percent:
Continuous Index:
Within 8" of Joint: **NO**
Remarks: **RMC**
