Profile/Photo Observation Report

Date:	03/20/2018	Weather:		Coding:	PACP 6.0
Pipe Length (ft):	237.2	Owner:	NA	Pre Clean:	No Pre-Cleaning
P.O.#:		Surveyor:	John Kuglmaier	PSR:	P-209-012-013
Customer:		Clean Date:	01/01/1900	Shape:	C

Street:	ALLEY BETWEEN MINNESOTA ST & C	Flow Control:	Not Controlled
City:	Hobart, IN	Year Renewed:	
Location:	Light Highway	Tape/Media #:	
Purpose:	Routine Assessment	Dia/Height:	8"
Use:	Sanitary	Material:	VCP
Drain Area:	NA	Lining:	
Category:	NA		
Comment:	F_S_P_C at 0 ft build up in the pipe . Flow direction		
Location Details:		Direction of Survey:	Downstream
US MH:	M-209-013	DS MH:	M-209-012
		Total Length Surveyed (ft):	1.3

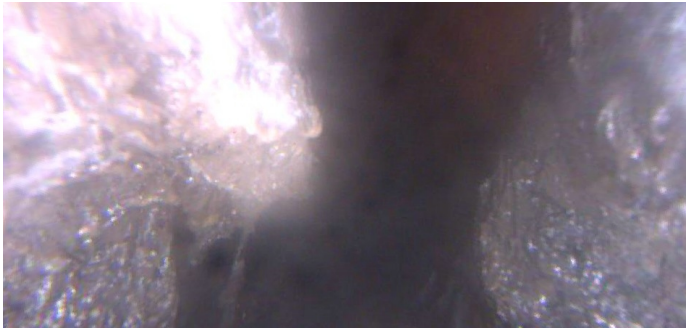
Code:	MWL
Description:	Water Level

Distance (ft):	.0
Structural Grade:	0
O&M Grade:	0
Clock Start/From:	
Clock To:	
1st Value:	
2nd Value:	
Value Percent:	5.000
Continuous Index:	
Within 8" of Joint:	NO
Remarks:

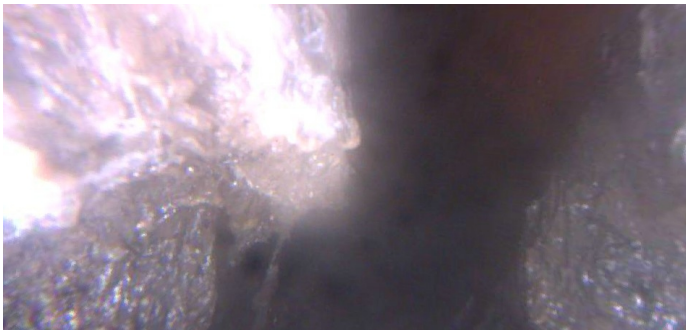
Code:	RMJ
Description:	Roots Medium Joint

Distance (ft):	.0
Structural Grade:	0
O&M Grade:	3
Clock Start/From:	7
Clock To:	5
1st Value:	
2nd Value:	
Value Percent:	40.000
Continuous Index:	
Within 8" of Joint:	YES
Remarks:

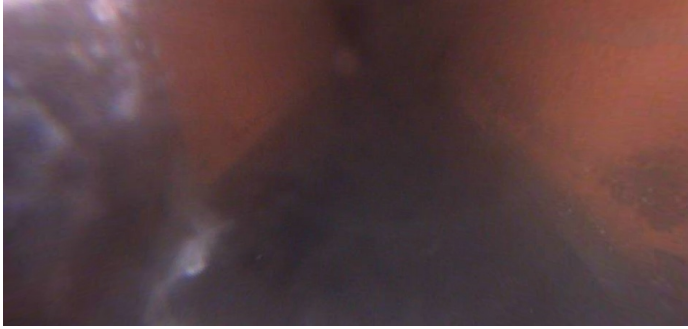
Code:	MSA
Description:	Abandoned Survey
Distance (ft):	1.3
Structural Grade:	0
O&M Grade:	0
Clock Start/From:	
Clock To:	
1st Value:	
2nd Value:	
Value Percent:	
Continuous Index:	
Within 8" of Joint:	NO
Remarks:	RMJ
