Profile/Photo Observation Report

Date:	03/20/2018	Weather:		Coding:	PACP 6.0
Pipe Length (ft):	237.2	Owner:	NA	Pre Clean:	No Pre-Cleaning
P.O.#:		Surveyor:	John Kuglmaier	PSR:	P-209-012-013
Customer:		Clean Date:	01/01/1900	Shape:	C

Street:	FOXCROFT STREET	Flow Control:	Not Controlled
City:	Hobart, IN	Year Renewed:	
Location:	Light Highway	Tape/Media #:	
Purpose:	Routine Assessment	Dia/Height:	8"
Use:	Sanitary	Material:	VCP
Drain Area:	NA	Lining:	
Category:	NA		
Comment:	F_S_P_C at 0 ft build up in the pipe . Flow direction		
Location Details:		Direction of Survey:	Downstream
US MH:	M-209-013	DS MH:	M-209-012
		Total Length Surveyed (ft):	1.3

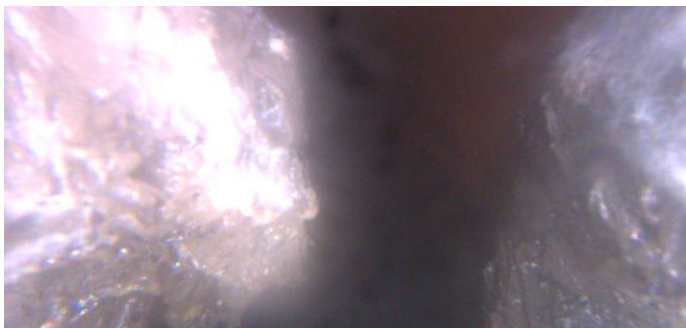
Code: **AMH**
Description: **Manhole**

Distance (ft): **.0**
Structural Grade: **0**
O&M Grade: **0**
Clock Start/From:
Clock To:
1st Value:
2nd Value:
Value Percent:
Continuous Index:
Within 8" of Joint: **NO**
Remarks: **M-209-013**

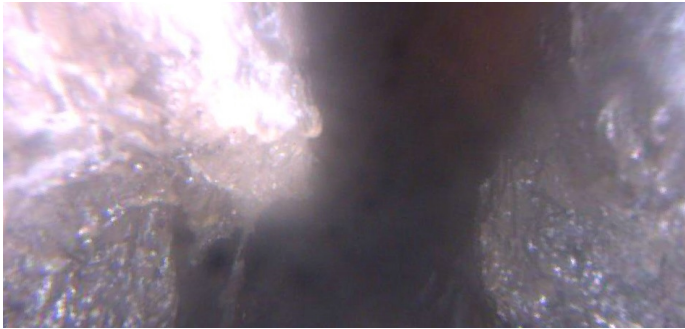
Code:	MWL
Description:	Water Level

Distance (ft):	.0
Structural Grade:	0
O&M Grade:	0
Clock Start/From:	
Clock To:	
1st Value:	
2nd Value:	
Value Percent:	5.000
Continuous Index:	
Within 8" of Joint:	NO
Remarks:

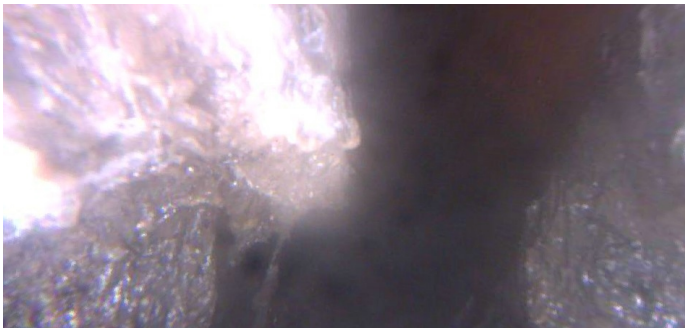
Code:	RMJ
Description:	Roots Medium Joint

Distance (ft):	.0
Structural Grade:	0
O&M Grade:	3
Clock Start/From:	7
Clock To:	5
1st Value:	
2nd Value:	
Value Percent:	40.000
Continuous Index:	
Within 8" of Joint:	YES
Remarks:

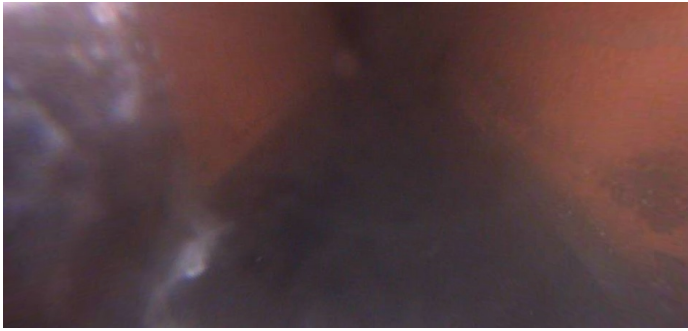
Code:	MSA
Description:	Abandoned Survey
Distance (ft):	1.3
Structural Grade:	0
O&M Grade:	0
Clock Start/From:	
Clock To:	
1st Value:	
2nd Value:	
Value Percent:	
Continuous Index:	
Within 8" of Joint:	NO
Remarks:	RMJ
