Profile/Photo Observation Report

Date:	03/20/2018	Weather:		Coding:	PACP 6.0
Pipe Length (ft):	237.2	Owner:	NA	Pre Clean:	No Pre-Cleaning
P.O.#:		Surveyor:	John Kuglmaier	PSR:	P-209-012-013
Customer:		Clean Date:	01/01/1900	Shape:	C

Street:	ALLEY BETWEEN MINNESOTA ST & C	Flow Control:	Not Controlled
City:	Hobart, IN	Year Renewed:	
Location:	Light Highway	Tape/Media #:	
Purpose:	Routine Assessment	Dia/Height:	8"
Use:	Sanitary	Material:	VCP
Drain Area:	NA	Lining:	
Category:	NA		
Comment:	O_C at 76 ft can see last image and cant find MH . Flow wrong		
Location Details:		Direction of Survey:	Upstream
US MH:	M-209-013	DS MH:	M-209-012
		Total Length Surveyed (ft):	78.0

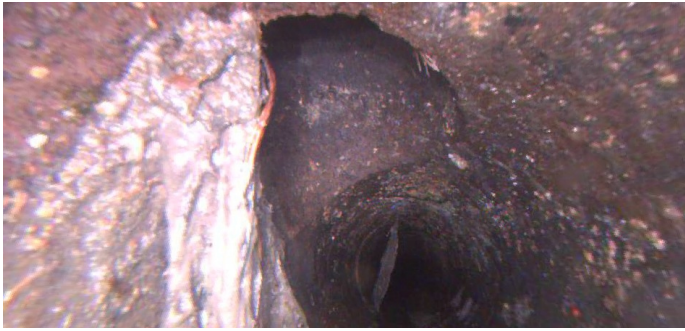
Code: **RFC**
Description: **Roots Fine Connection**

Distance (ft): **12.6**
Structural Grade: **0**
O&M Grade: **1**
Clock Start/From: **11**
Clock To:
1st Value:
2nd Value:
Value Percent:
Continuous Index:
Within 8" of Joint: **NO**
Remarks:

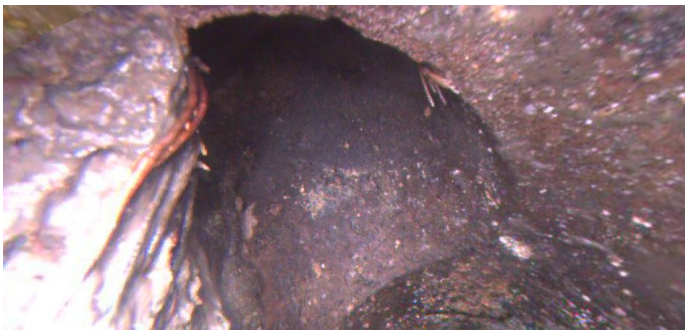
Code: **TFD**
Description: **Tap Factory Defective**

Distance (ft): **12.7**
Structural Grade: **0**
O&M Grade: **2**
Clock Start/From: **11**
Clock To:
1st Value: **4.000**
2nd Value:
Value Percent:
Continuous Index:
Within 8" of Joint:
Remarks: **Roots**

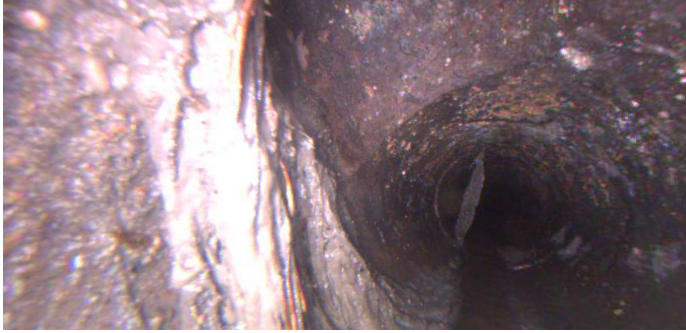
Code: **DAR**
Description: **Deposits Attached Ragging**

Distance (ft): **12.7**
Structural Grade: **0**
O&M Grade: **2**
Clock Start/From: **7**
Clock To: **10**
1st Value:
2nd Value:
Value Percent: **10.000**
Continuous Index:
Within 8" of Joint: **NO**
Remarks:

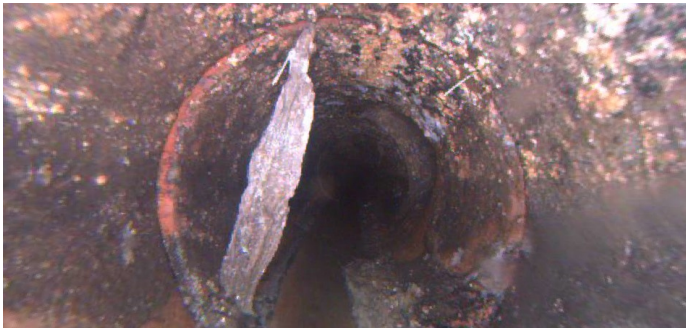
Code: **RFJ**
Description: **Roots Fine Joint**

Distance (ft): **14.0**
Structural Grade: **0**
O&M Grade: **1**
Clock Start/From: **11**
Clock To:
1st Value:
2nd Value:
Value Percent:
Continuous Index:
Within 8" of Joint: **YES**
Remarks:

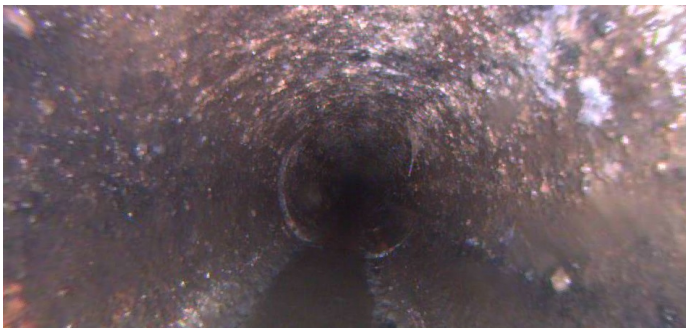
Code: **DAZ**
Description: **Deposits Attached Other**

Distance (ft): **15.3**
Structural Grade: **0**
O&M Grade: **2**
Clock Start/From: **7**
Clock To: **5**
1st Value:
2nd Value:
Value Percent: **5.000**
Continuous Index: **S01**
Within 8" of Joint: **NO**
Remarks: **Mixed materials**

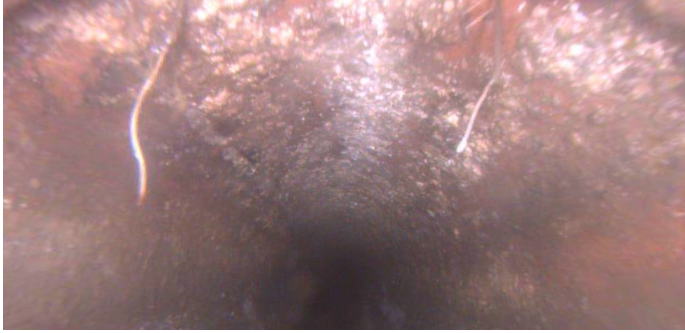
Code: **RFJ**
Description: **Roots Fine Joint**

Distance (ft): **28.5**
Structural Grade: **0**
O&M Grade: **1**
Clock Start/From: **11**
Clock To: **1**
1st Value:
2nd Value:
Value Percent:
Continuous Index:
Within 8" of Joint: **YES**
Remarks:

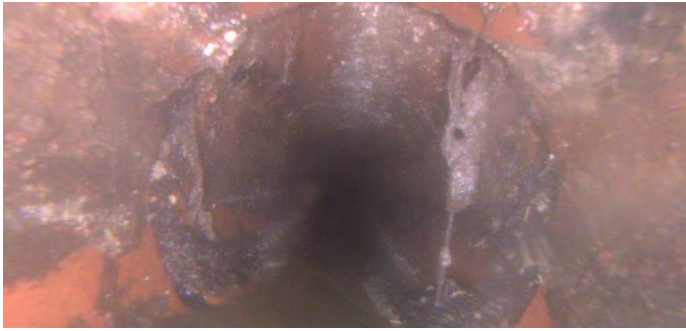
Code: **RFJ**
Description: **Roots Fine Joint**

Distance (ft): **36.3**
Structural Grade: **0**
O&M Grade: **1**
Clock Start/From: **7**
Clock To: **5**
1st Value:
2nd Value:
Value Percent:
Continuous Index:
Within 8" of Joint: **YES**
Remarks:

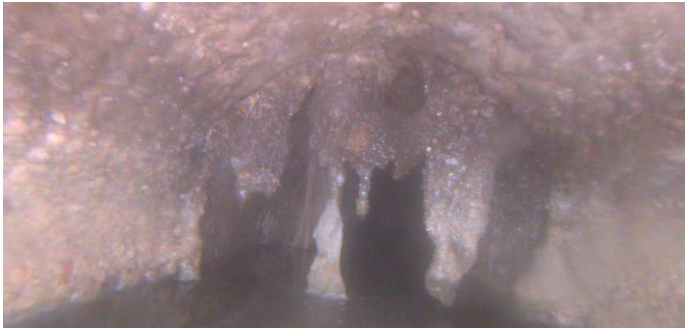
Code: **RMJ**
Description: **Roots Medium Joint**

Distance (ft): **44.5**
Structural Grade: **0**
O&M Grade: **3**
Clock Start/From: **8**
Clock To: **2**
1st Value:
2nd Value:
Value Percent: **25.000**
Continuous Index:
Within 8" of Joint: **YES**
Remarks:

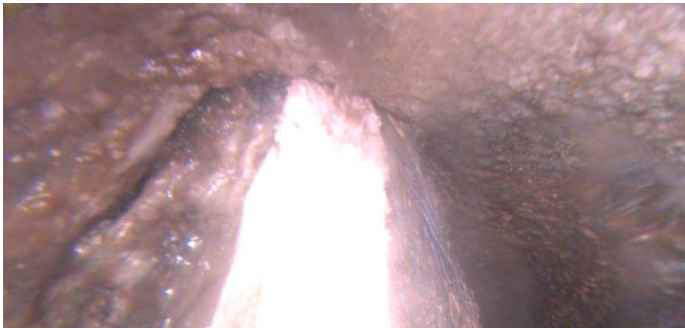
Code: **TFD**
Description: **Tap Factory Defective**

Distance (ft): **45.3**
Structural Grade: **0**
O&M Grade: **2**
Clock Start/From: **11**
Clock To:
1st Value: **4.000**
2nd Value:
Value Percent:
Continuous Index:
Within 8" of Joint:
Remarks: **Roots**

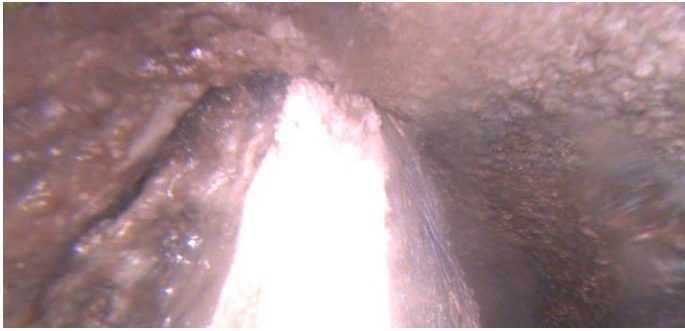
Code: **RBC**
Description: **Roots Ball Connection**

Distance (ft): **45.3**
Structural Grade: **0**
O&M Grade: **4**
Clock Start/From: **11**
Clock To:
1st Value:
2nd Value:
Value Percent: **100.000**
Continuous Index:
Within 8" of Joint: **NO**
Remarks:

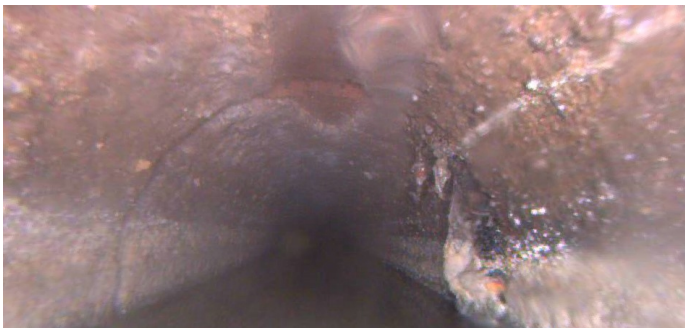
Code: **CL**
Description: **Crack Longitudinal**

Distance (ft): **46.7**
Structural Grade: **2**
O&M Grade: **0**
Clock Start/From: **2**
Clock To:
1st Value:
2nd Value:
Value Percent:
Continuous Index:
Within 8" of Joint: **YES**
Remarks:

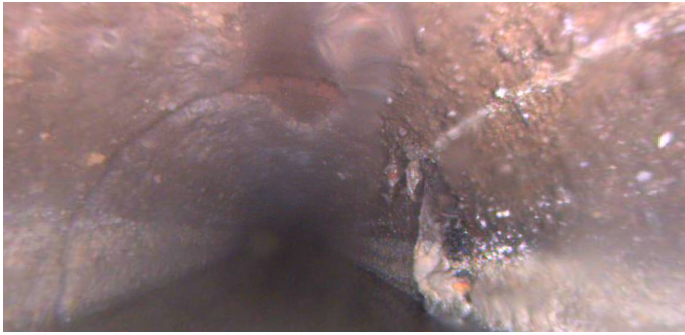
Code: **DAR**
Description: **Deposits Attached Ragging**

Distance (ft): **46.7**
Structural Grade: **0**
O&M Grade: **2**
Clock Start/From: **3**
Clock To: **4**
1st Value:
2nd Value:
Value Percent: **5.000**
Continuous Index:
Within 8" of Joint: **YES**
Remarks:

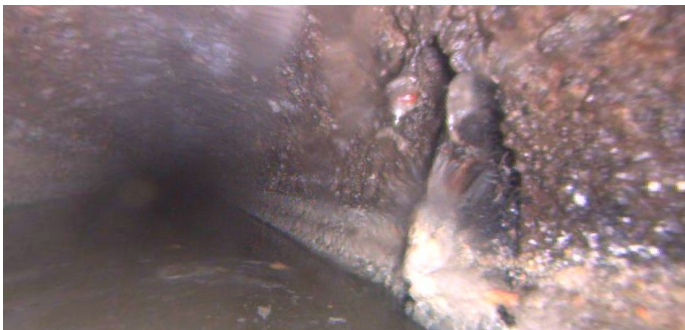
Code: **RFJ**
Description: **Roots Fine Joint**

Distance (ft): **46.8**
Structural Grade: **0**
O&M Grade: **1**
Clock Start/From: **2**
Clock To: **4**
1st Value:
2nd Value:
Value Percent:
Continuous Index:
Within 8" of Joint: **YES**
Remarks:

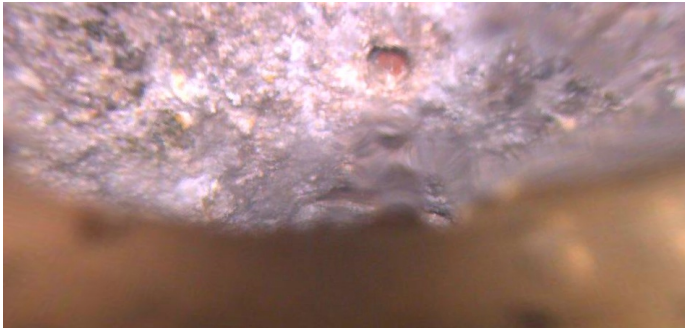
Code: **DAZ**
Description: **Deposits Attached Other**

Distance (ft): **50.6**
Structural Grade: **0**
O&M Grade: **2**
Clock Start/From: **7**
Clock To: **5**
1st Value:
2nd Value:
Value Percent: **5.000**
Continuous Index: **F01**
Within 8" of Joint: **NO**
Remarks: **Mixed materials / Clock positions vary**

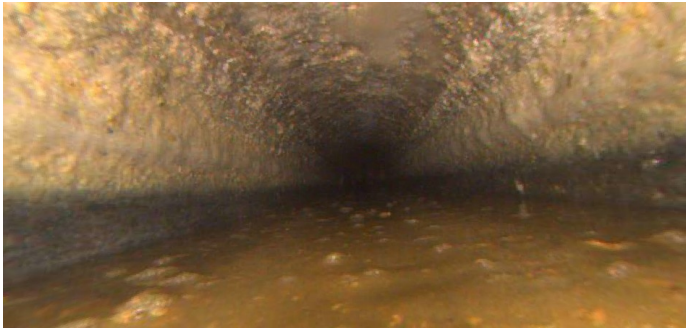
Code: **DAZ**
Description: **Deposits Attached Other**

Distance (ft): **50.6**
Structural Grade: **0**
O&M Grade: **2**
Clock Start/From: **9**
Clock To: **3**
1st Value:
2nd Value:
Value Percent: **10.000**
Continuous Index: **S02**
Within 8" of Joint: **NO**
Remarks: **Mixed materials**

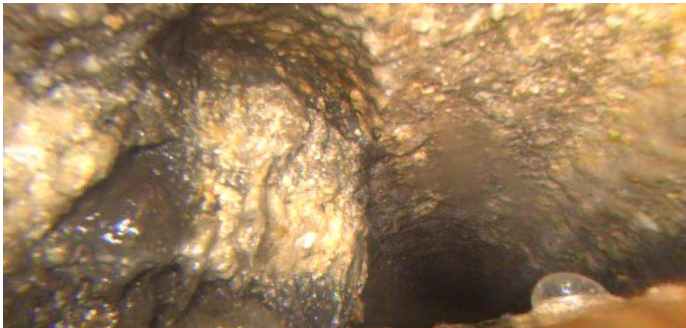
Code: **TFD**
Description: **Tap Factory Defective**

Distance (ft): **52.1**
Structural Grade: **0**
O&M Grade: **2**
Clock Start/From: **2**
Clock To:
1st Value: **4.000**
2nd Value:
Value Percent:
Continuous Index:
Within 8" of Joint:
Remarks: **Roots**

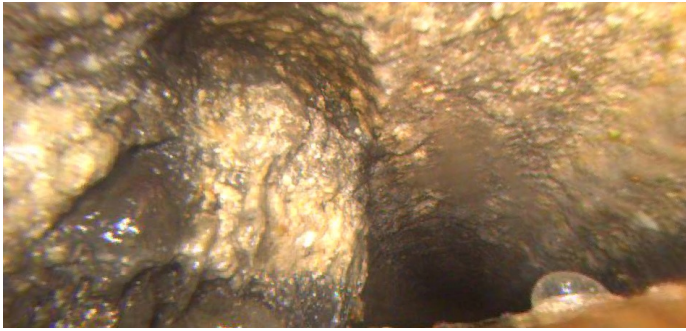
Code: **RML**
Description: **Roots Medium Lateral**

Distance (ft): **52.1**
Structural Grade: **0**
O&M Grade: **3**
Clock Start/From: **1**
Clock To: **3**
1st Value:
2nd Value:
Value Percent: **20.000**
Continuous Index:
Within 8" of Joint: **NO**
Remarks:

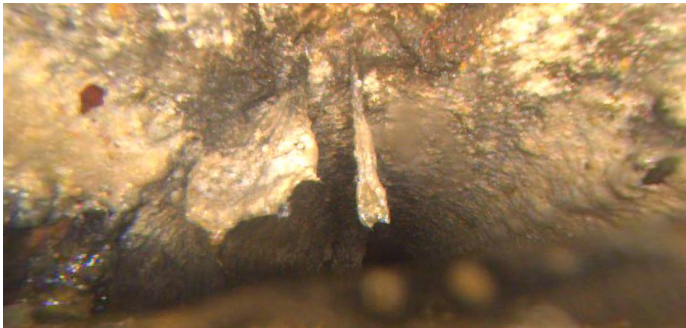
Code: **RFJ**
Description: **Roots Fine Joint**

Distance (ft): **53.4**
Structural Grade: **0**
O&M Grade: **1**
Clock Start/From: **12**
Clock To: **1**
1st Value:
2nd Value:
Value Percent:
Continuous Index:
Within 8" of Joint: **YES**
Remarks:

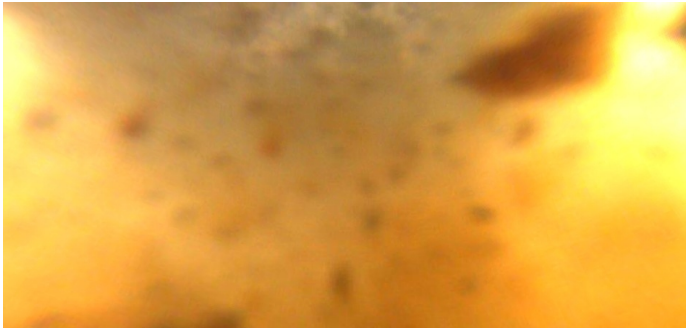
Code: **DAZ**
Description: **Deposits Attached Other**

Distance (ft): **58.7**
Structural Grade: **0**
O&M Grade: **2**
Clock Start/From: **9**
Clock To: **3**
1st Value:
2nd Value:
Value Percent: **10.000**
Continuous Index: **F02**
Within 8" of Joint: **NO**
Remarks: **Mixed materials / Clock positions vary**

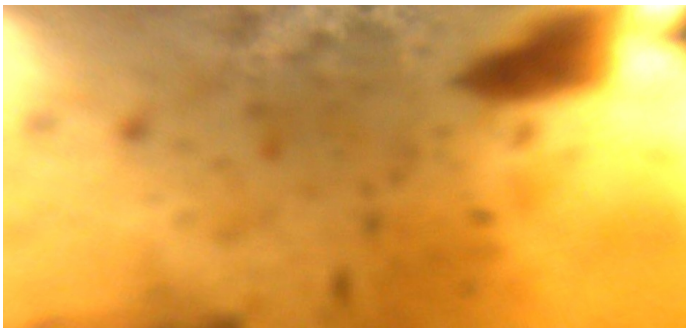
Code: **MCU**
Description: **Camera Underwater**

Distance (ft): **58.7**
Structural Grade: **0**
O&M Grade: **4**
Clock Start/From:
Clock To:
1st Value:
2nd Value:
Value Percent:
Continuous Index:
Within 8" of Joint: **NO**
Remarks:

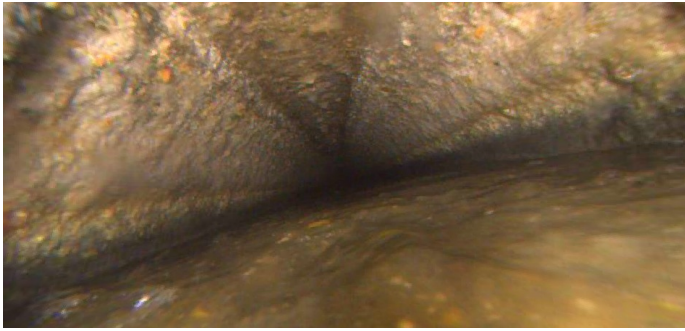
Code: **DAZ**
Description: **Deposits Attached Other**

Distance (ft): **61.4**
Structural Grade: **0**
O&M Grade: **2**
Clock Start/From: **9**
Clock To: **3**
1st Value:
2nd Value:
Value Percent: **10.000**
Continuous Index: **S03**
Within 8" of Joint: **NO**
Remarks: **Mixed materials**

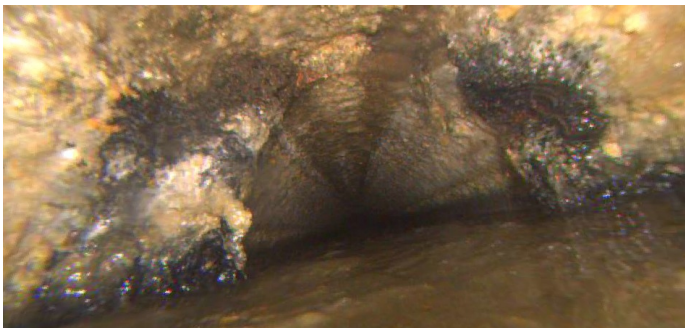
Code: **RMJ**
Description: **Roots Medium Joint**

Distance (ft): **61.7**
Structural Grade: **0**
O&M Grade: **3**
Clock Start/From: **9**
Clock To: **3**
1st Value:
2nd Value:
Value Percent: **20.000**
Continuous Index:
Within 8" of Joint: **YES**
Remarks:

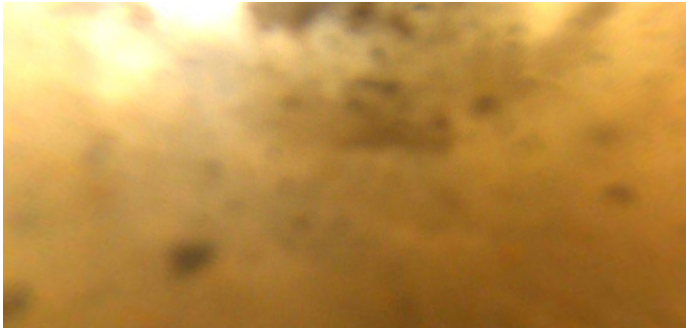
Code: **DAZ**
Description: **Deposits Attached Other**

Distance (ft): **65.6**
Structural Grade: **0**
O&M Grade: **2**
Clock Start/From: **9**
Clock To: **3**
1st Value:
2nd Value:
Value Percent: **10.000**
Continuous Index: **F03**
Within 8" of Joint: **NO**
Remarks: **Mixed materials / Clock positions vary**

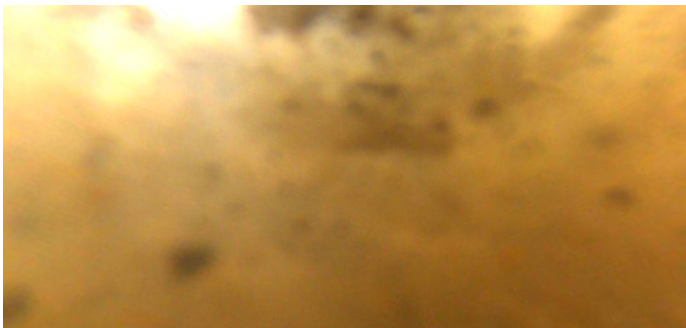
Code: **MCU**
Description: **Camera Underwater**

Distance (ft): **65.6**
Structural Grade: **0**
O&M Grade: **4**
Clock Start/From:
Clock To:
1st Value:
2nd Value:
Value Percent:
Continuous Index: **S04**
Within 8" of Joint: **NO**
Remarks:

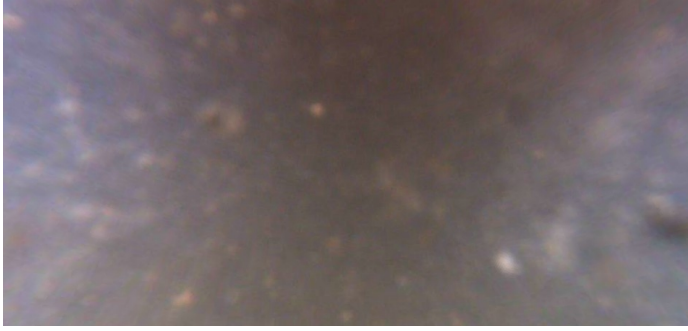
Code:	MSA
Description:	Abandoned Survey
Distance (ft):	78.0
Structural Grade:	0
O&M Grade:	0
Clock Start/From:	
Clock To:	
1st Value:	
2nd Value:	
Value Percent:	
Continuous Index:	
Within 8" of Joint:	NO
Remarks:	Unknown
