Profile/Photo Observation Report

Date:	03/20/2018	Weather:		Coding:	PACP 6.0
Pipe Length (ft):	237.2	Owner:	NA	Pre Clean:	No Pre-Cleaning
P.O.#:		Surveyor:	John Kuglmaier	PSR:	P-209-012-013
Customer:		Clean Date:	01/01/1900	Shape:	C

Street:	FOXCROFT STREET	Flow Control:	Not Controlled
City:	Hobart, IN	Year Renewed:	
Location:	Light Highway	Tape/Media #:	
Purpose:	Routine Assessment	Dia/Height:	8"
Use:	Sanitary	Material:	VCP
Drain Area:	NA	Lining:	
Category:	NA		
Comment:	O_C at 76 ft can see last image and cant find MH . Flow wrong		
Location Details:		Direction of Survey:	Upstream
US MH:	M-209-013	DS MH:	M-209-012
		Total Length Surveyed (ft):	78.0

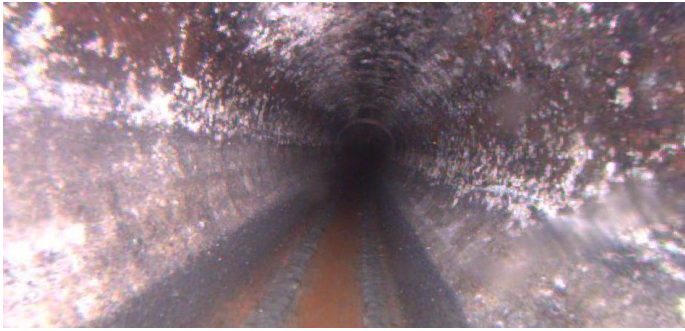
Code: **AMH**
Description: **Manhole**

Distance (ft): **.0**
Structural Grade: **0**
O&M Grade: **0**
Clock Start/From:
Clock To:
1st Value:
2nd Value:
Value Percent:
Continuous Index:
Within 8" of Joint: **NO**
Remarks: **M-209-012**

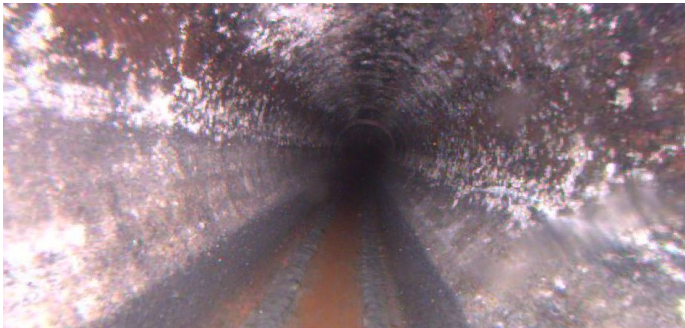
Code: **MWL**
Description: **Water Level**

Distance (ft): **.0**
Structural Grade: **0**
O&M Grade: **0**
Clock Start/From:
Clock To:
1st Value:
2nd Value:
Value Percent: **5.000**
Continuous Index:
Within 8" of Joint: **NO**
Remarks:

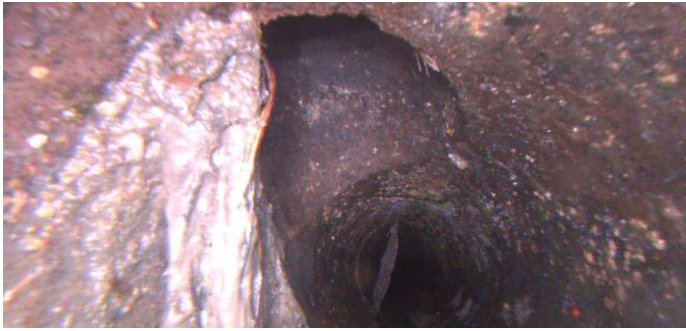
Code: **RFC**
Description: **Roots Fine Connection**

Distance (ft): **12.6**
Structural Grade: **0**
O&M Grade: **1**
Clock Start/From: **11**
Clock To:
1st Value:
2nd Value:
Value Percent:
Continuous Index:
Within 8" of Joint: **NO**
Remarks:

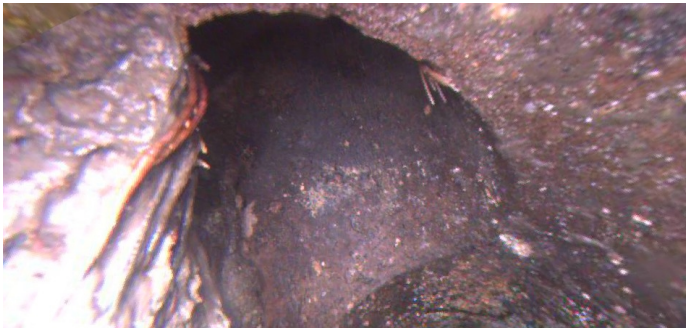
Code: **TFD**
Description: **Tap Factory Defective**

Distance (ft): **12.7**
Structural Grade: **0**
O&M Grade: **2**
Clock Start/From: **11**
Clock To:
1st Value: **4.000**
2nd Value:
Value Percent:
Continuous Index:
Within 8" of Joint:
Remarks: **Roots**

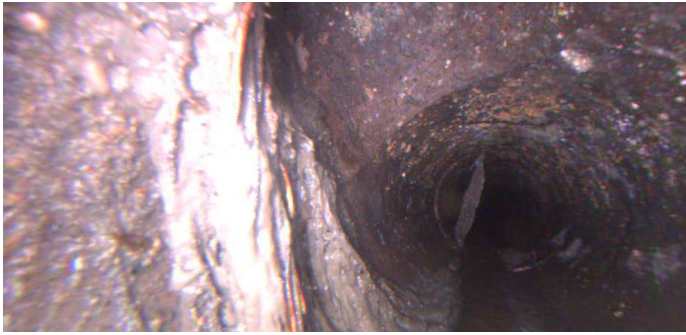
Code: **DAR**
Description: **Deposits Attached Ragging**

Distance (ft): **12.7**
Structural Grade: **0**
O&M Grade: **2**
Clock Start/From: **7**
Clock To: **10**
1st Value:
2nd Value:
Value Percent: **10.000**
Continuous Index:
Within 8" of Joint: **NO**
Remarks:

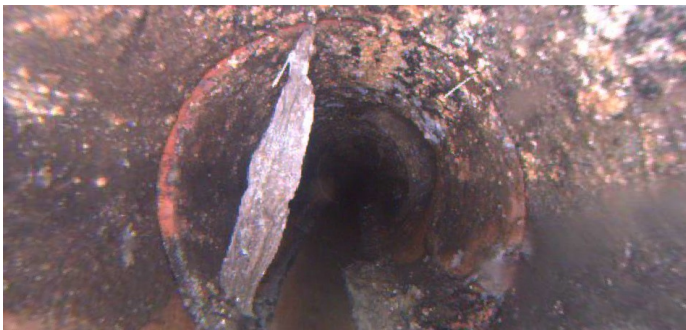
Code: **RFJ**
Description: **Roots Fine Joint**

Distance (ft): **14.0**
Structural Grade: **0**
O&M Grade: **1**
Clock Start/From: **11**
Clock To:
1st Value:
2nd Value:
Value Percent:
Continuous Index:
Within 8" of Joint: **YES**
Remarks:

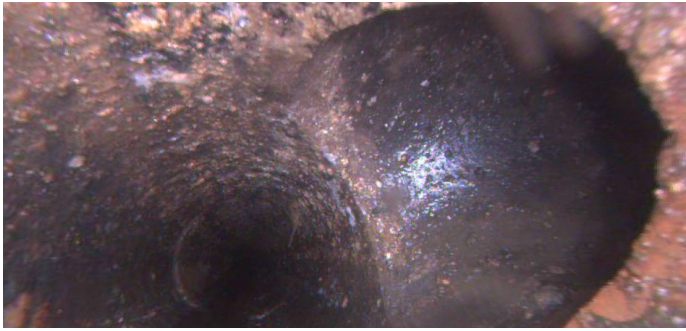
Code: **TF**
Description: **Tap Factory**

Distance (ft): **14.8**
Structural Grade: **0**
O&M Grade: **0**
Clock Start/From: **2**
Clock To:
1st Value: **4.000**
2nd Value:
Value Percent:
Continuous Index:
Within 8" of Joint:
Remarks:

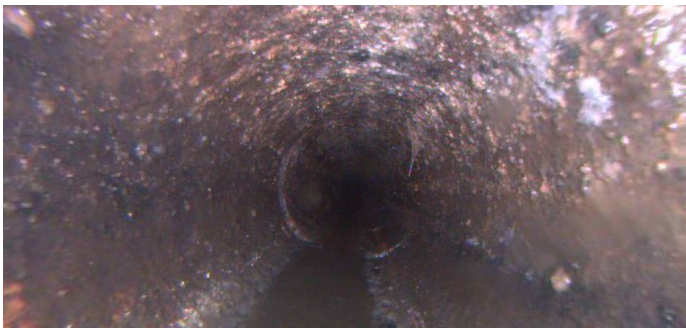
Code: **DAZ**
Description: **Deposits Attached Other**

Distance (ft): **15.3**
Structural Grade: **0**
O&M Grade: **2**
Clock Start/From: **7**
Clock To: **5**
1st Value:
2nd Value:
Value Percent: **5.000**
Continuous Index: **S01**
Within 8" of Joint: **NO**
Remarks: **Mixed materials**

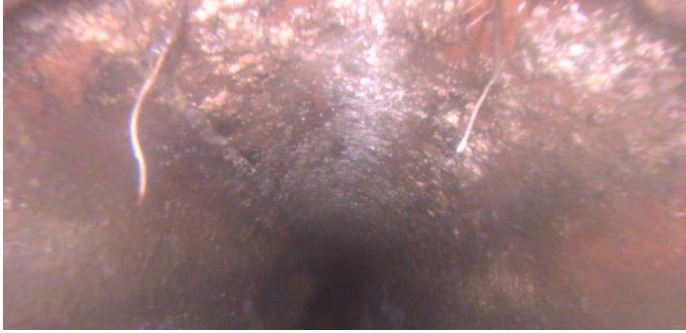
Code: **RFJ**
Description: **Roots Fine Joint**

Distance (ft): **28.5**
Structural Grade: **0**
O&M Grade: **1**
Clock Start/From: **11**
Clock To: **1**
1st Value:
2nd Value:
Value Percent:
Continuous Index:
Within 8" of Joint: **YES**
Remarks:

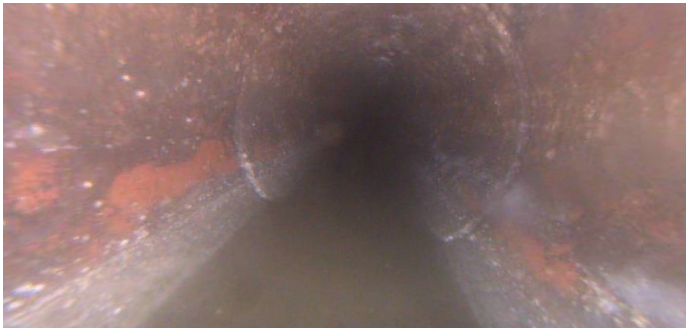
Code: **MWL**
Description: **Water Level**

Distance (ft): **32.1**
Structural Grade: **0**
O&M Grade: **0**
Clock Start/From:
Clock To:
1st Value:
2nd Value:
Value Percent: **15.000**
Continuous Index:
Within 8" of Joint: **NO**
Remarks:

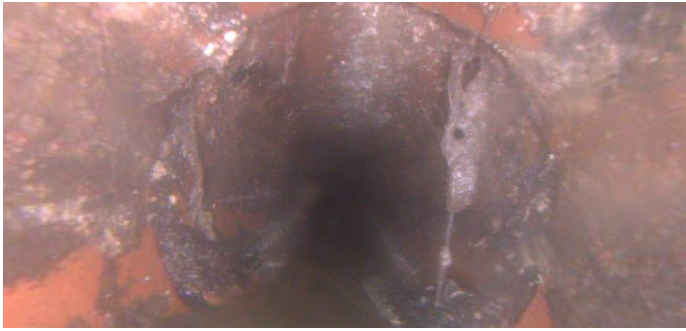
Code: **RFJ**
Description: **Roots Fine Joint**

Distance (ft): **36.3**
Structural Grade: **0**
O&M Grade: **1**
Clock Start/From: **7**
Clock To: **5**
1st Value:
2nd Value:
Value Percent:
Continuous Index:
Within 8" of Joint: **YES**
Remarks:

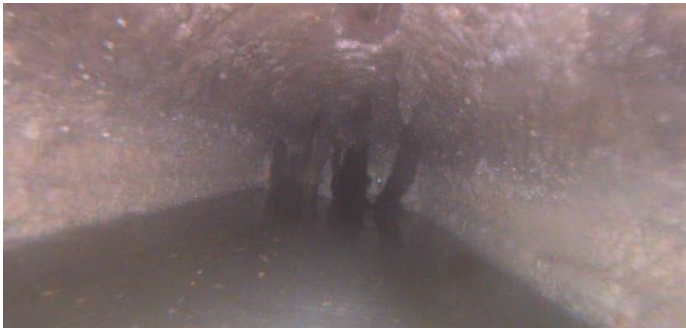
Code: **MWL**
Description: **Water Level**

Distance (ft): **43.9**
Structural Grade: **0**
O&M Grade: **0**
Clock Start/From:
Clock To:
1st Value:
2nd Value:
Value Percent: **35.000**
Continuous Index:
Within 8" of Joint: **NO**
Remarks:

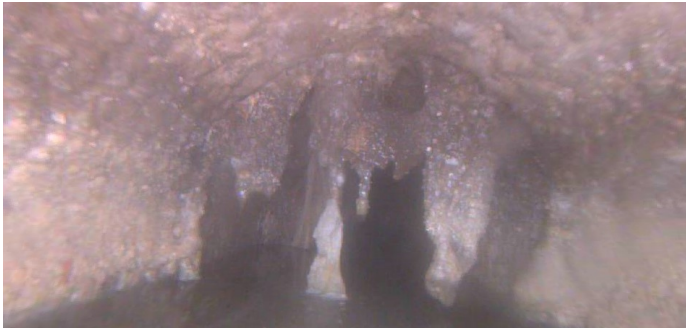
Code: **RMJ**
Description: **Roots Medium Joint**

Distance (ft): **44.5**
Structural Grade: **0**
O&M Grade: **3**
Clock Start/From: **8**
Clock To: **2**
1st Value:
2nd Value:
Value Percent: **25.000**
Continuous Index:
Within 8" of Joint: **YES**
Remarks:

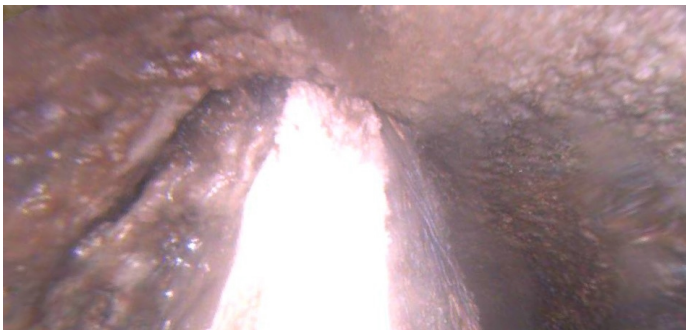
Code: **TFD**
Description: **Tap Factory Defective**

Distance (ft): **45.3**
Structural Grade: **0**
O&M Grade: **2**
Clock Start/From: **11**
Clock To:
1st Value: **4.000**
2nd Value:
Value Percent:
Continuous Index:
Within 8" of Joint:
Remarks: **Roots**

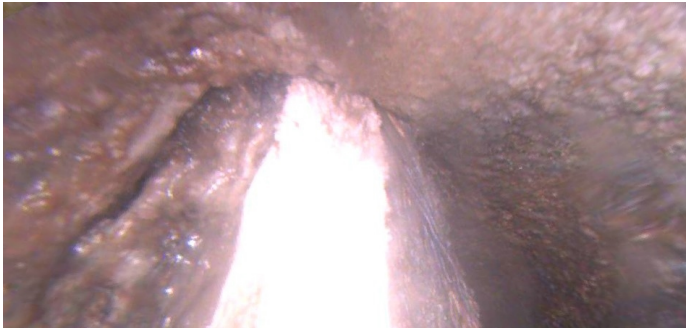
Code: **RBC**
Description: **Roots Ball Connection**

Distance (ft): **45.3**
Structural Grade: **0**
O&M Grade: **4**
Clock Start/From: **11**
Clock To:
1st Value:
2nd Value:
Value Percent: **100.000**
Continuous Index:
Within 8" of Joint: **NO**
Remarks:

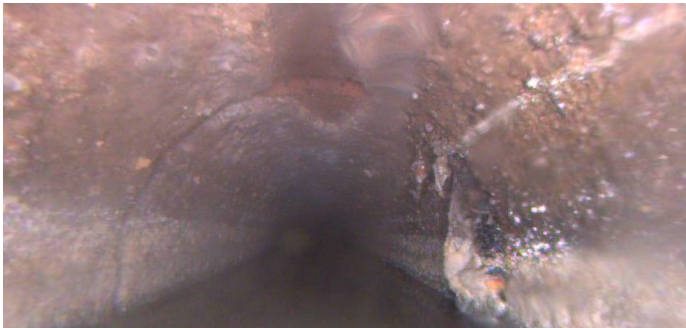
Code: **CL**
Description: **Crack Longitudinal**

Distance (ft): **46.7**
Structural Grade: **2**
O&M Grade: **0**
Clock Start/From: **2**
Clock To:
1st Value:
2nd Value:
Value Percent:
Continuous Index:
Within 8" of Joint: **YES**
Remarks:

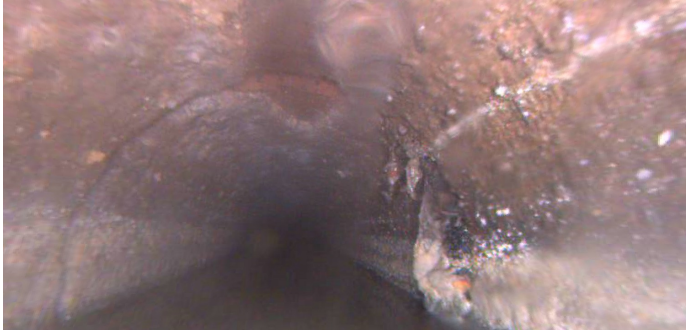
Code: **DAR**
Description: **Deposits Attached Ragging**

Distance (ft): **46.7**
Structural Grade: **0**
O&M Grade: **2**
Clock Start/From: **3**
Clock To: **4**
1st Value:
2nd Value:
Value Percent: **5.000**
Continuous Index:
Within 8" of Joint: **YES**
Remarks:

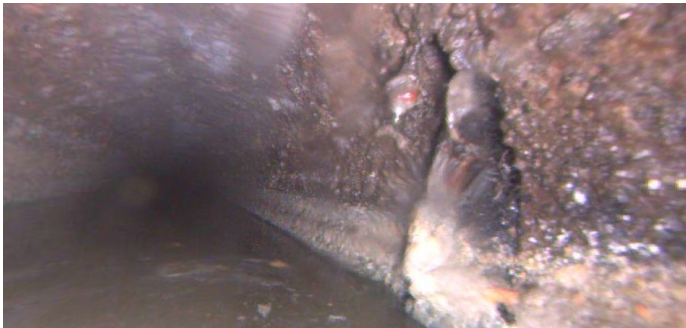
Code: **RFJ**
Description: **Roots Fine Joint**

Distance (ft): **46.8**
Structural Grade: **0**
O&M Grade: **1**
Clock Start/From: **2**
Clock To: **4**
1st Value:
2nd Value:
Value Percent:
Continuous Index:
Within 8" of Joint: **YES**
Remarks:

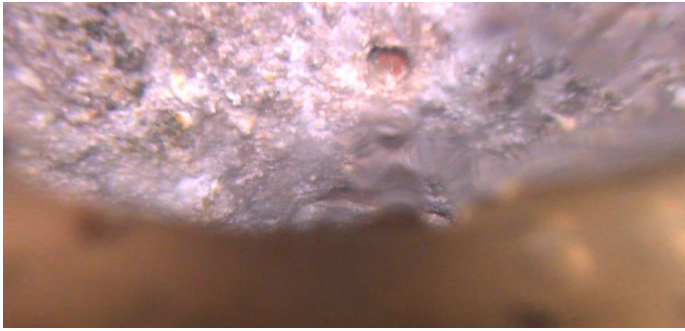
Code: **DAZ**
Description: **Deposits Attached Other**

Distance (ft): **50.6**
Structural Grade: **0**
O&M Grade: **2**
Clock Start/From: **7**
Clock To: **5**
1st Value:
2nd Value:
Value Percent: **5.000**
Continuous Index: **F01**
Within 8" of Joint: **NO**
Remarks: **Mixed materials / Clock positions vary**

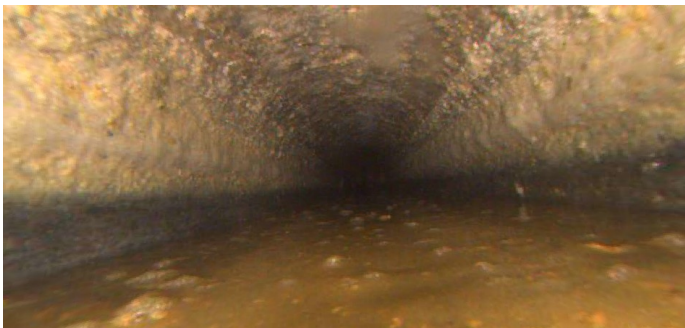
Code: **MGO**
Description: **General Observation**

Distance (ft): **50.6**
Structural Grade: **0**
O&M Grade: **0**
Clock Start/From:
Clock To:
1st Value:
2nd Value:
Value Percent:
Continuous Index:
Within 8" of Joint: **NO**
Remarks: **Switching to rear camera**

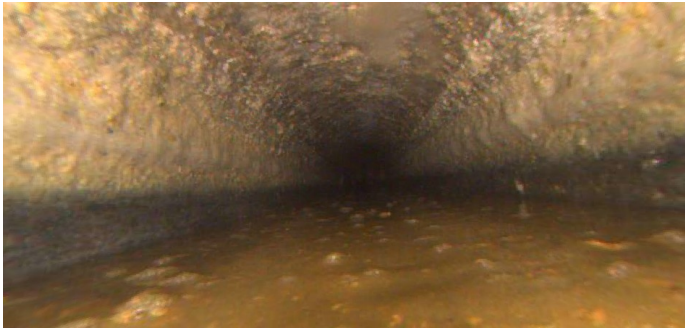
Code: **DAZ**
Description: **Deposits Attached Other**

Distance (ft): **50.6**
Structural Grade: **0**
O&M Grade: **2**
Clock Start/From: **9**
Clock To: **3**
1st Value:
2nd Value:
Value Percent: **10.000**
Continuous Index: **S02**
Within 8" of Joint: **NO**
Remarks: **Mixed materials**

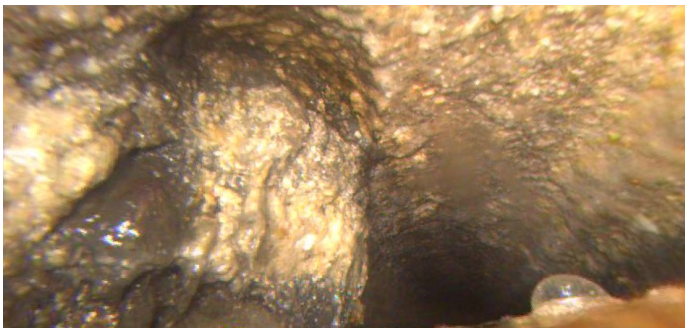
Code: **TFD**
Description: **Tap Factory Defective**

Distance (ft): **52.1**
Structural Grade: **0**
O&M Grade: **2**
Clock Start/From: **2**
Clock To:
1st Value: **4.000**
2nd Value:
Value Percent:
Continuous Index:
Within 8" of Joint:
Remarks: **Roots**

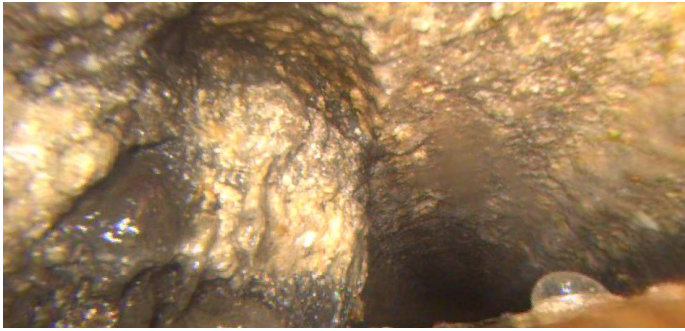
Code: **RML**
Description: **Roots Medium Lateral**

Distance (ft): **52.1**
Structural Grade: **0**
O&M Grade: **3**
Clock Start/From: **1**
Clock To: **3**
1st Value:
2nd Value:
Value Percent: **20.000**
Continuous Index:
Within 8" of Joint: **NO**
Remarks:

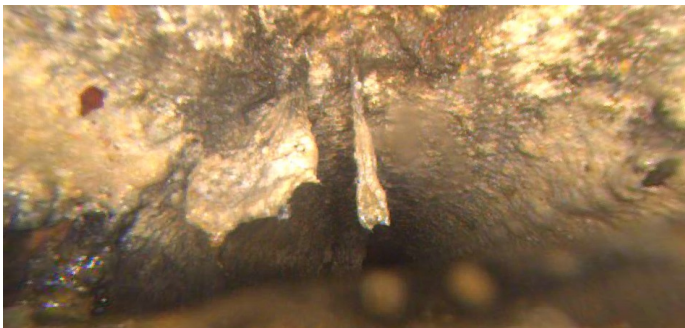
Code: **RFJ**
Description: **Roots Fine Joint**

Distance (ft): **53.4**
Structural Grade: **0**
O&M Grade: **1**
Clock Start/From: **12**
Clock To: **1**
1st Value:
2nd Value:
Value Percent:
Continuous Index:
Within 8" of Joint: **YES**
Remarks:

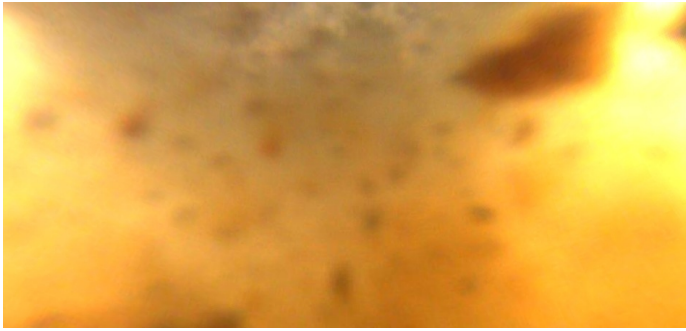
Code: **DAZ**
Description: **Deposits Attached Other**

Distance (ft): **58.7**
Structural Grade: **0**
O&M Grade: **2**
Clock Start/From: **9**
Clock To: **3**
1st Value:
2nd Value:
Value Percent: **10.000**
Continuous Index: **F02**
Within 8" of Joint: **NO**
Remarks: **Mixed materials / Clock positions vary**

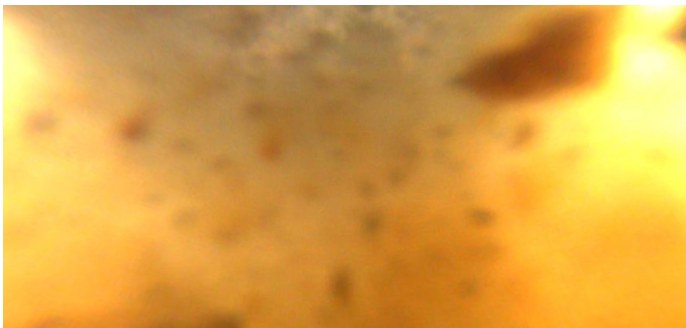
Code: **MCU**
Description: **Camera Underwater**

Distance (ft): **58.7**
Structural Grade: **0**
O&M Grade: **4**
Clock Start/From:
Clock To:
1st Value:
2nd Value:
Value Percent:
Continuous Index:
Within 8" of Joint: **NO**
Remarks:

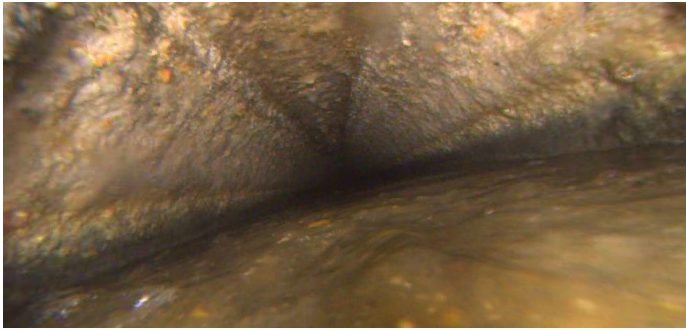
Code: **DAZ**
Description: **Deposits Attached Other**

Distance (ft): **61.4**
Structural Grade: **0**
O&M Grade: **2**
Clock Start/From: **9**
Clock To: **3**
1st Value:
2nd Value:
Value Percent: **10.000**
Continuous Index: **S03**
Within 8" of Joint: **NO**
Remarks: **Mixed materials**

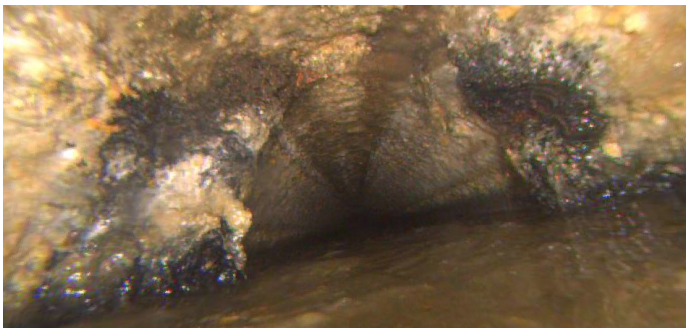
Code: **RMJ**
Description: **Roots Medium Joint**

Distance (ft): **61.7**
Structural Grade: **0**
O&M Grade: **3**
Clock Start/From: **9**
Clock To: **3**
1st Value:
2nd Value:
Value Percent: **20.000**
Continuous Index:
Within 8" of Joint: **YES**
Remarks:

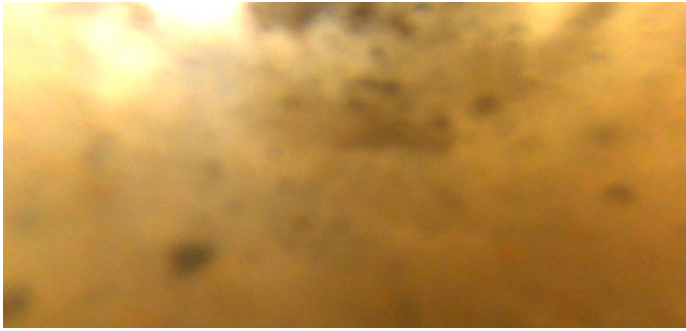
Code: **DAZ**
Description: **Deposits Attached Other**

Distance (ft): **65.6**
Structural Grade: **0**
O&M Grade: **2**
Clock Start/From: **9**
Clock To: **3**
1st Value:
2nd Value:
Value Percent: **10.000**
Continuous Index: **F03**
Within 8" of Joint: **NO**
Remarks: **Mixed materials / Clock positions vary**

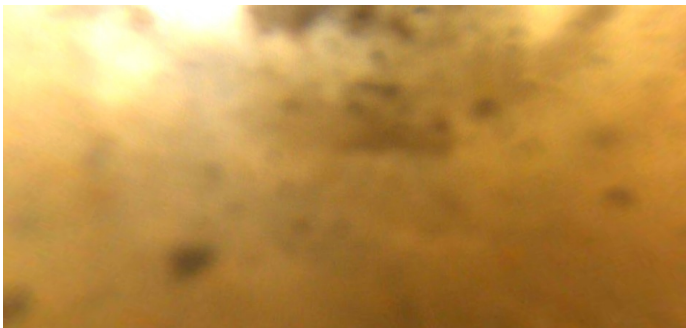
Code: **MCU**
Description: **Camera Underwater**

Distance (ft): **65.6**
Structural Grade: **0**
O&M Grade: **4**
Clock Start/From:
Clock To:
1st Value:
2nd Value:
Value Percent:
Continuous Index: **S04**
Within 8" of Joint: **NO**
Remarks:

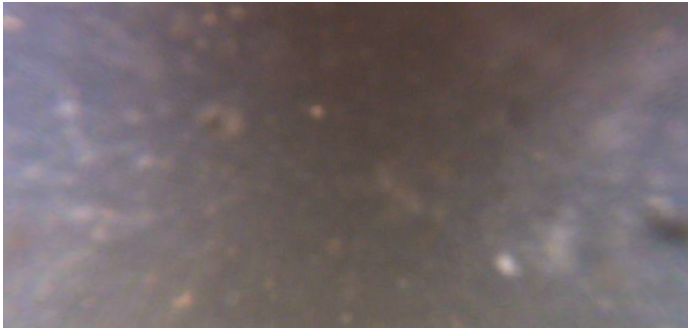
Code:	MSA
Description:	Abandoned Survey
Distance (ft):	78.0
Structural Grade:	0
O&M Grade:	0
Clock Start/From:	
Clock To:	
1st Value:	
2nd Value:	
Value Percent:	
Continuous Index:	
Within 8" of Joint:	NO
Remarks:	Unknown
