## Profile/Photo Observation Report

Date:	<b>03/19/2018</b>	Weather:		Coding:	<b>PACP 6.0</b>
Pipe Length (ft):	<b>288.5</b>	Owner:	<b>NA</b>	Pre Clean:	<b>No Pre-Cleaning</b>
P.O.#:		Surveyor:	<b>John Kuglmaier</b>	PSR:	<b>P-209-008-014</b>
Customer:		Clean Date:	<b>01/01/1900</b>	Shape:	<b>C</b>

Street:	<b>MINNESOTA ST</b>	Flow Control:	<b>Not Controlled</b>
City:	<b>Hobart, IN</b>	Year Renewed:	
Location:	<b>Light Highway</b>	Tape/Media #:	
Purpose:	<b>Routine Assessment</b>	Dia/Height:	<b>8"</b>
Use:	<b>Sanitary</b>	Material:	<b>VCP</b>
Drain Area:	<b>NA</b>	Lining:	
Category:	<b>NA</b>		
Comment:	<b>P_C at 102 ft nothing visible . flow direction</b>		
Location Details:		Direction of Survey:	<b>Downstream</b>
US MH:	<b>M-209-014</b>	DS MH:	<b>M-209-008</b>
		Total Length Surveyed (ft):	<b>103.2</b>

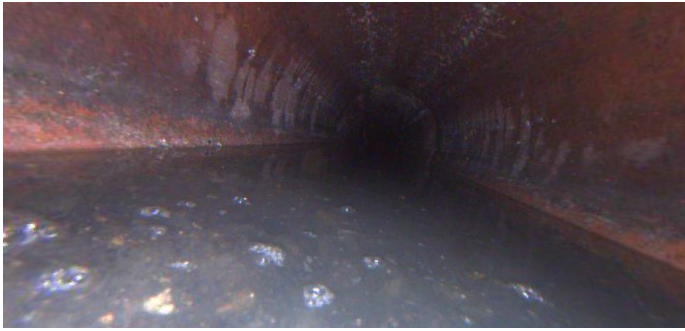
Code: **AMH**  
Description: **Manhole**

Distance (ft): **.0**  
Structural Grade: **0**  
O&M Grade: **0**  
Clock Start/From:  
Clock To:  
1st Value:  
2nd Value:  
Value Percent:  
Continuous Index:  
Within 8" of Joint: **NO**  
Remarks: **M-209-014**

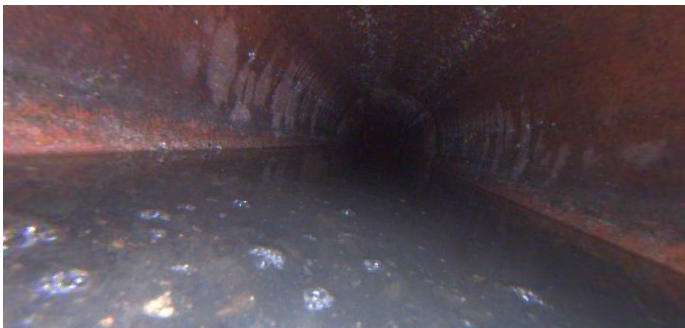
Code: **MWL**  
Description: **Water Level**

Distance (ft): **.0**  
Structural Grade: **0**  
O&M Grade: **0**  
Clock Start/From:  
Clock To:  
1st Value:  
2nd Value:  
Value Percent: **25.000**  
Continuous Index:  
Within 8" of Joint: **NO**  
Remarks:

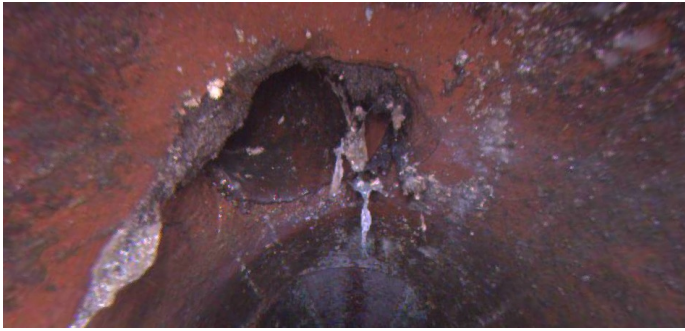
Code: **TBD**  
Description: **Tap Break-in Defective**

Distance (ft): **6.9**  
Structural Grade: **0**  
O&M Grade: **3**  
Clock Start/From: **11**  
Clock To:  
1st Value: **4.000**  
2nd Value:  
Value Percent:  
Continuous Index:  
Within 8" of Joint:  
Remarks: **Roots**

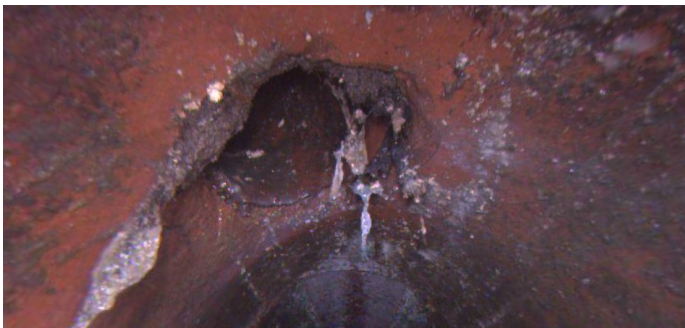
Code: **RFC**  
Description: **Roots Fine Connection**

Distance (ft): **6.9**  
Structural Grade: **0**  
O&M Grade: **1**  
Clock Start/From: **11**  
Clock To:  
1st Value:  
2nd Value:  
Value Percent:  
Continuous Index:  
Within 8" of Joint: **NO**  
Remarks:

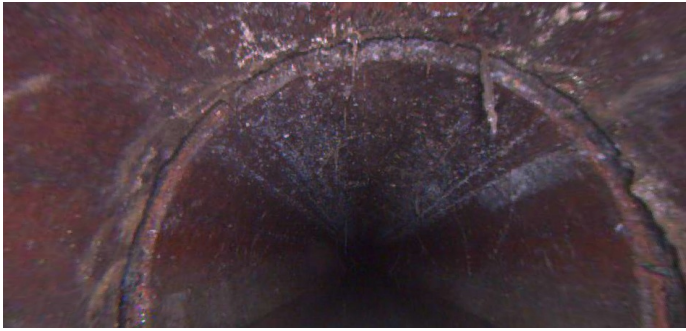
Code: **RFJ**  
Description: **Roots Fine Joint**

Distance (ft): **15.9**  
Structural Grade: **0**  
O&M Grade: **1**  
Clock Start/From: **11**  
Clock To: **1**  
1st Value:  
2nd Value:  
Value Percent:  
Continuous Index:  
Within 8" of Joint: **YES**  
Remarks:

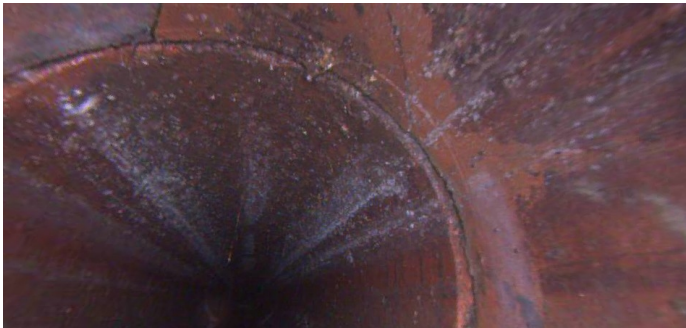
Code: **CM**  
Description: **Crack Multiple**

Distance (ft): **20.0**  
Structural Grade: **3**  
O&M Grade: **0**  
Clock Start/From: **11**  
Clock To: **2**  
1st Value:  
2nd Value:  
Value Percent:  
Continuous Index:  
Within 8" of Joint: **YES**  
Remarks:

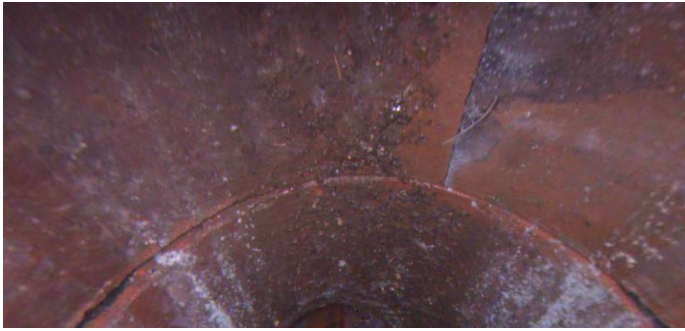
Code: **CL**  
Description: **Crack Longitudinal**

Distance (ft): **28.3**  
Structural Grade: **2**  
O&M Grade: **0**  
Clock Start/From: **1**  
Clock To:  
1st Value:  
2nd Value:  
Value Percent:  
Continuous Index:  
Within 8" of Joint: **YES**  
Remarks:

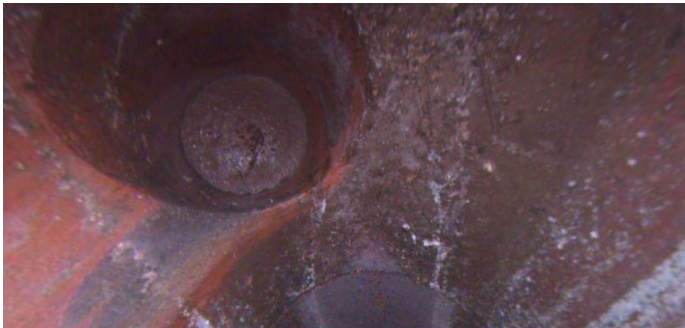
Code: **TFC**  
Description: **Tap Factory Capped**

Distance (ft): **29.7**  
Structural Grade: **0**  
O&M Grade: **0**  
Clock Start/From: **11**  
Clock To:  
1st Value: **4.000**  
2nd Value:  
Value Percent:  
Continuous Index:  
Within 8" of Joint:  
Remarks:

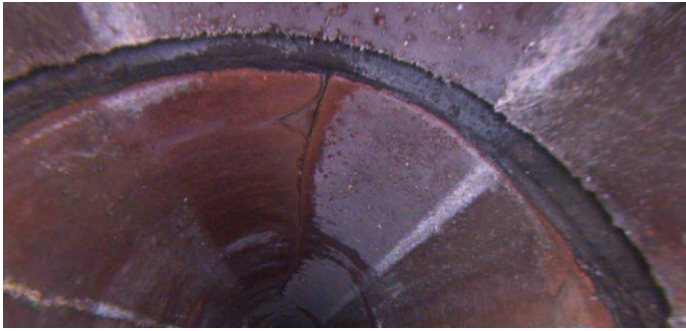
Code: **FL**  
Description: **Fracture Longitudinal**

Distance (ft): **34.8**  
Structural Grade: **3**  
O&M Grade: **0**  
Clock Start/From: **1**  
Clock To:  
1st Value:  
2nd Value:  
Value Percent:  
Continuous Index:  
Within 8" of Joint: **YES**  
Remarks:

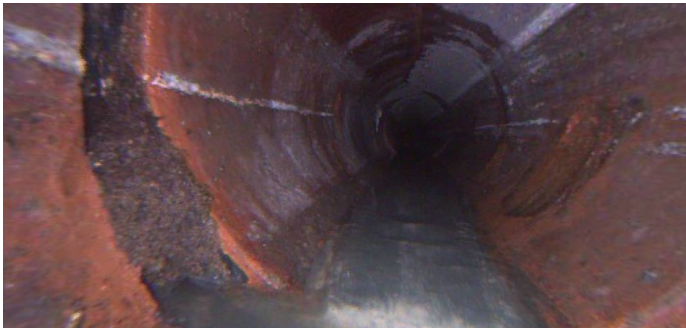
Code: **RFJ**  
Description: **Roots Fine Joint**

Distance (ft): **34.8**  
Structural Grade: **0**  
O&M Grade: **1**  
Clock Start/From: **8**  
Clock To:  
1st Value:  
2nd Value:  
Value Percent:  
Continuous Index:  
Within 8" of Joint: **YES**  
Remarks:

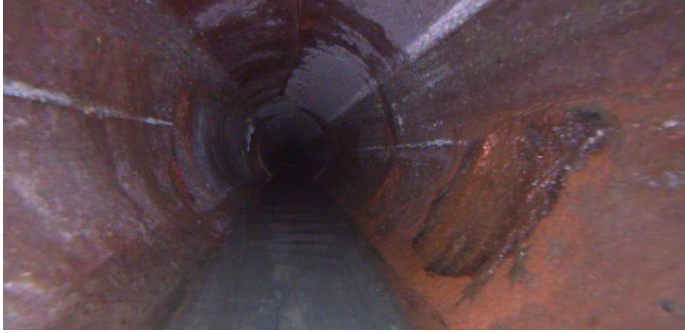
Code: **IW**  
Description: **Infil Weeper**

Distance (ft): **35.3**  
Structural Grade: **0**  
O&M Grade: **2**  
Clock Start/From: **3**  
Clock To: **4**  
1st Value:  
2nd Value:  
Value Percent:  
Continuous Index:  
Within 8" of Joint:  
Remarks:

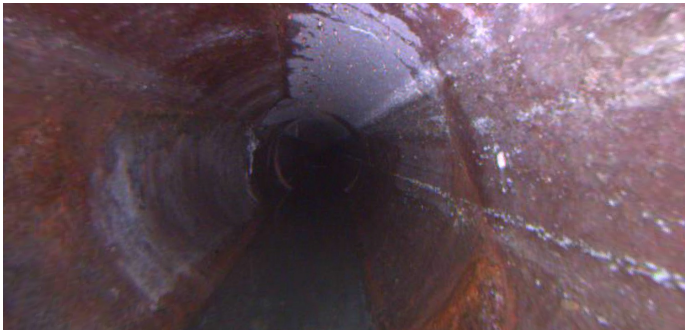
Code: **FM**  
Description: **Fracture Multiple**

Distance (ft): **36.1**  
Structural Grade: **4**  
O&M Grade: **0**  
Clock Start/From: **8**  
Clock To: **4**  
1st Value:  
2nd Value:  
Value Percent:  
Continuous Index:  
Within 8" of Joint:  
Remarks:

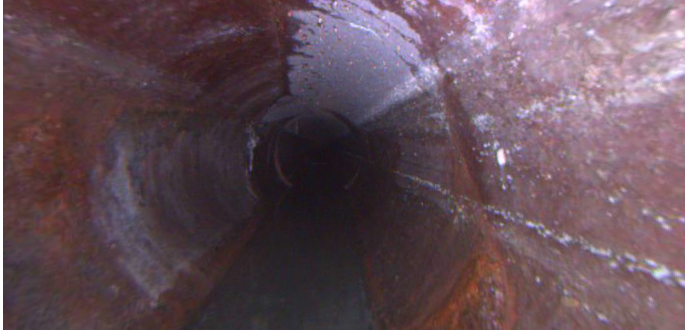
Code: **IW**  
Description: **Infil Weeper**

Distance (ft): **36.1**  
Structural Grade: **0**  
O&M Grade: **2**  
Clock Start/From: **3**  
Clock To: **4**  
1st Value:  
2nd Value:  
Value Percent:  
Continuous Index:  
Within 8" of Joint:  
Remarks:

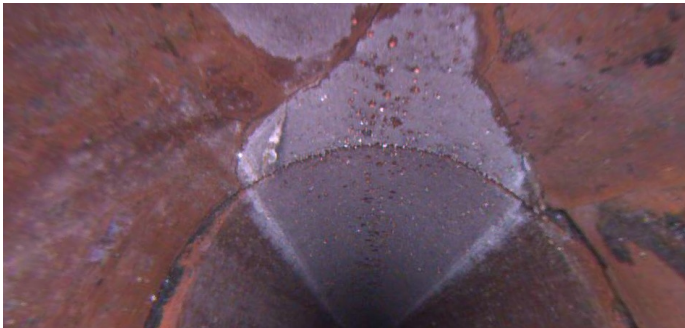
Code: **CM**  
Description: **Crack Multiple**

Distance (ft): **38.7**  
Structural Grade: **3**  
O&M Grade: **0**  
Clock Start/From: **11**  
Clock To: **1**  
1st Value:  
2nd Value:  
Value Percent:  
Continuous Index:  
Within 8" of Joint: **YES**  
Remarks:

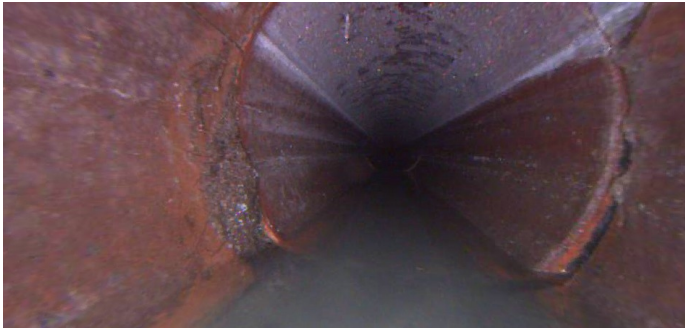
Code: **RFJ**  
Description: **Roots Fine Joint**

Distance (ft): **47.0**  
Structural Grade: **0**  
O&M Grade: **1**  
Clock Start/From: **8**  
Clock To:  
1st Value:  
2nd Value:  
Value Percent:  
Continuous Index:  
Within 8" of Joint: **YES**  
Remarks:

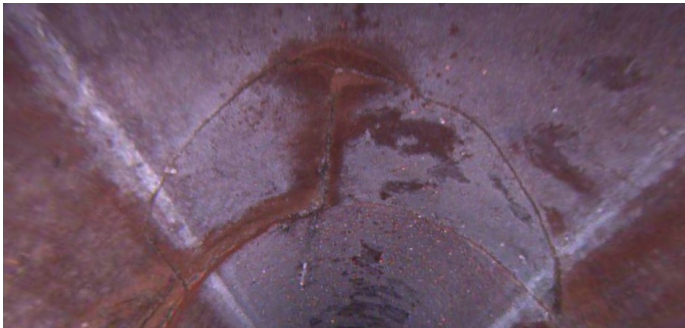
Code: **FM**  
Description: **Fracture Multiple**

Distance (ft): **47.0**  
Structural Grade: **4**  
O&M Grade: **0**  
Clock Start/From: **11**  
Clock To: **2**  
1st Value:  
2nd Value:  
Value Percent:  
Continuous Index:  
Within 8" of Joint: **YES**  
Remarks:

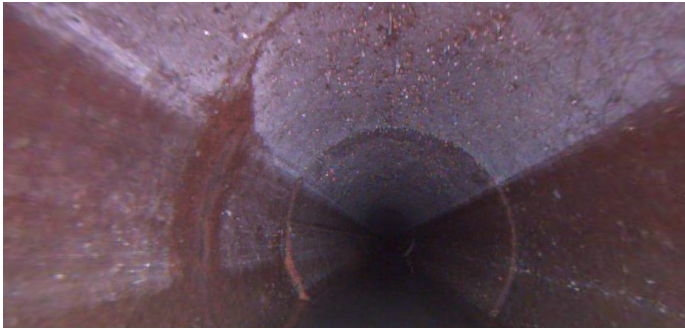
Code: **CC**  
Description: **Crack Circumferential**

Distance (ft): **54.6**  
Structural Grade: **1**  
O&M Grade: **0**  
Clock Start/From: **8**  
Clock To: **11**  
1st Value:  
2nd Value:  
Value Percent:  
Continuous Index:  
Within 8" of Joint:  
Remarks:

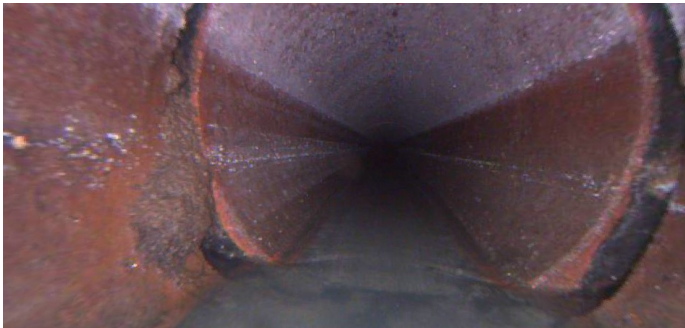
Code: **DAZ**  
Description: **Deposits Attached Other**

Distance (ft): **63.6**  
Structural Grade: **0**  
O&M Grade: **2**  
Clock Start/From: **8**  
Clock To: **9**  
1st Value:  
2nd Value:  
Value Percent: **5.000**  
Continuous Index:  
Within 8" of Joint: **YES**  
Remarks: **Mixed materials**

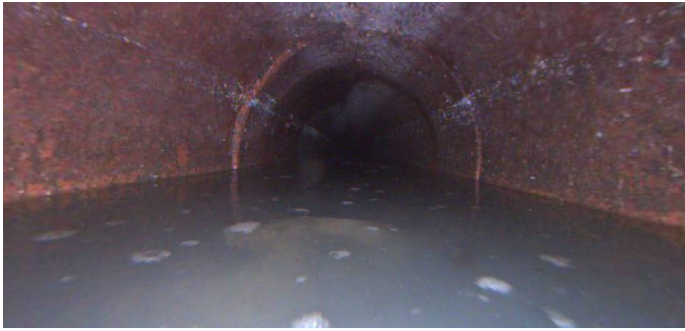
Code: **MWL**  
Description: **Water Level**

Distance (ft): **75.4**  
Structural Grade: **0**  
O&M Grade: **0**  
Clock Start/From:  
Clock To:  
1st Value:  
2nd Value:  
Value Percent: **40.000**  
Continuous Index:  
Within 8" of Joint: **NO**  
Remarks:

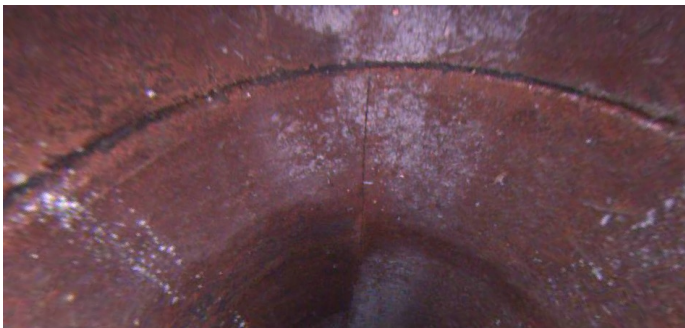
Code: **CL**  
Description: **Crack Longitudinal**

Distance (ft): **76.3**  
Structural Grade: **2**  
O&M Grade: **0**  
Clock Start/From: **12**  
Clock To:  
1st Value:  
2nd Value:  
Value Percent:  
Continuous Index:  
Within 8" of Joint: **YES**  
Remarks:

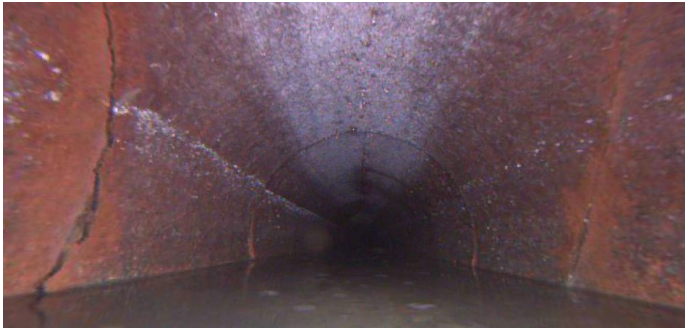
Code: **FM**  
Description: **Fracture Multiple**

Distance (ft): **79.5**  
Structural Grade: **4**  
O&M Grade: **0**  
Clock Start/From: **8**  
Clock To: **4**  
1st Value:  
2nd Value:  
Value Percent:  
Continuous Index:  
Within 8" of Joint:  
Remarks:

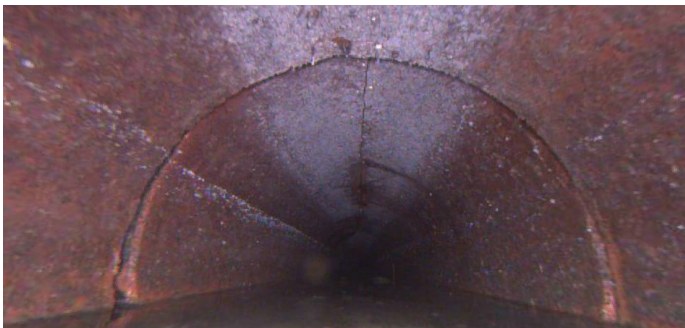
Code: **CL**  
Description: **Crack Longitudinal**

Distance (ft): **80.1**  
Structural Grade: **2**  
O&M Grade: **0**  
Clock Start/From: **12**  
Clock To:  
1st Value:  
2nd Value:  
Value Percent:  
Continuous Index:  
Within 8" of Joint: **YES**  
Remarks:

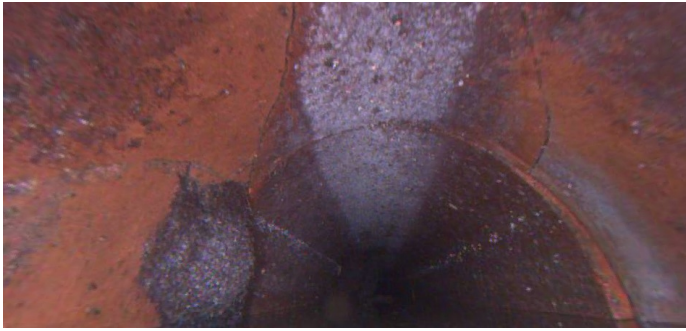
Code: **FM**  
Description: **Fracture Multiple**

Distance (ft): **84.1**  
Structural Grade: **4**  
O&M Grade: **0**  
Clock Start/From: **11**  
Clock To: **1**  
1st Value:  
2nd Value:  
Value Percent:  
Continuous Index:  
Within 8" of Joint: **YES**  
Remarks:

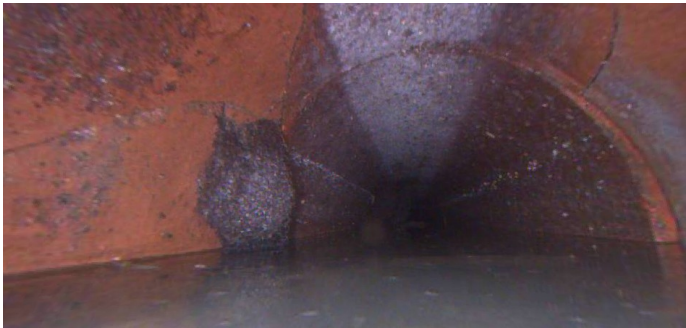
Code: **RMJ**  
Description: **Roots Medium Joint**

Distance (ft): **84.1**  
Structural Grade: **0**  
O&M Grade: **3**  
Clock Start/From: **9**  
Clock To: **10**  
1st Value:  
2nd Value:  
Value Percent: **5.000**  
Continuous Index:  
Within 8" of Joint: **YES**  
Remarks:

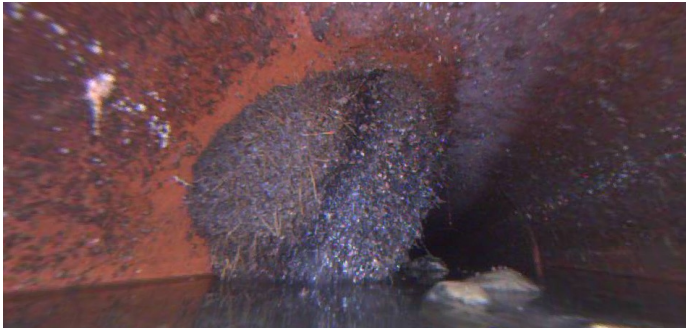
Code: **TFD**  
Description: **Tap Factory Defective**

Distance (ft): **86.6**  
Structural Grade: **0**  
O&M Grade: **2**  
Clock Start/From: **11**  
Clock To:  
1st Value: **4.000**  
2nd Value:  
Value Percent:  
Continuous Index:  
Within 8" of Joint:  
Remarks: **Roots**

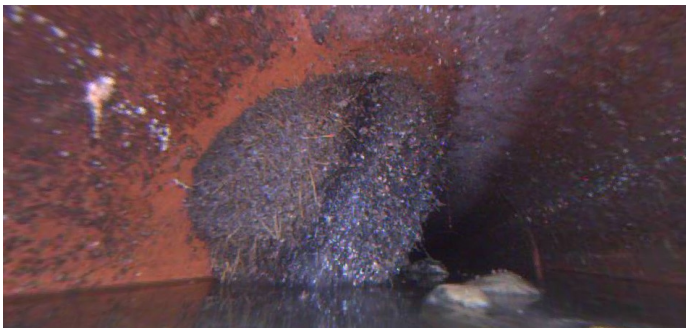
Code: **RBC**  
Description: **Roots Ball Connection**

Distance (ft): **86.6**  
Structural Grade: **0**  
O&M Grade: **4**  
Clock Start/From: **11**  
Clock To:  
1st Value:  
2nd Value:  
Value Percent: **100.000**  
Continuous Index:  
Within 8" of Joint: **NO**  
Remarks:

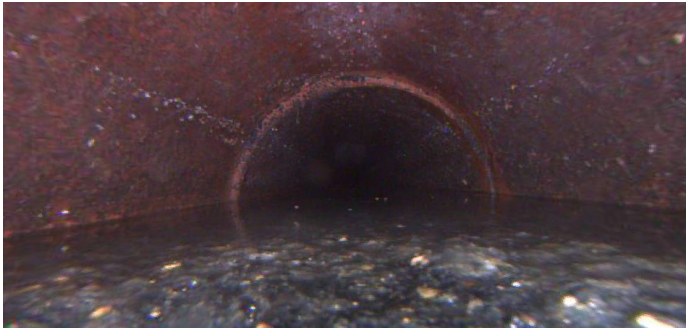
Code: **MWL**  
Description: **Water Level**

Distance (ft): **91.5**  
Structural Grade: **0**  
O&M Grade: **0**  
Clock Start/From:  
Clock To:  
1st Value:  
2nd Value:  
Value Percent: **50.000**  
Continuous Index:  
Within 8" of Joint: **NO**  
Remarks:

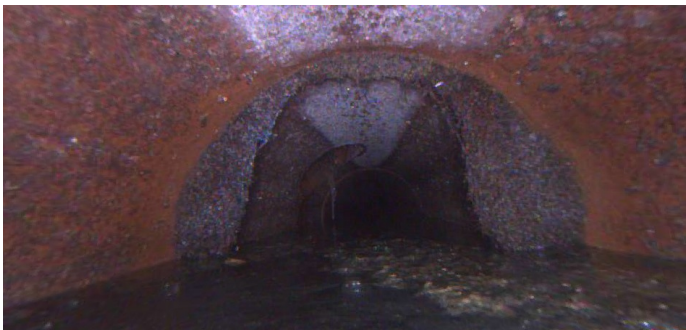
Code: **RMJ**  
Description: **Roots Medium Joint**

Distance (ft): **100.3**  
Structural Grade: **0**  
O&M Grade: **3**  
Clock Start/From: **9**  
Clock To: **3**  
1st Value:  
2nd Value:  
Value Percent: **25.000**  
Continuous Index:  
Within 8" of Joint: **YES**  
Remarks:

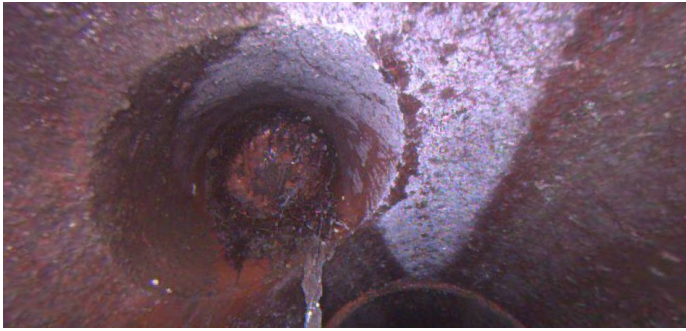
Code: **TFC**  
Description: **Tap Factory Capped**

Distance (ft): **101.8**  
Structural Grade: **0**  
O&M Grade: **0**  
Clock Start/From: **11**  
Clock To:  
1st Value: **4.000**  
2nd Value:  
Value Percent:  
Continuous Index:  
Within 8" of Joint:  
Remarks:

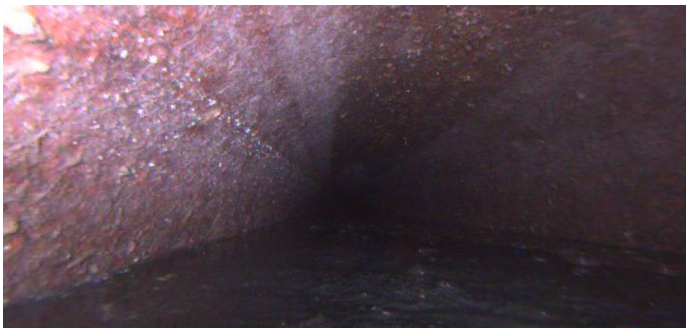
Code: **MSA**  
Description: **Abandoned Survey**

Distance (ft): **103.2**  
Structural Grade: **0**  
O&M Grade: **0**  
Clock Start/From:  
Clock To:  
1st Value:  
2nd Value:  
Value Percent:  
Continuous Index:  
Within 8" of Joint: **NO**  
Remarks: **Unknown**
