Profile/Photo Observation Report

Date:	03/19/2018	Weather:		Coding:	PACP 6.0
Pipe Length (ft):	288.5	Owner:	NA	Pre Clean:	No Pre-Cleaning
P.O.#:		Surveyor:	John Kuglmaier	PSR:	P-209-008-014
Customer:		Clean Date:	01/01/1900	Shape:	C

Street:	FOXCROFT STREET	Flow Control:	Not Controlled
City:	Hobart, IN	Year Renewed:	
Location:	Light Highway	Tape/Media #:	
Purpose:	Routine Assessment	Dia/Height:	8"
Use:	Sanitary	Material:	VCP
Drain Area:	NA	Lining:	
Category:	NA		
Comment:	P_C at 102 ft nothing visible . flow direction		
Location Details:		Direction of Survey:	Downstream
US MH:	M-209-014	DS MH:	M-209-008
		Total Length Surveyed (ft):	103.2

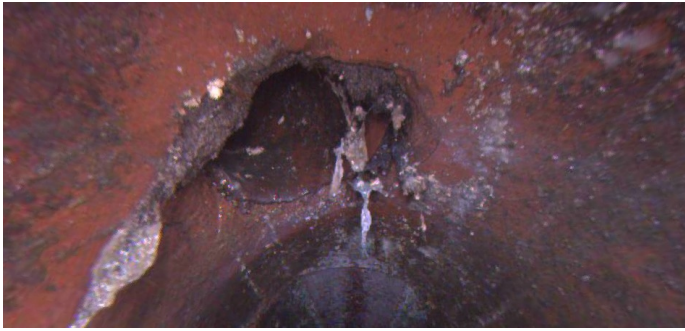
Code: **TBD**
Description: **Tap Break-in Defective**

Distance (ft): **6.9**
Structural Grade: **0**
O&M Grade: **3**
Clock Start/From: **11**
Clock To:
1st Value: **4.000**
2nd Value:
Value Percent:
Continuous Index:
Within 8" of Joint:
Remarks: **Roots**

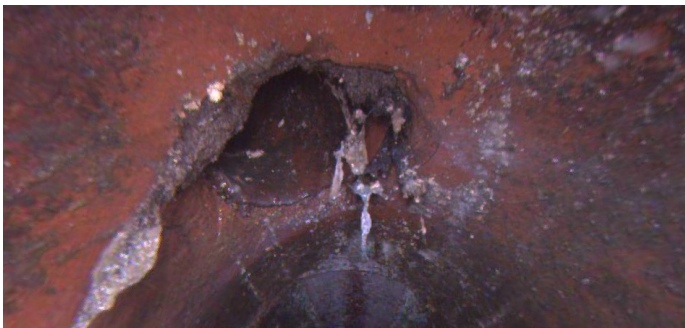
Code: **RFC**
Description: **Roots Fine Connection**

Distance (ft): **6.9**
Structural Grade: **0**
O&M Grade: **1**
Clock Start/From: **11**
Clock To:
1st Value:
2nd Value:
Value Percent:
Continuous Index:
Within 8" of Joint: **NO**
Remarks:

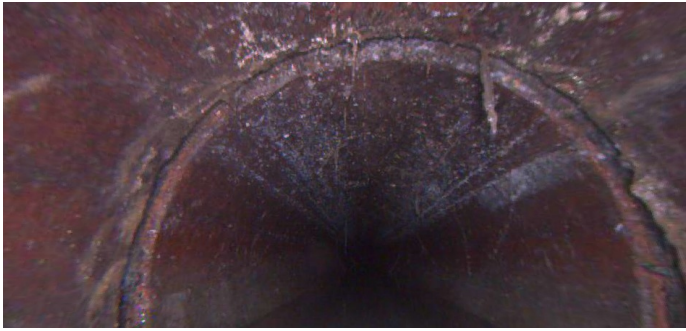
Code: **RFJ**
Description: **Roots Fine Joint**

Distance (ft): **15.9**
Structural Grade: **0**
O&M Grade: **1**
Clock Start/From: **11**
Clock To: **1**
1st Value:
2nd Value:
Value Percent:
Continuous Index:
Within 8" of Joint: **YES**
Remarks:

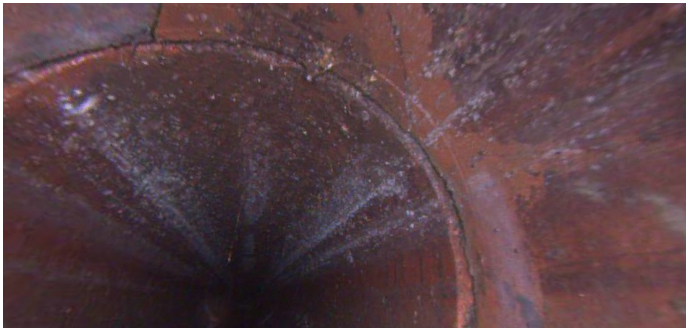
Code: **CM**
Description: **Crack Multiple**

Distance (ft): **20.0**
Structural Grade: **3**
O&M Grade: **0**
Clock Start/From: **11**
Clock To: **2**
1st Value:
2nd Value:
Value Percent:
Continuous Index:
Within 8" of Joint: **YES**
Remarks:

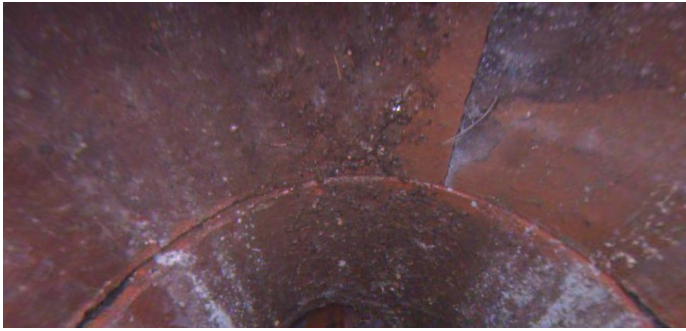
Code: **CL**
Description: **Crack Longitudinal**

Distance (ft): **28.3**
Structural Grade: **2**
O&M Grade: **0**
Clock Start/From: **1**
Clock To:
1st Value:
2nd Value:
Value Percent:
Continuous Index:
Within 8" of Joint: **YES**
Remarks:

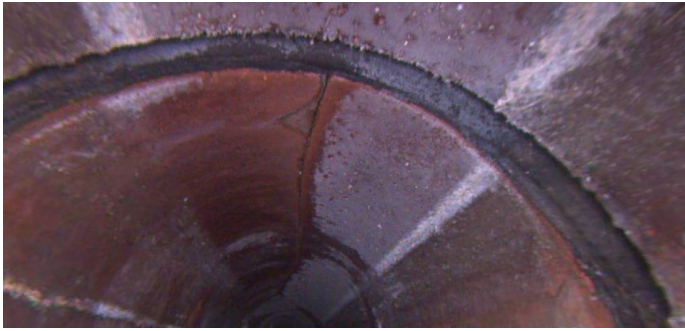
Code: **FL**
Description: **Fracture Longitudinal**

Distance (ft): **34.8**
Structural Grade: **3**
O&M Grade: **0**
Clock Start/From: **1**
Clock To:
1st Value:
2nd Value:
Value Percent:
Continuous Index:
Within 8" of Joint: **YES**
Remarks:

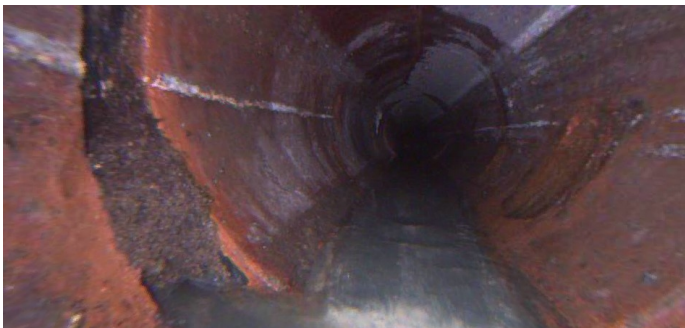
Code: **RFJ**
Description: **Roots Fine Joint**

Distance (ft): **34.8**
Structural Grade: **0**
O&M Grade: **1**
Clock Start/From: **8**
Clock To:
1st Value:
2nd Value:
Value Percent:
Continuous Index:
Within 8" of Joint: **YES**
Remarks:

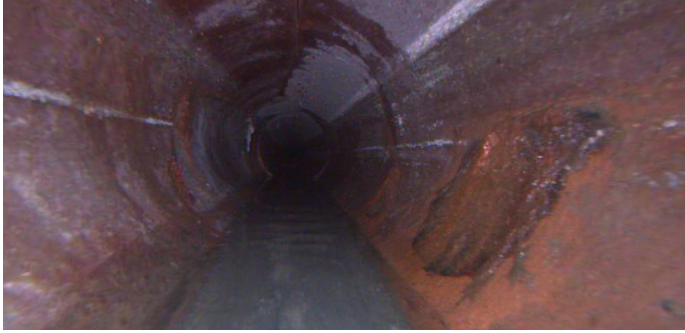
Code: **IW**
Description: **Infil Weeper**

Distance (ft): **35.3**
Structural Grade: **0**
O&M Grade: **2**
Clock Start/From: **3**
Clock To: **4**
1st Value:
2nd Value:
Value Percent:
Continuous Index:
Within 8" of Joint:
Remarks:

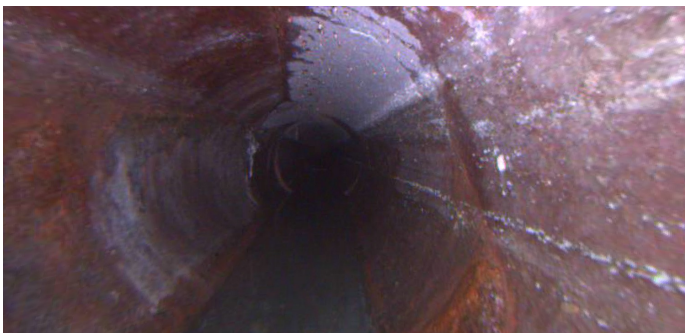
Code: **FM**
Description: **Fracture Multiple**

Distance (ft): **36.1**
Structural Grade: **4**
O&M Grade: **0**
Clock Start/From: **8**
Clock To: **4**
1st Value:
2nd Value:
Value Percent:
Continuous Index:
Within 8" of Joint:
Remarks:

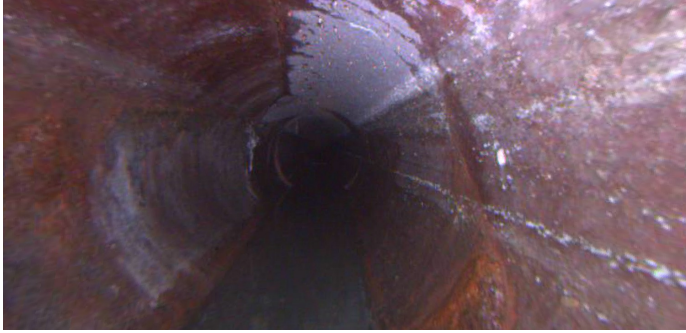
Code: **IW**
Description: **Infil Weeper**

Distance (ft): **36.1**
Structural Grade: **0**
O&M Grade: **2**
Clock Start/From: **3**
Clock To: **4**
1st Value:
2nd Value:
Value Percent:
Continuous Index:
Within 8" of Joint:
Remarks:

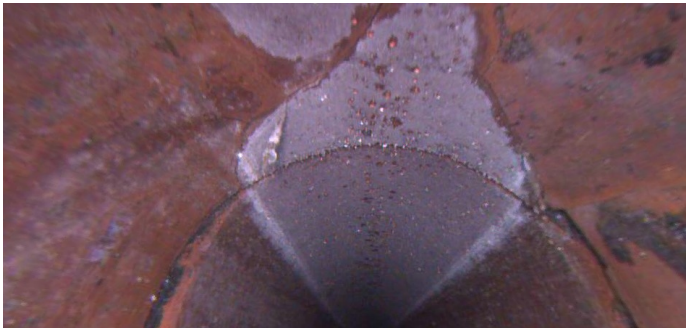
Code: **CM**
Description: **Crack Multiple**

Distance (ft): **38.7**
Structural Grade: **3**
O&M Grade: **0**
Clock Start/From: **11**
Clock To: **1**
1st Value:
2nd Value:
Value Percent:
Continuous Index:
Within 8" of Joint: **YES**
Remarks:

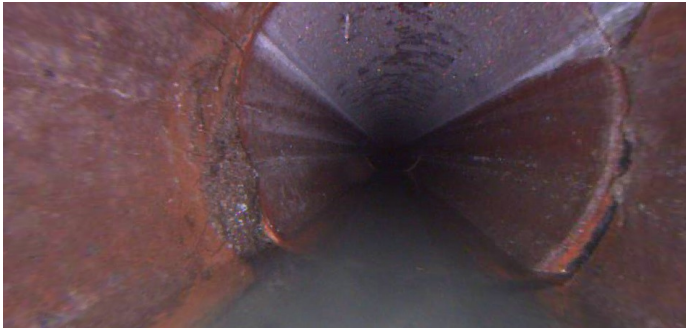
Code: **RFJ**
Description: **Roots Fine Joint**

Distance (ft): **47.0**
Structural Grade: **0**
O&M Grade: **1**
Clock Start/From: **8**
Clock To:
1st Value:
2nd Value:
Value Percent:
Continuous Index:
Within 8" of Joint: **YES**
Remarks:

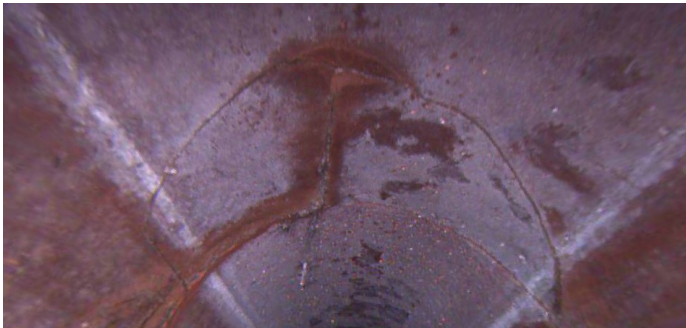
Code: **FM**
Description: **Fracture Multiple**

Distance (ft): **47.0**
Structural Grade: **4**
O&M Grade: **0**
Clock Start/From: **11**
Clock To: **2**
1st Value:
2nd Value:
Value Percent:
Continuous Index:
Within 8" of Joint: **YES**
Remarks:

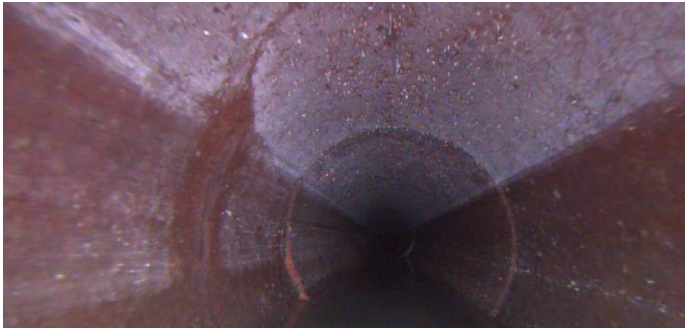
Code: **CC**
Description: **Crack Circumferential**

Distance (ft): **54.6**
Structural Grade: **1**
O&M Grade: **0**
Clock Start/From: **8**
Clock To: **11**
1st Value:
2nd Value:
Value Percent:
Continuous Index:
Within 8" of Joint:
Remarks:

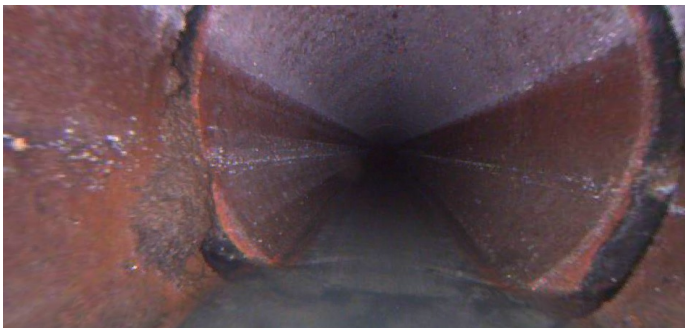
Code: **DAZ**
Description: **Deposits Attached Other**

Distance (ft): **63.6**
Structural Grade: **0**
O&M Grade: **2**
Clock Start/From: **8**
Clock To: **9**
1st Value:
2nd Value:
Value Percent: **5.000**
Continuous Index:
Within 8" of Joint: **YES**
Remarks: **Mixed materials**

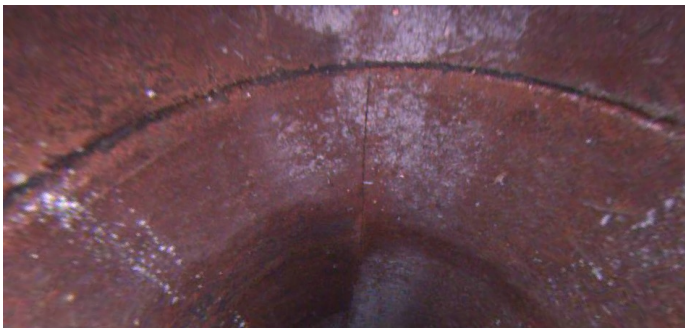
Code: **CL**
Description: **Crack Longitudinal**

Distance (ft): **76.3**
Structural Grade: **2**
O&M Grade: **0**
Clock Start/From: **12**
Clock To:
1st Value:
2nd Value:
Value Percent:
Continuous Index:
Within 8" of Joint: **YES**
Remarks:

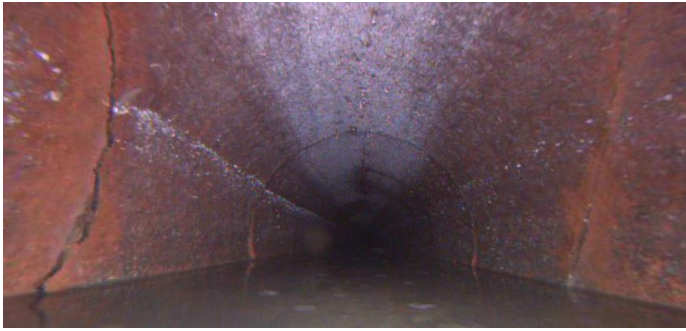
Code: **FM**
Description: **Fracture Multiple**

Distance (ft): **79.5**
Structural Grade: **4**
O&M Grade: **0**
Clock Start/From: **8**
Clock To: **4**
1st Value:
2nd Value:
Value Percent:
Continuous Index:
Within 8" of Joint:
Remarks:

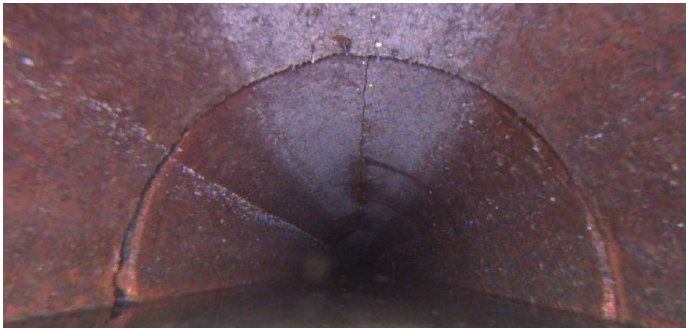
Code: **CL**
Description: **Crack Longitudinal**

Distance (ft): **80.1**
Structural Grade: **2**
O&M Grade: **0**
Clock Start/From: **12**
Clock To:
1st Value:
2nd Value:
Value Percent:
Continuous Index:
Within 8" of Joint: **YES**
Remarks:

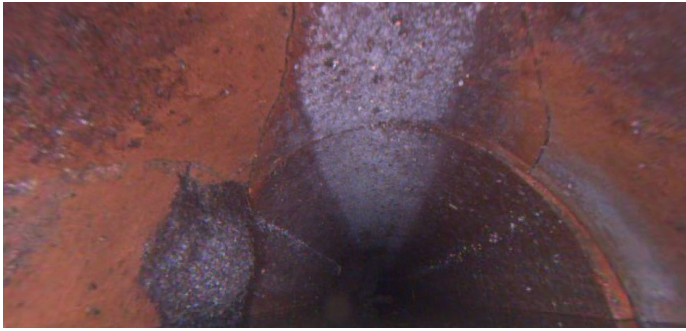
Code: **FM**
Description: **Fracture Multiple**

Distance (ft): **84.1**
Structural Grade: **4**
O&M Grade: **0**
Clock Start/From: **11**
Clock To: **1**
1st Value:
2nd Value:
Value Percent:
Continuous Index:
Within 8" of Joint: **YES**
Remarks:

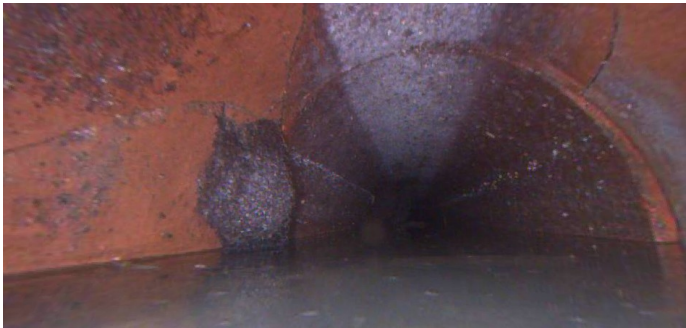
Code: **RMJ**
Description: **Roots Medium Joint**

Distance (ft): **84.1**
Structural Grade: **0**
O&M Grade: **3**
Clock Start/From: **9**
Clock To: **10**
1st Value:
2nd Value:
Value Percent: **5.000**
Continuous Index:
Within 8" of Joint: **YES**
Remarks:

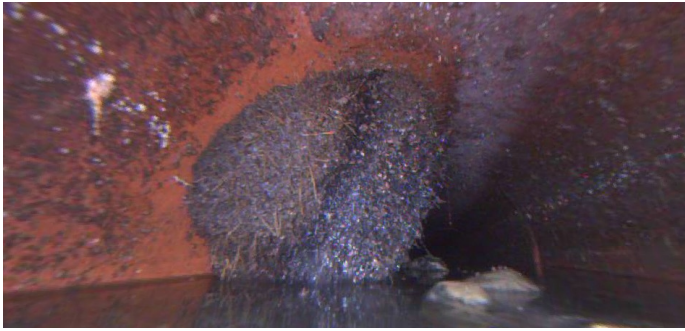
Code: **TFD**
Description: **Tap Factory Defective**

Distance (ft): **86.6**
Structural Grade: **0**
O&M Grade: **2**
Clock Start/From: **11**
Clock To:
1st Value: **4.000**
2nd Value:
Value Percent:
Continuous Index:
Within 8" of Joint:
Remarks: **Roots**

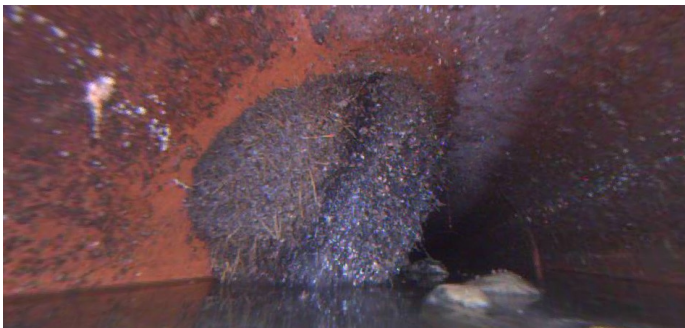
Code: **RBC**
Description: **Roots Ball Connection**

Distance (ft): **86.6**
Structural Grade: **0**
O&M Grade: **4**
Clock Start/From: **11**
Clock To:
1st Value:
2nd Value:
Value Percent: **100.000**
Continuous Index:
Within 8" of Joint: **NO**
Remarks:

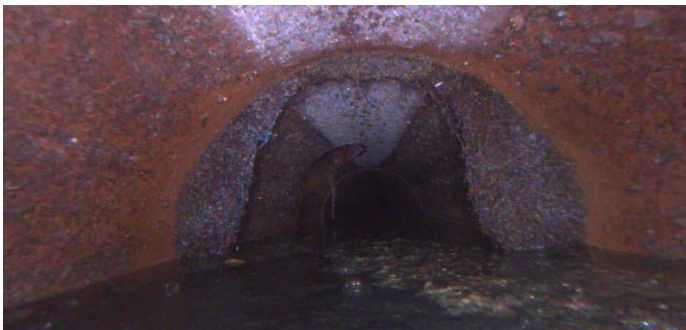
Code: **RMJ**
Description: **Roots Medium Joint**

Distance (ft): **100.3**
Structural Grade: **0**
O&M Grade: **3**
Clock Start/From: **9**
Clock To: **3**
1st Value:
2nd Value:
Value Percent: **25.000**
Continuous Index:
Within 8" of Joint: **YES**
Remarks:
