## Profile/Photo Observation Report

Date:	<b>03/19/2018</b>	Weather:		Coding:	<b>PACP 6.0</b>
Pipe Length (ft):	<b>288.5</b>	Owner:	<b>NA</b>	Pre Clean:	<b>No Pre-Cleaning</b>
P.O.#:		Surveyor:	<b>John Kuglmaier</b>	PSR:	<b>P-209-008-014</b>
Customer:		Clean Date:	<b>01/01/1900</b>	Shape:	<b>C</b>

Street:	<b>MINNESOTA ST</b>	Flow Control:	<b>Not Controlled</b>
City:	<b>Hobart, IN</b>	Year Renewed:	
Location:	<b>Light Highway</b>	Tape/Media #:	
Purpose:	<b>Routine Assessment</b>	Dia/Height:	<b>12"</b>
Use:	<b>Sanitary</b>	Material:	<b>VCP</b>
Drain Area:	<b>NA</b>	Lining:	
Category:	<b>NA</b>		
Comment:	<b>P_C at 27 ft debris .Flow direction wrong</b>		
Location Details:		Direction of Survey:	<b>Upstream</b>
US MH:	<b>M-209-014</b>	DS MH:	<b>M-209-008</b>
		Total Length Surveyed (ft):	<b>28.3</b>

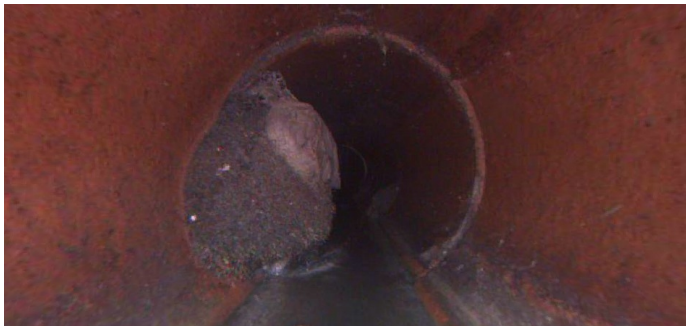
Code: **AMH**  
Description: **Manhole**

Distance (ft): **.0**  
Structural Grade: **0**  
O&M Grade: **0**  
Clock Start/From:  
Clock To:  
1st Value:  
2nd Value:  
Value Percent:  
Continuous Index:  
Within 8" of Joint: **NO**  
Remarks: **M-209-008**

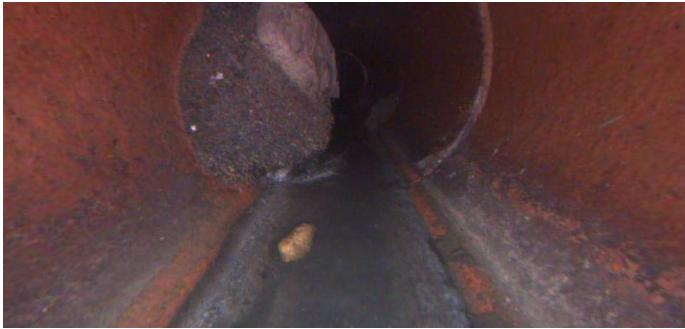
Code:	<b>MWL</b>
Description:	<b>Water Level</b>

Distance (ft):	<b>.0</b>
Structural Grade:	<b>0</b>
O&M Grade:	<b>0</b>
Clock Start/From:	
Clock To:	
1st Value:	
2nd Value:	
Value Percent:	<b>5.000</b>
Continuous Index:	
Within 8" of Joint:	<b>NO</b>
Remarks:

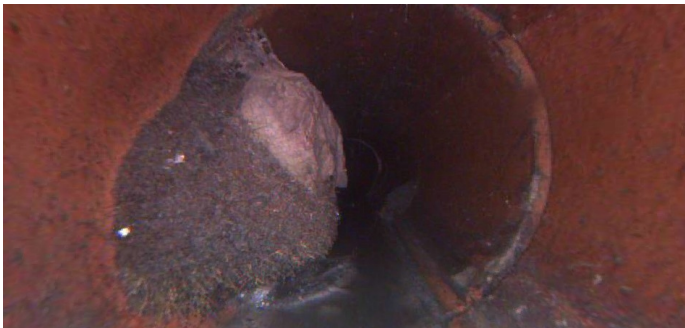
Code:	<b>RMJ</b>
Description:	<b>Roots Medium Joint</b>

Distance (ft):	<b>.5</b>
Structural Grade:	<b>0</b>
O&M Grade:	<b>3</b>
Clock Start/From:	<b>6</b>
Clock To:	<b>11</b>
1st Value:	
2nd Value:	
Value Percent:	<b>30.000</b>
Continuous Index:	
Within 8" of Joint:	<b>YES</b>
Remarks:

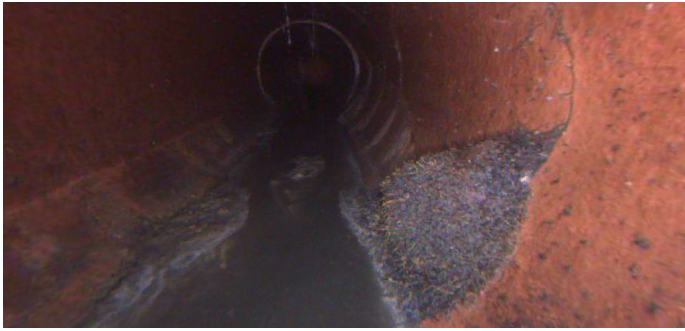
Code: **RMB**  
Description: **Roots Medium Barrel**

Distance (ft): **3.3**  
Structural Grade: **0**  
O&M Grade: **4**  
Clock Start/From: **3**  
Clock To: **5**  
1st Value:  
2nd Value:  
Value Percent: **15.000**  
Continuous Index:  
Within 8" of Joint: **NO**  
Remarks:

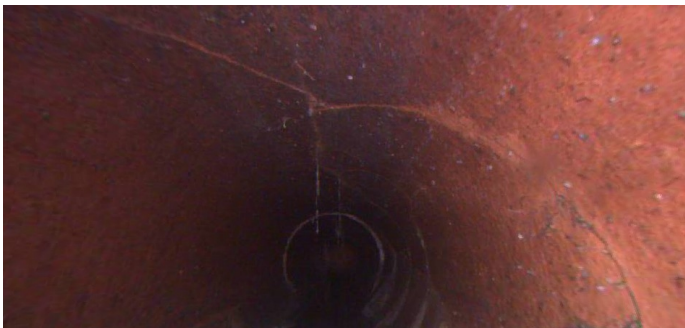
Code: **CM**  
Description: **Crack Multiple**

Distance (ft): **3.3**  
Structural Grade: **3**  
O&M Grade: **0**  
Clock Start/From: **11**  
Clock To: **4**  
1st Value:  
2nd Value:  
Value Percent:  
Continuous Index:  
Within 8" of Joint:  
Remarks:

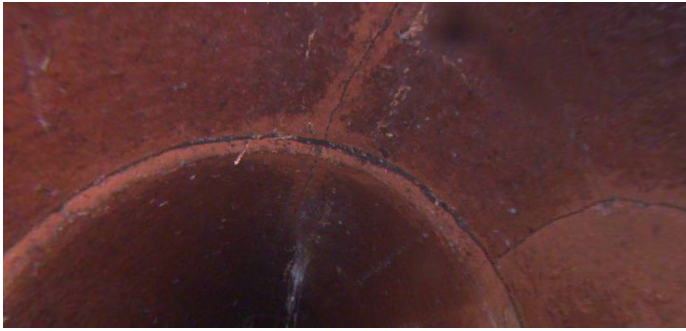
Code: **CM**  
Description: **Crack Multiple**

Distance (ft): **5.6**  
Structural Grade: **3**  
O&M Grade: **0**  
Clock Start/From: **1**  
Clock To: **2**  
1st Value:  
2nd Value:  
Value Percent:  
Continuous Index:  
Within 8" of Joint: **YES**  
Remarks:

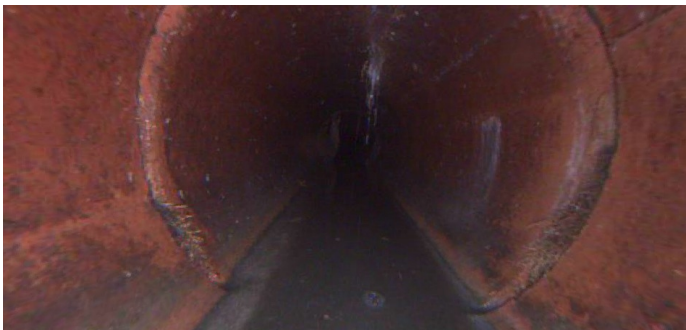
Code: **RFJ**  
Description: **Roots Fine Joint**

Distance (ft): **5.6**  
Structural Grade: **0**  
O&M Grade: **1**  
Clock Start/From: **3**  
Clock To: **8**  
1st Value:  
2nd Value:  
Value Percent:  
Continuous Index:  
Within 8" of Joint: **YES**  
Remarks:

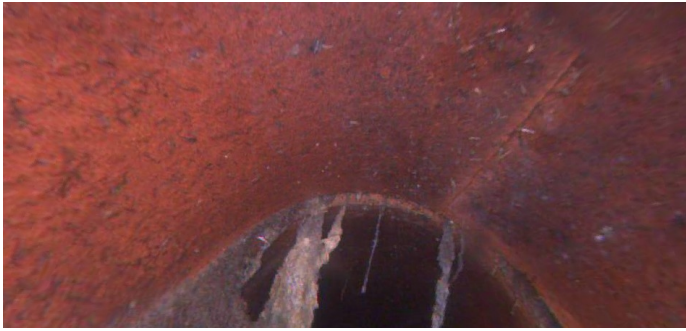
Code: **CL**  
Description: **Crack Longitudinal**

Distance (ft): **9.5**  
Structural Grade: **2**  
O&M Grade: **0**  
Clock Start/From: **1**  
Clock To:  
1st Value:  
2nd Value:  
Value Percent:  
Continuous Index:  
Within 8" of Joint: **YES**  
Remarks:

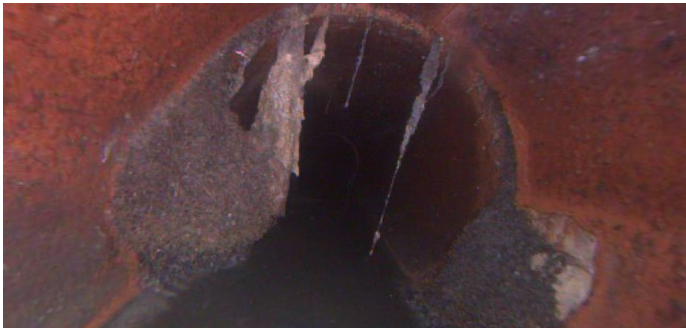
Code: **RMJ**  
Description: **Roots Medium Joint**

Distance (ft): **9.5**  
Structural Grade: **0**  
O&M Grade: **3**  
Clock Start/From: **7**  
Clock To: **5**  
1st Value:  
2nd Value:  
Value Percent: **30.000**  
Continuous Index:  
Within 8" of Joint: **YES**  
Remarks:

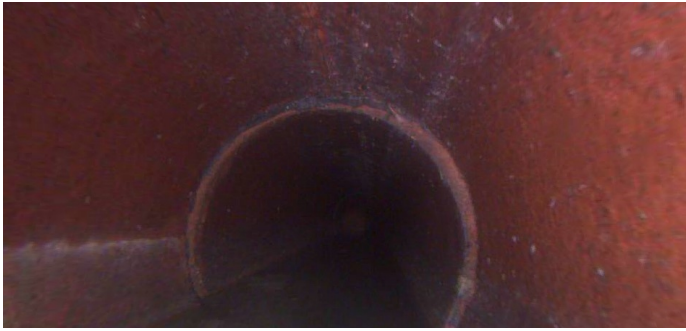
Code: **CM**  
Description: **Crack Multiple**

Distance (ft): **13.4**  
Structural Grade: **3**  
O&M Grade: **0**  
Clock Start/From: **9**  
Clock To: **12**  
1st Value:  
2nd Value:  
Value Percent:  
Continuous Index:  
Within 8" of Joint: **YES**  
Remarks:

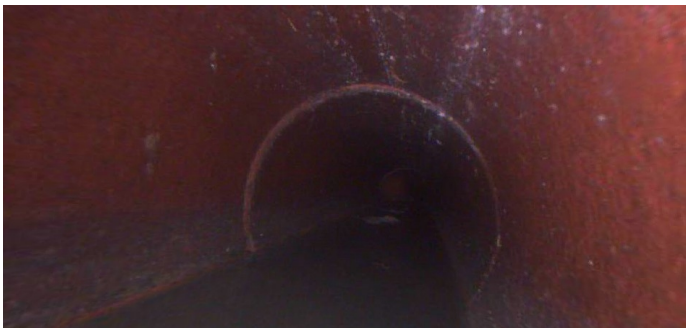
Code: **MWL**  
Description: **Water Level**

Distance (ft): **17.5**  
Structural Grade: **0**  
O&M Grade: **0**  
Clock Start/From:  
Clock To:  
1st Value:  
2nd Value:  
Value Percent: **20.000**  
Continuous Index:  
Within 8" of Joint: **NO**  
Remarks:

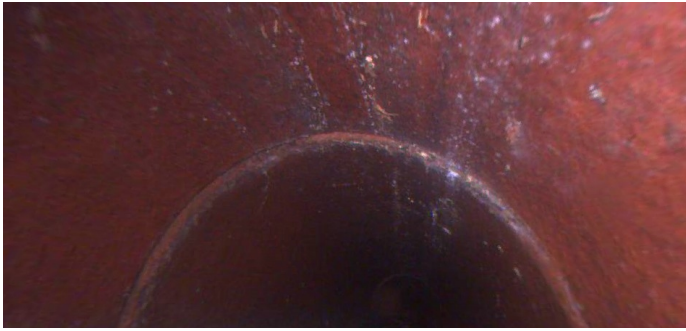
Code: **CL**  
Description: **Crack Longitudinal**

Distance (ft): **17.9**  
Structural Grade: **2**  
O&M Grade: **0**  
Clock Start/From: **1**  
Clock To:  
1st Value:  
2nd Value:  
Value Percent:  
Continuous Index:  
Within 8" of Joint: **YES**  
Remarks:

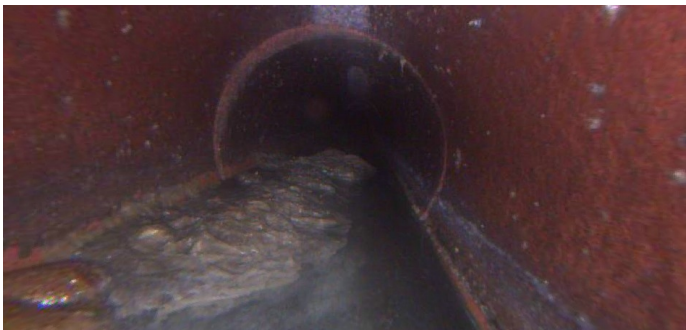
Code: **OBZ**  
Description: **Obstacle Other**

Distance (ft): **25.5**  
Structural Grade: **0**  
O&M Grade: **4**  
Clock Start/From: **5**  
Clock To: **7**  
1st Value:  
2nd Value:  
Value Percent: **25.000**  
Continuous Index:  
Within 8" of Joint: **NO**  
Remarks: **Mixed materials**

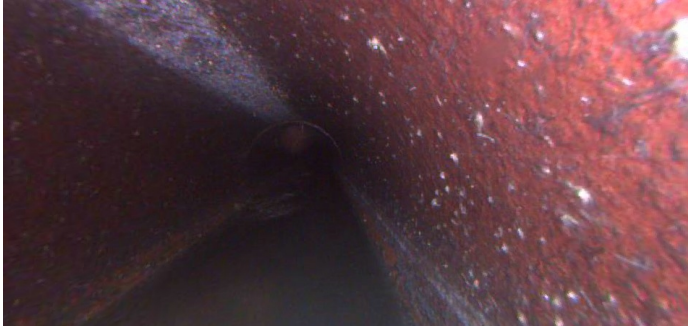
Code:	<b>MSA</b>
Description:	<b>Abandoned Survey</b>
Distance (ft):	<b>28.3</b>
Structural Grade:	<b>0</b>
O&M Grade:	<b>0</b>
Clock Start/From:	
Clock To:	
1st Value:	
2nd Value:	
Value Percent:	
Continuous Index:	
Within 8" of Joint:	<b>NO</b>
Remarks:	<b>OBZ</b>
