Profile/Photo Observation Report

Street:	E 61ST PL	Flow Control:	Not Controlled
City:	Hobart, IN	Year Renewed:	
Location:	Light Highway	Tape/Media #:	
Purpose:	Routine Assessment	Dia/Height:	8"
Use:	Sanitary	Material:	VCP
Drain Area:	NA	Lining:	
Category:	NA		
Comment:	P_C at 27 ft roots . Flow direction wrong		
Location Details:		Direction of Survey:	Downstream
US MH:	M-209-014	DS MH:	M-209-013
		Total Length Surveyed (ft):	28.6

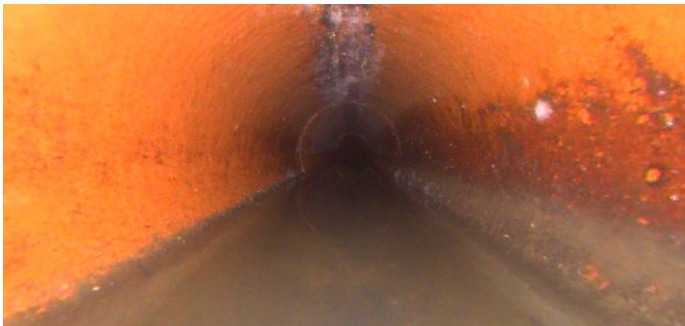
Code: **AMH**
Description: **Manhole**

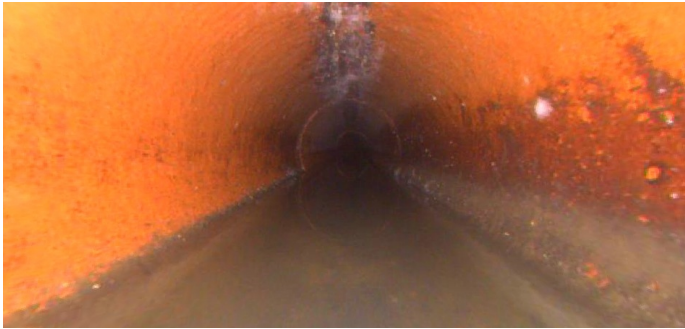
Code:	MWL
Description:	Water Level

Distance (ft):	.0
Structural Grade:	0
O&M Grade:	0
Clock Start/From:	
Clock To:	
1st Value:	
2nd Value:	
Value Percent:	25.000
Continuous Index:	
Within 8" of Joint:	NO
Remarks:

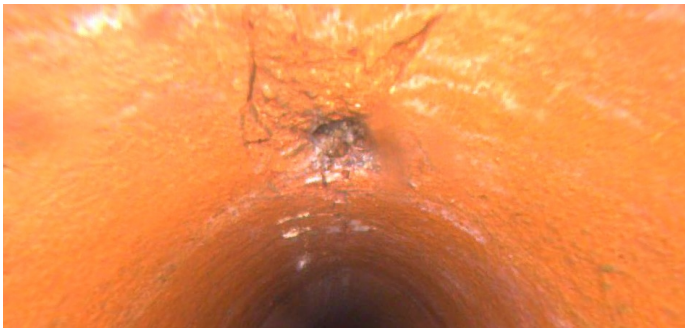
Code:	HSV
Description:	Hole Soil Visible

Distance (ft):	16.1
Structural Grade:	5
O&M Grade:	0
Clock Start/From:	12
Clock To:	
1st Value:	
2nd Value:	
Value Percent:	
Continuous Index:	
Within 8" of Joint:	
Remarks:

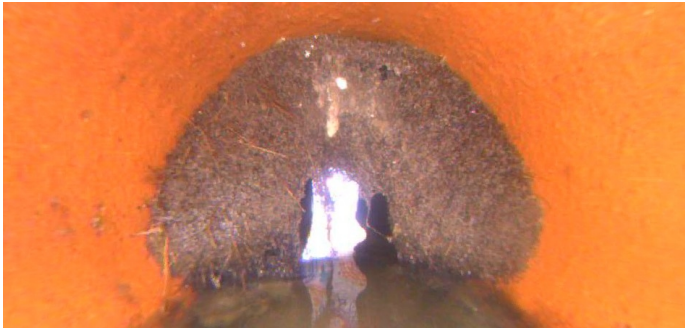
Code: **RBJ**
Description: **Roots Ball Joint**

Distance (ft): **27.8**
Structural Grade: **0**
O&M Grade: **4**
Clock Start/From: **8**
Clock To: **4**
1st Value:
2nd Value:
Value Percent: **70.000**
Continuous Index:
Within 8" of Joint: **YES**
Remarks:

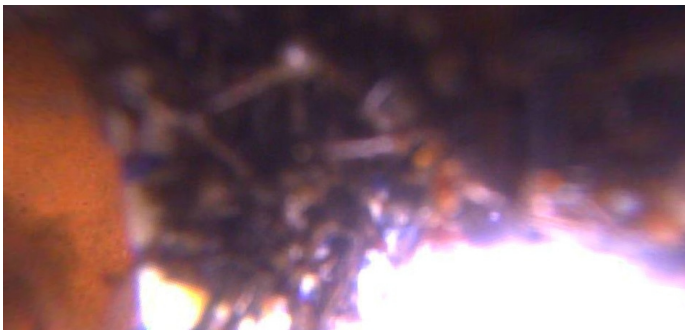
Code: **MSA**
Description: **Abandoned Survey**

Distance (ft): **28.6**
Structural Grade: **0**
O&M Grade: **0**
Clock Start/From:
Clock To:
1st Value:
2nd Value:
Value Percent:
Continuous Index:
Within 8" of Joint: **NO**
Remarks: **RBJ**
