## Profile/Photo Observation Report

Date:	<b>03/19/2018</b>	Weather:		Coding:	<b>PACP 6.0</b>
Pipe Length (ft):	<b>247.0</b>	Owner:	<b>NA</b>	Pre Clean:	<b>No Pre-Cleaning</b>
P.O.#:		Surveyor:	<b>Byrd Fitzgerald</b>	PSR:	<b>P-209-015-016</b>
Customer:		Clean Date:	<b>01/01/1900</b>	Shape:	<b>C</b>

Street:	<b>E 62ND PL</b>	Flow Control:	<b>Not Controlled</b>
City:	<b>Hobart, IN</b>	Year Renewed:	
Location:	<b>Light Highway</b>	Tape/Media #:	
Purpose:	<b>Routine Assessment</b>	Dia/Height:	<b>8"</b>
Use:	<b>Sanitary</b>	Material:	<b>VCP</b>
Drain Area:	<b>NA</b>	Lining:	
Category:	<b>NA</b>		
Comment:	<b>P_C at 103 ft debris . Flow direction wrong</b>		
Location Details:		Direction of Survey:	<b>Upstream</b>
US MH:	<b>M-209-016</b>	DS MH:	<b>M-209-015</b>
		Total Length Surveyed (ft):	<b>104.9</b>

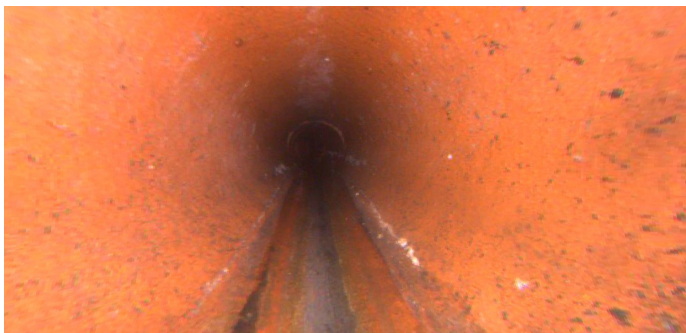
Code: **AMH**  
Description: **Manhole**

Distance (ft): **.0**  
Structural Grade: **0**  
O&M Grade: **0**  
Clock Start/From:  
Clock To:  
1st Value:  
2nd Value:  
Value Percent:  
Continuous Index:  
Within 8" of Joint: **NO**  
Remarks: **M-209-015**

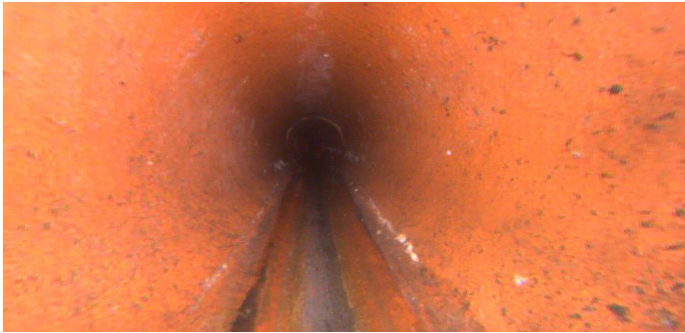
Code:	<b>MWL</b>
Description:	<b>Water Level</b>

Distance (ft):	<b>.0</b>
Structural Grade:	<b>0</b>
O&M Grade:	<b>0</b>
Clock Start/From:	
Clock To:	
1st Value:	
2nd Value:	
Value Percent:	<b>5.000</b>
Continuous Index:	
Within 8" of Joint:	<b>NO</b>
Remarks:

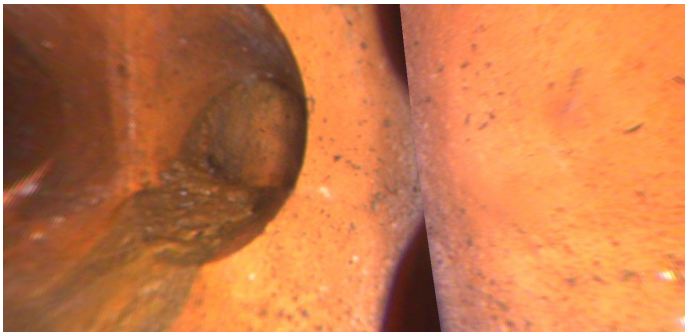
Code:	<b>TFC</b>
Description:	<b>Tap Factory Capped</b>

Distance (ft):	<b>5.0</b>
Structural Grade:	<b>0</b>
O&M Grade:	<b>0</b>
Clock Start/From:	<b>9</b>
Clock To:	
1st Value:	<b>4.000</b>
2nd Value:	
Value Percent:	
Continuous Index:	
Within 8" of Joint:	<b>YES</b>
Remarks:

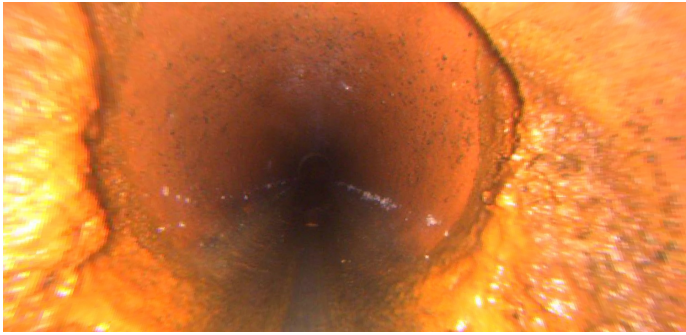
Code: **DAE**  
Description: **Deposits Attached Encrustation**

Distance (ft): **5.6**  
Structural Grade: **0**  
O&M Grade: **2**  
Clock Start/From: **7**  
Clock To: **5**  
1st Value:  
2nd Value:  
Value Percent: **5.000**  
Continuous Index:  
Within 8" of Joint: **YES**  
Remarks:

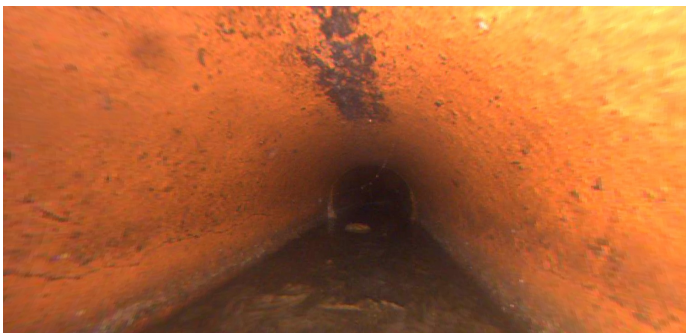
Code: **CM**  
Description: **Crack Multiple**

Distance (ft): **12.6**  
Structural Grade: **3**  
O&M Grade: **0**  
Clock Start/From: **7**  
Clock To: **5**  
1st Value:  
2nd Value:  
Value Percent:  
Continuous Index:  
Within 8" of Joint:  
Remarks:

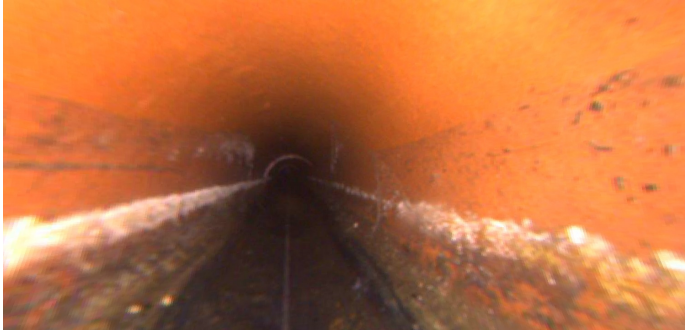
Code: **MGO**  
Description: **General Observation**

Distance (ft): **21.9**  
Structural Grade: **0**  
O&M Grade: **0**  
Clock Start/From:  
Clock To:  
1st Value:  
2nd Value:  
Value Percent:  
Continuous Index:  
Within 8" of Joint: **NO**  
Remarks: **rear camera**

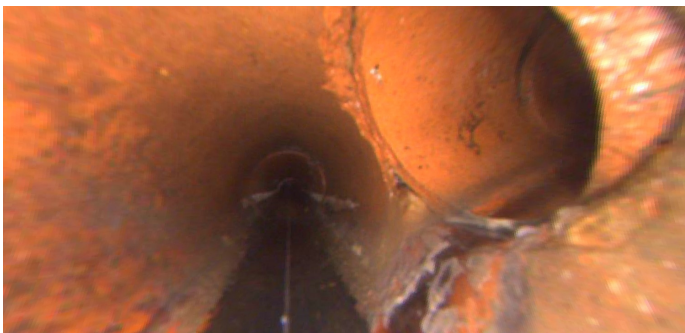
Code: **TB**  
Description: **Tap Break-in**

Distance (ft): **25.2**  
Structural Grade: **0**  
O&M Grade: **0**  
Clock Start/From: **10**  
Clock To:  
1st Value: **4.000**  
2nd Value:  
Value Percent:  
Continuous Index:  
Within 8" of Joint:  
Remarks:

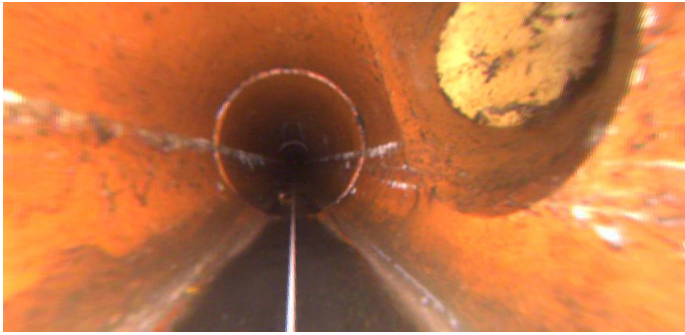
Code: **TFC**  
Description: **Tap Factory Capped**

Distance (ft): **41.3**  
Structural Grade: **0**  
O&M Grade: **0**  
Clock Start/From: **10**  
Clock To:  
1st Value: **4.000**  
2nd Value:  
Value Percent:  
Continuous Index:  
Within 8" of Joint:  
Remarks:

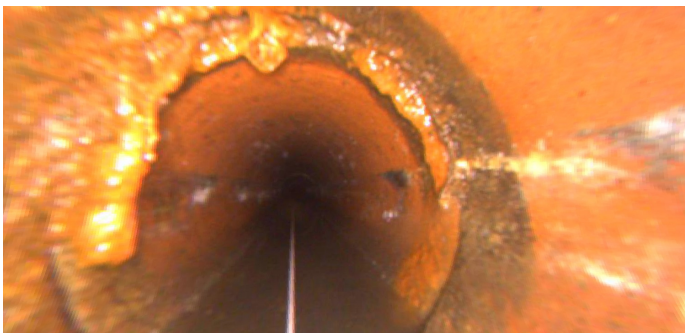
Code: **DAE**  
Description: **Deposits Attached Encrustation**

Distance (ft): **55.5**  
Structural Grade: **0**  
O&M Grade: **2**  
Clock Start/From: **7**  
Clock To: **5**  
1st Value:  
2nd Value:  
Value Percent: **5.000**  
Continuous Index: **S01**  
Within 8" of Joint: **YES**  
Remarks: **wandering**

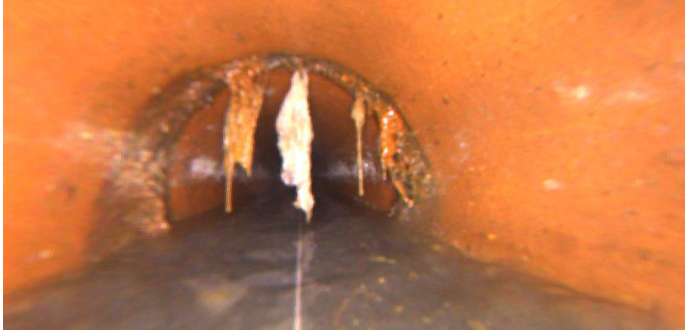
Code: **DAR**  
Description: **Deposits Attached Ragging**

Distance (ft): **81.5**  
Structural Grade: **0**  
O&M Grade: **2**  
Clock Start/From: **12**  
Clock To:  
1st Value:  
2nd Value:  
Value Percent: **5.000**  
Continuous Index:  
Within 8" of Joint: **YES**  
Remarks:

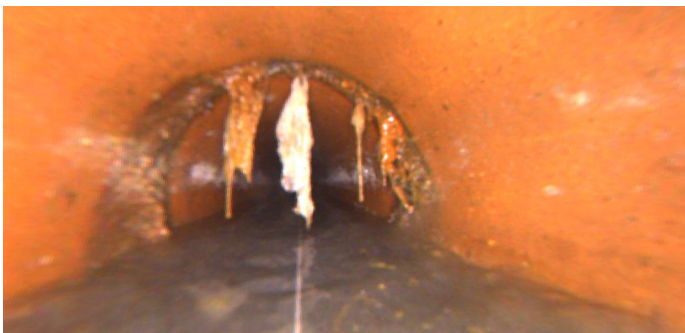
Code: **RFJ**  
Description: **Roots Fine Joint**

Distance (ft): **81.5**  
Structural Grade: **0**  
O&M Grade: **1**  
Clock Start/From: **9**  
Clock To: **1**  
1st Value:  
2nd Value:  
Value Percent:  
Continuous Index:  
Within 8" of Joint: **YES**  
Remarks:

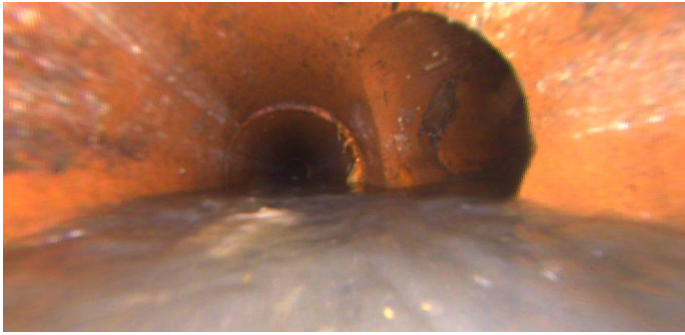
Code: **TF**  
Description: **Tap Factory**

Distance (ft): **94.9**  
Structural Grade: **0**  
O&M Grade: **0**  
Clock Start/From: **9**  
Clock To:  
1st Value: **4.000**  
2nd Value:  
Value Percent:  
Continuous Index:  
Within 8" of Joint:  
Remarks:

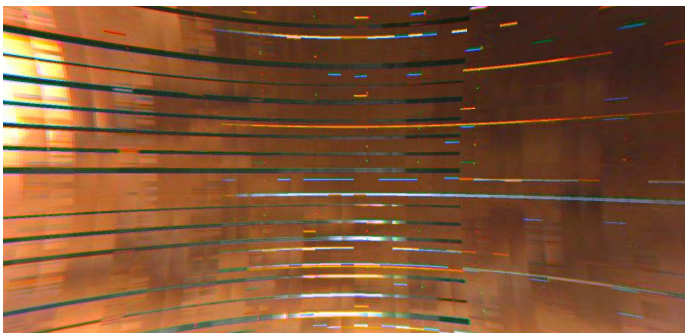
Code: **MSA**  
Description: **Abandoned Survey**

Distance (ft): **104.9**  
Structural Grade: **0**  
O&M Grade: **0**  
Clock Start/From:  
Clock To:  
1st Value:  
2nd Value:  
Value Percent:  
Continuous Index:  
Within 8" of Joint: **NO**  
Remarks: **camera stopped/video distorted**

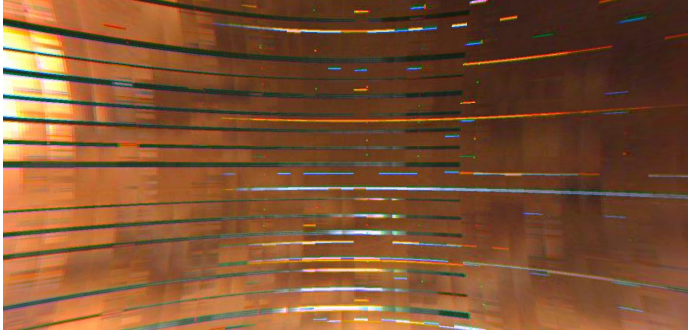
Code:	<b>DAE</b>
Description:	<b>Deposits Attached Encrustation</b>
Distance (ft):	<b>104.9</b>
Structural Grade:	<b>0</b>
O&M Grade:	<b>2</b>
Clock Start/From:	<b>7</b>
Clock To:	<b>5</b>
1st Value:	
2nd Value:	
Value Percent:	<b>5.000</b>
Continuous Index:	<b>F01</b>
Within 8" of Joint:	<b>YES</b>
Remarks:	<b>wandering</b>
