Profile/Photo Observation Report

Date:	03/19/2018	Weather:		Coding:	PACP 6.0
Pipe Length (ft):	247.0	Owner:	NA	Pre Clean:	No Pre-Cleaning
P.O.#:		Surveyor:	Byrd Fitzgerald	PSR:	P-209-015-016
Customer:		Clean Date:	01/01/1900	Shape:	C

Street:	FOXCROFT STREET	Flow Control:	Not Controlled
City:	Hobart, IN	Year Renewed:	
Location:	Light Highway	Tape/Media #:	
Purpose:	Routine Assessment	Dia/Height:	8"
Use:	Sanitary	Material:	VCP
Drain Area:	NA	Lining:	
Category:	NA		
Comment:	P_C at 103 ft debris . Flow direction wrong		
Location Details:		Direction of Survey:	Upstream
US MH:	M-209-016	DS MH:	M-209-015
		Total Length Surveyed (ft):	104.9

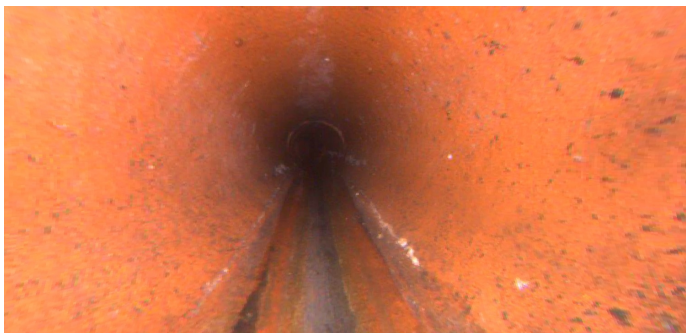
Code: **AMH**
Description: **Manhole**

Distance (ft): **.0**
Structural Grade: **0**
O&M Grade: **0**
Clock Start/From:
Clock To:
1st Value:
2nd Value:
Value Percent:
Continuous Index:
Within 8" of Joint: **NO**
Remarks: **M-209-015**

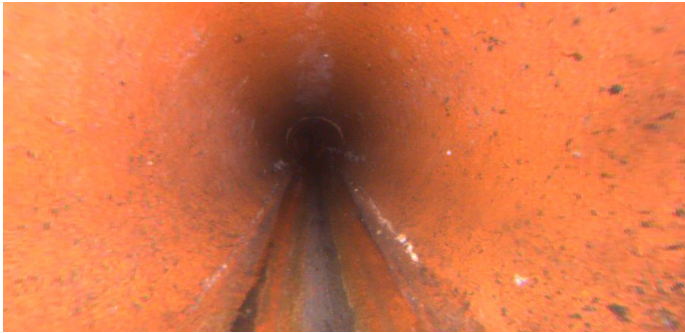
Code:	MWL
Description:	Water Level

Distance (ft):	.0
Structural Grade:	0
O&M Grade:	0
Clock Start/From:	
Clock To:	
1st Value:	
2nd Value:	
Value Percent:	5.000
Continuous Index:	
Within 8" of Joint:	NO
Remarks:

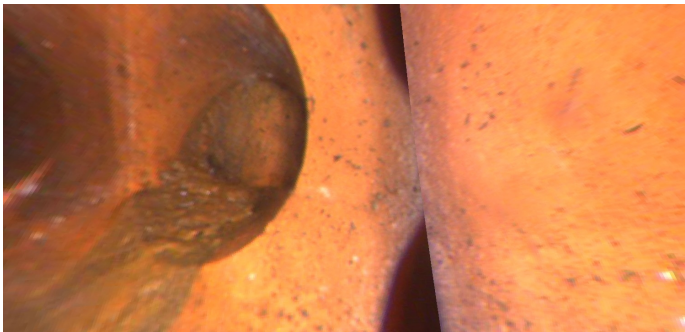
Code:	TFC
Description:	Tap Factory Capped

Distance (ft):	5.0
Structural Grade:	0
O&M Grade:	0
Clock Start/From:	9
Clock To:	
1st Value:	4.000
2nd Value:	
Value Percent:	
Continuous Index:	
Within 8" of Joint:	YES
Remarks:

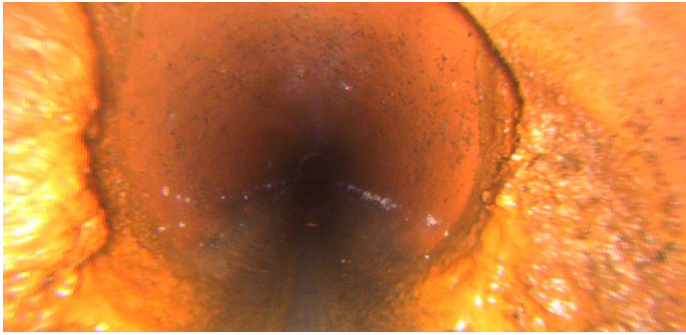
Code: **DAE**
Description: **Deposits Attached Encrustation**

Distance (ft): **5.6**
Structural Grade: **0**
O&M Grade: **2**
Clock Start/From: **7**
Clock To: **5**
1st Value:
2nd Value:
Value Percent: **5.000**
Continuous Index:
Within 8" of Joint: **YES**
Remarks:

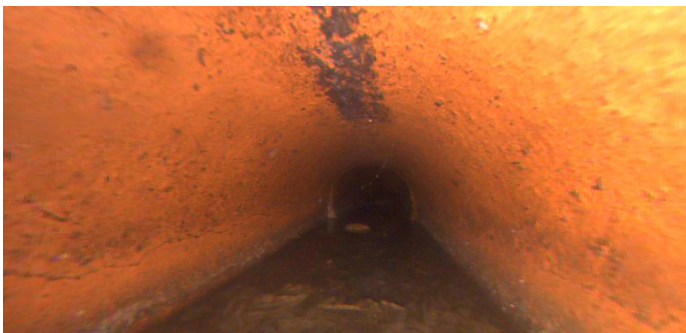
Code: **CM**
Description: **Crack Multiple**

Distance (ft): **12.6**
Structural Grade: **3**
O&M Grade: **0**
Clock Start/From: **7**
Clock To: **5**
1st Value:
2nd Value:
Value Percent:
Continuous Index:
Within 8" of Joint:
Remarks:

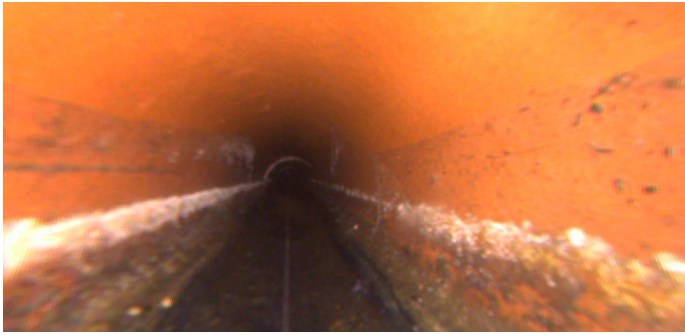
Code: **MGO**
Description: **General Observation**

Distance (ft): **21.9**
Structural Grade: **0**
O&M Grade: **0**
Clock Start/From:
Clock To:
1st Value:
2nd Value:
Value Percent:
Continuous Index:
Within 8" of Joint: **NO**
Remarks: **rear camera**

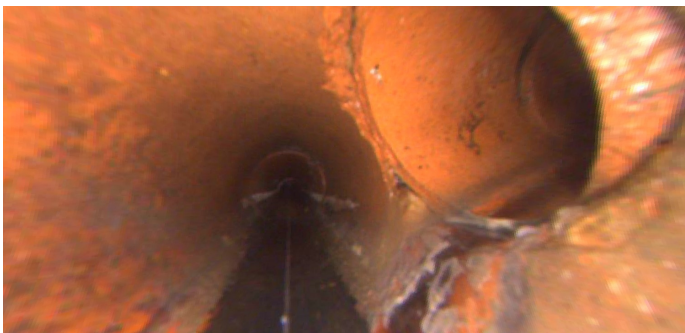
Code: **TB**
Description: **Tap Break-in**

Distance (ft): **25.2**
Structural Grade: **0**
O&M Grade: **0**
Clock Start/From: **10**
Clock To:
1st Value: **4.000**
2nd Value:
Value Percent:
Continuous Index:
Within 8" of Joint:
Remarks:

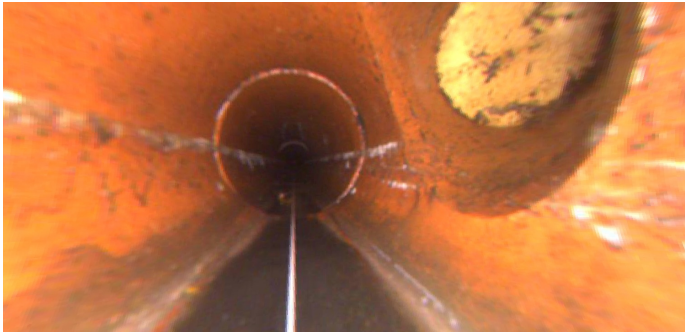
Code: **TFC**
Description: **Tap Factory Capped**

Distance (ft): **41.3**
Structural Grade: **0**
O&M Grade: **0**
Clock Start/From: **10**
Clock To:
1st Value: **4.000**
2nd Value:
Value Percent:
Continuous Index:
Within 8" of Joint:
Remarks:

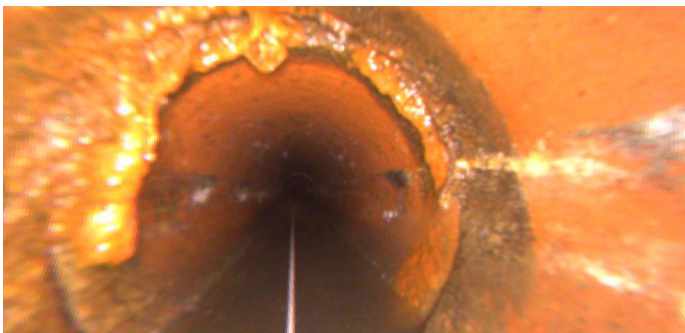
Code: **DAE**
Description: **Deposits Attached Encrustation**

Distance (ft): **55.5**
Structural Grade: **0**
O&M Grade: **2**
Clock Start/From: **7**
Clock To: **5**
1st Value:
2nd Value:
Value Percent: **5.000**
Continuous Index: **S01**
Within 8" of Joint: **YES**
Remarks: **wandering**

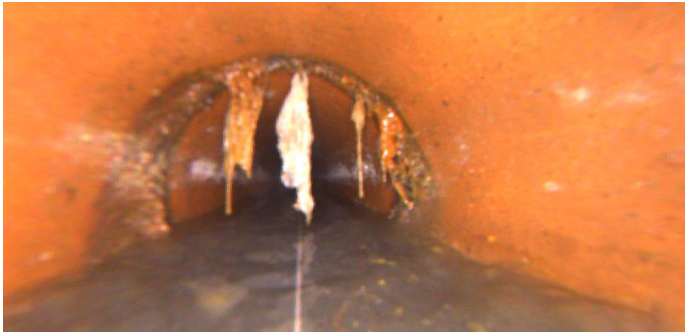
Code: **DAR**
Description: **Deposits Attached Ragging**

Distance (ft): **81.5**
Structural Grade: **0**
O&M Grade: **2**
Clock Start/From: **12**
Clock To:
1st Value:
2nd Value:
Value Percent: **5.000**
Continuous Index:
Within 8" of Joint: **YES**
Remarks:

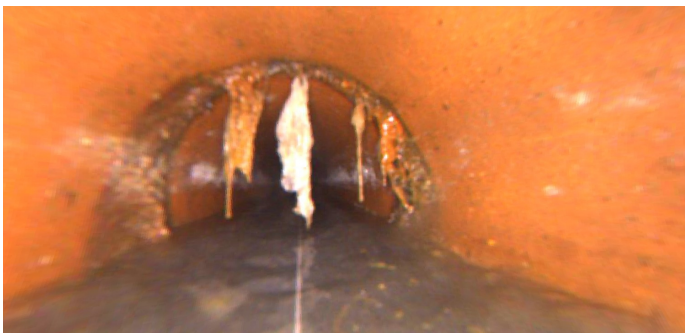
Code: **RFJ**
Description: **Roots Fine Joint**

Distance (ft): **81.5**
Structural Grade: **0**
O&M Grade: **1**
Clock Start/From: **9**
Clock To: **1**
1st Value:
2nd Value:
Value Percent:
Continuous Index:
Within 8" of Joint: **YES**
Remarks:

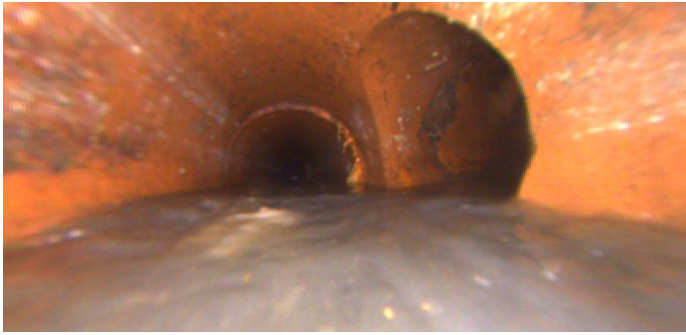
Code: **TF**
Description: **Tap Factory**

Distance (ft): **94.9**
Structural Grade: **0**
O&M Grade: **0**
Clock Start/From: **9**
Clock To:
1st Value: **4.000**
2nd Value:
Value Percent:
Continuous Index:
Within 8" of Joint:
Remarks:

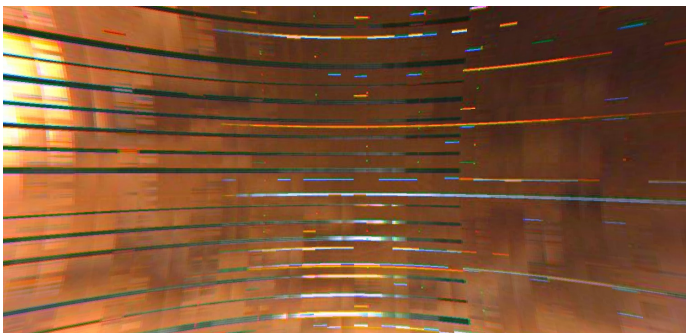
Code: **MSA**
Description: **Abandoned Survey**

Distance (ft): **104.9**
Structural Grade: **0**
O&M Grade: **0**
Clock Start/From:
Clock To:
1st Value:
2nd Value:
Value Percent:
Continuous Index:
Within 8" of Joint: **NO**
Remarks: **camera stopped/video distorted**

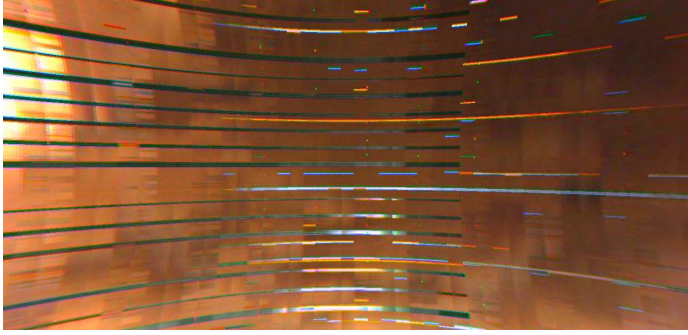
Code:	DAE
Description:	Deposits Attached Encrustation
Distance (ft):	104.9
Structural Grade:	0
O&M Grade:	2
Clock Start/From:	7
Clock To:	5
1st Value:	
2nd Value:	
Value Percent:	5.000
Continuous Index:	F01
Within 8" of Joint:	YES
Remarks:	wandering
