## Profile/Photo Observation Report

Date:	<b>03/19/2018</b>	Weather:		Coding:	<b>PACP 6.0</b>
Pipe Length (ft):	<b>117.8</b>	Owner:	<b>NA</b>	Pre Clean:	<b>No Pre-Cleaning</b>
P.O.#:		Surveyor:	<b>John Kuglmaier</b>	PSR:	<b>P-209-016-017</b>
Customer:		Clean Date:	<b>01/01/1900</b>	Shape:	<b>C</b>

Street:	<b>E 62ND PL</b>	Flow Control:	<b>Not Controlled</b>
City:	<b>Hobart, IN</b>	Year Renewed:	
Location:	<b>Light Highway</b>	Tape/Media #:	
Purpose:	<b>Routine Assessment</b>	Dia/Height:	<b>8"</b>
Use:	<b>Sanitary</b>	Material:	<b>VCP</b>
Drain Area:	<b>NA</b>	Lining:	
Category:	<b>NA</b>		
Comment:	<b>flow direction wrong . P_C at 7 ft mineral deposit</b>		
Location Details:		Direction of Survey:	<b>Upstream</b>
US MH:	<b>M-209-017</b>	DS MH:	<b>M-209-016</b>
		Total Length Surveyed (ft):	<b>8.0</b>

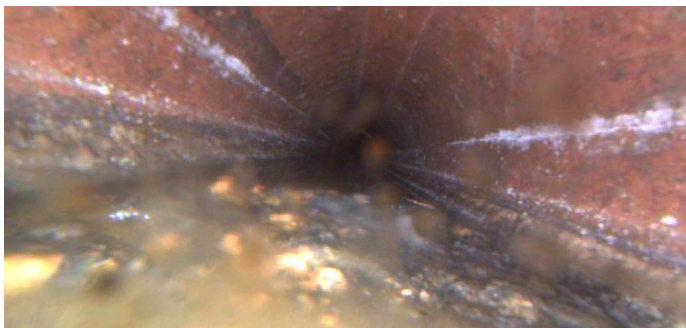
Code: **AMH**  
Description: **Manhole**

Distance (ft): **.0**  
Structural Grade: **0**  
O&M Grade: **0**  
Clock Start/From:  
Clock To:  
1st Value:  
2nd Value:  
Value Percent:  
Continuous Index:  
Within 8" of Joint: **NO**  
Remarks: **M-209-016**

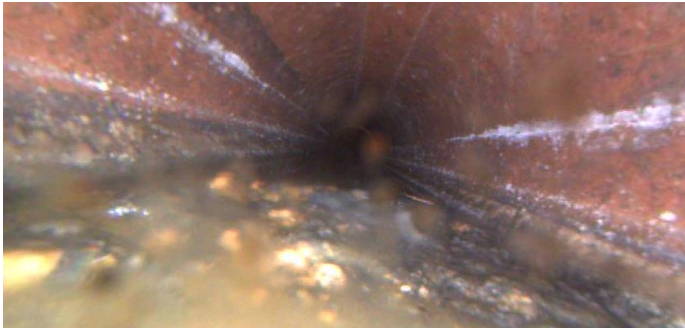
Code:	<b>MWL</b>
Description:	<b>Water Level</b>

Distance (ft):	<b>.0</b>
Structural Grade:	<b>0</b>
O&M Grade:	<b>0</b>
Clock Start/From:	
Clock To:	
1st Value:	
2nd Value:	
Value Percent:	<b>25.000</b>
Continuous Index:	
Within 8" of Joint:	<b>NO</b>
Remarks:

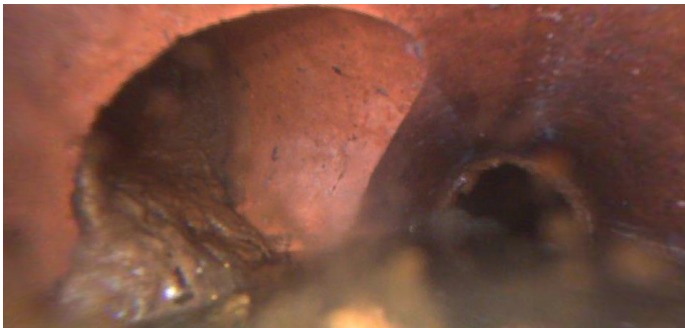
Code:	<b>TFD</b>
Description:	<b>Tap Factory Defective</b>

Distance (ft):	<b>5.6</b>
Structural Grade:	<b>0</b>
O&M Grade:	<b>2</b>
Clock Start/From:	<b>10</b>
Clock To:	
1st Value:	<b>4.000</b>
2nd Value:	
Value Percent:	
Continuous Index:	
Within 8" of Joint:	
Remarks:	<b>DSF</b>

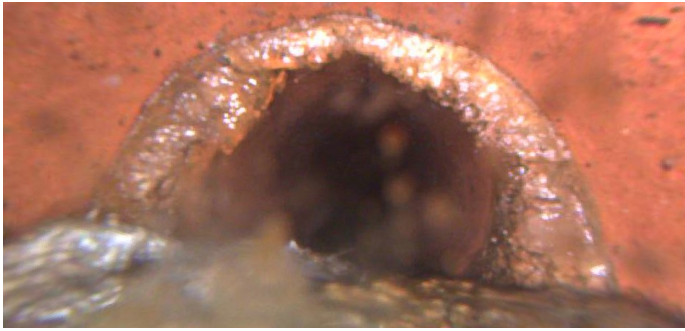
Code: **DAE**  
Description: **Deposits Attached Encrustation**

Distance (ft): **6.8**  
Structural Grade: **0**  
O&M Grade: **3**  
Clock Start/From: **9**  
Clock To: **3**  
1st Value:  
2nd Value:  
Value Percent: **15.000**  
Continuous Index:  
Within 8" of Joint: **YES**  
Remarks:

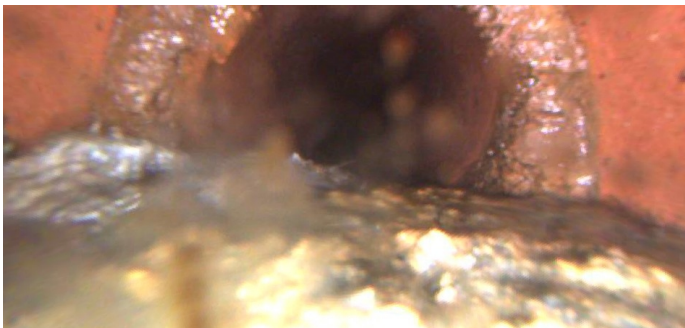
Code: **OBZ**  
Description: **Obstacle Other**

Distance (ft): **6.8**  
Structural Grade: **0**  
O&M Grade: **4**  
Clock Start/From: **4**  
Clock To: **8**  
1st Value:  
2nd Value:  
Value Percent: **25.000**  
Continuous Index:  
Within 8" of Joint: **NO**  
Remarks: **Mixed materials**

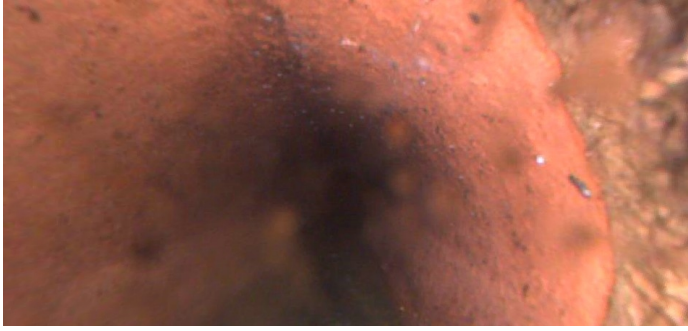
Code:	<b>MSA</b>
Description:	<b>Abandoned Survey</b>
Distance (ft):	<b>8.0</b>
Structural Grade:	<b>0</b>
O&M Grade:	<b>0</b>
Clock Start/From:	
Clock To:	
1st Value:	
2nd Value:	
Value Percent:	
Continuous Index:	
Within 8" of Joint:	<b>NO</b>
Remarks:	<b>OBZ</b>
